**ACCIDENT**

| <b>Aircraft Type and Registration:</b> | Boeing 737-800, EI-DLV | |
| <b>Nature of Damage:</b> | Failure of left nose landing gear axle and separation of left nosewheel | |

**Synopsis**

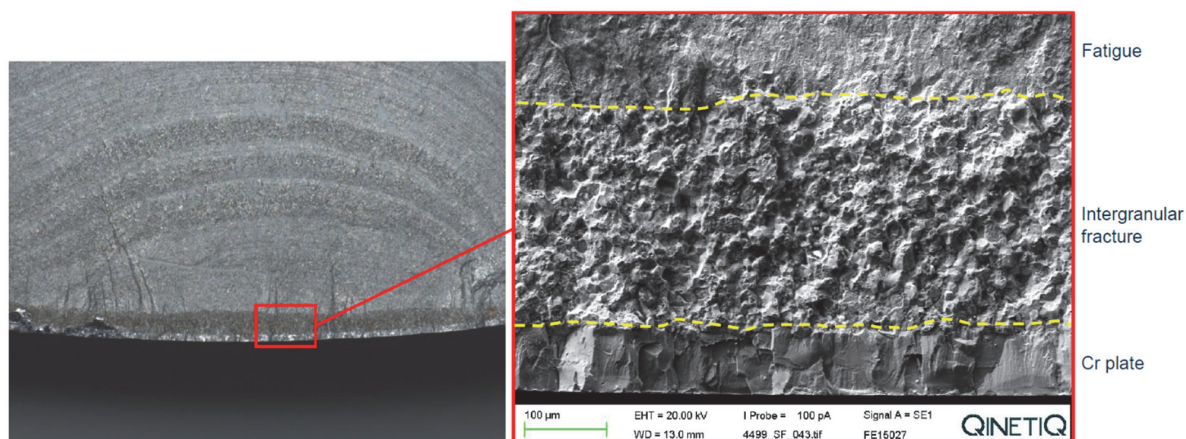
**Figure 4**

Visual examination of the chrome plating showed some surface cracking adjacent to the fracture in a direction perpendicular to the axle, but there was no widespread cracking. A fluorescent dye penetrant inspection (FPI) revealed additional cracks, in the same

direction, in the area of the main initiation point on both the inboard and outboard surfaces of the axle. A FPI of the left outboard journal and both journals on the right axle did not reveal any cracks.

Scanning Electron Microscope image of primary crack initiation site  
(near 6 o'clock position)

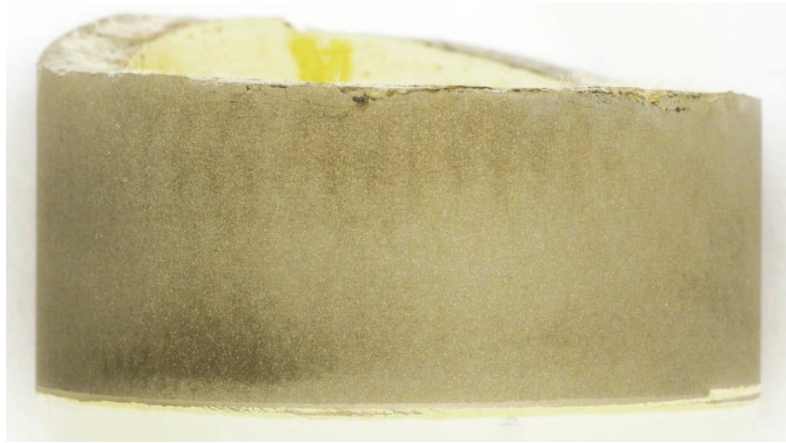
**Figure 5**

The NLG cylinder was sent to the aircraft manufacturer for a Barkhausen inspection. This is a non-destructive inspection that uses a sensor to measure the material's magnetic properties. It can detect heat damage in steel beneath non-ferromagnetic coatings such as chrome. When applied to the failed journal it detected a raised Barkhausen response, consistent with base metal heat damage in the area around the 6 o'clock position. A similar but smaller area of base metal heat damage was also detected on the outboard journal of the intact right axle, also near the 6 o'clock position. The remaining two journals did not exhibit any heat damage. The base metal heat damage was subsequently confirmed following the removal of the chrome plate. Nital etch<sup>2</sup> revealed characteristic dark patches in the areas with the raised Barkhausen response (Figure 5). The aircraft manufacturer stated that these dark patches indicated that the steel microstructure had changed to overtempered martensite (OTM), also known as a re-tempering burn. This can occur if the part is excessively heated during grinding of the chrome plating and is commonly referred to as 'abusive grinding'.

An examination of the wheel bearings showed that they were in good condition and rotated freely indicating that bearing deterioration did not contribute to the heating of the axle bearing journals. The bearing covers about half the width of the axle bearing journal and yet the heat damage expanded nearly the entire width of the journal. Given this information, the aircraft manufacturer concluded that the only explanation for the base metal heat damage was that it had occurred during post-plating grinding.

Lower face of the failed axle after chrome removal.  
The dark areas are evidence of heat damage

When the base metal becomes overtempered from abusive grinding, there is a softening of the material and its strength reduces. The heating also causes a significant change in residual stress from compressive stresses on the surface to tensile stresses which increase the part's susceptibility to cracking. During an abusive grinding event there is rapid localised heating followed by rapid cooling which results in thermal strain that can cause heat-induced cracking. During subsequent cadmium plating of other parts of the inner cylinder, hydrogen can diffuse into areas of tensile stress causing hydrogen embrittlement cracking. This can occur during the period between the cadmium plating and the stress relief bake which removes the hydrogen. These cracks can then propagate in service due to SCC or fatigue or both.

The initial cracks had developed because the journal, whilst being overhauled, had experienced a re-tempering burn near the 6 o'clock position during post-chrome plate grinding. This abusive grinding would have resulted in heat-induced cracking in the base metal that probably grew by hydrogen embrittlement cracking during the cadmium plating process, prior to the stress relief bake. If the cracks had extended through the chrome surface from the base metal then they were probably microscopic cracks as they were not detected during the post-grinding visual inspection. The MPI did not detect any cracks but it will not detect cracks in non-ferrous material such as chrome, and it may not detect cracks in steel beneath a chrome layer. There was no requirement to perform an FPI which might have detected cracks in the chrome plating. Because no cracks were detected, the part was returned to service. Over time, in-service axle flexure caused fatigue cracks to initiate from the hydrogen embrittlement region, and propagate through the wall of the axle. This flexure probably also caused through thickness cracks to develop in the chrome plating, at locations coincident with the base metal cracks. These cracks would have allowed moisture to reach the advancing crack tip and cause the fracture to continue to propagate by the observed alternating modes of SCC and fatigue, until final ultimate fracture occurred by ductile separation through the remaining intact axle wall.

To ensure that any abusive grinding is detected, the MRO of EI-DLV has introduced a new process to perform a Barkhausen inspection on all journals after grinding. The MRO has also introduced a Barkhausen inspection early in the overhaul process, prior to the Nital etch test.

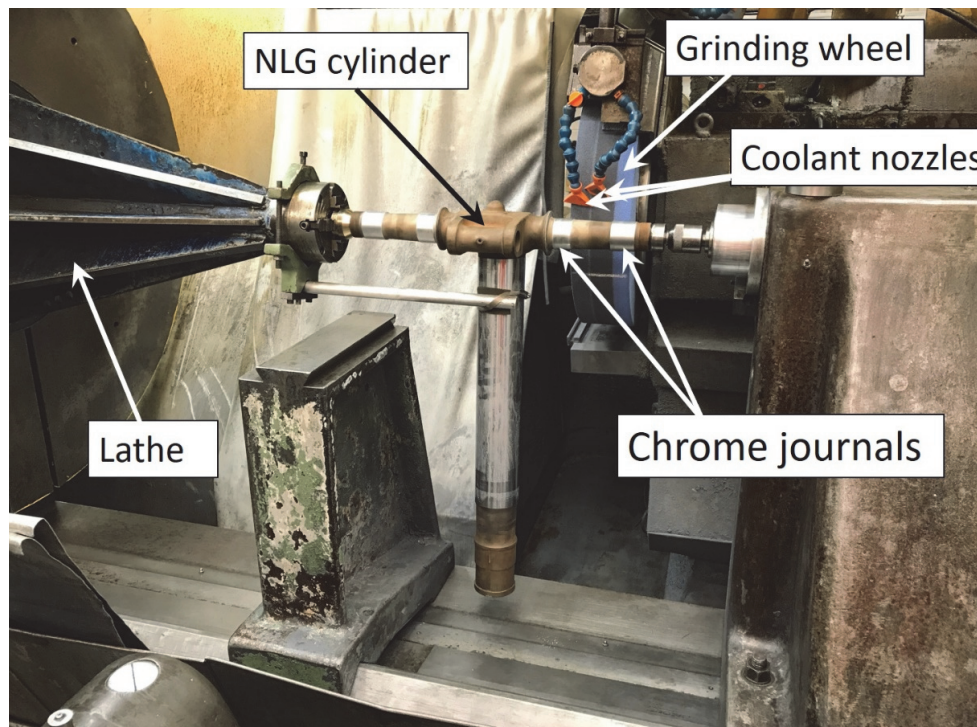
**Figure 6**

The grinding was then carried out using a manual grinder. The basic setup of the grinder, grinding wheel and the NLG cylinder is shown in Figure 6. The process is manual and involves the operator turning a wheel to move the grinding wheel towards the cylinder which is rotated by the grinder at a speed of 20 rpm. Before starting the grinding operation, the operator uses a Dial Test Indicator (DTI) gauge to measure any high spots on the journals and then marks them with a chinagraph pen. With the grinding wheel stationary, it is then slowly brought towards the rotating cylinder until first contact, which is the highest spot. The digital reader on the machine is then zeroed and the wheel is brought back by 0.1 inches. During the grinding operation there is a ratchet on the handle which prevents the wheel being moved in by more than 0.0001 inches between movements of the ratchet. Checks are carried out and the grinding wheel is dressed (sharpened) after every 0.003 inches to 0.005 inches of material removal.

MRO's grinding setup for the NLG cylinder

As part of the investigation, the MRO carried out some grinding tests to see if there were any deflections of the part during spinning due to an imbalance. Because of the long cylinder at right angles to the axle, the part is not balanced about the rotational axis. The aircraft manufacturer stated that a counterweight might need to be added; however, tests at different speeds using a DTI gauge to measure deflection did not reveal any variations, so the benefit of installing a counterweight is not clear. During one of the tests observed by the AAIB, the DTI gauge indicated a fluctuation of 0.001 inches during rotation of the part. This could not be explained and subsequent tests did not reveal the same level of fluctuation. It is possible that differences in the setup could result in the part sometimes not being spun concentrically which could increase the chance of inadvertent contact with the grinding wheel.

As some of the manufacturer's SOPM instructions, such as wheel dressing, are open to interpretation, the MRO is developing an internal protocol for grinding so that there is greater consistency among grinding operators.
