AAIB Special Bulletins / Interim Reports

Aircraft Type and Registration:	EC225 LP Super Puma, G-REDW	
No & Type of Engines:	2 Turbomeca Makila 2A1 turboshaft engines	
Year of Manufacture:	2009 (Serial no: 2734)	
Date & Time (UTC):	10 May 2012 at 1114 hrs	
Location:	20 nm east of Aberdeen	
Type of Flight:	Commercial Air Transport (Passenger)	
Persons on Board:	Crew - 2	Passengers - 12
Injuries:	Crew - None	Passengers - 2 (Minor)
Nature of Damage:	Salt water immersion	
Commander's Licence:	Airline Transport Pilot's Licence	
Commander's Age:	40 years	
Commander's Flying Experience:	3,060 hours (of which 2,740 hours were on type)	
Information Source:	AAIB Field Investigation

Aircraft Type and Registration:	EC225 LP Super Puma, G-CHCN	
No & Type of Engines:	2 Turbomeca Makila 2A1 turboshaft engines	
Year of Manufacture:	2007 (Serial no: 2679)	
Date & Time (UTC):	22 October 2012 at 1425 hrs	
Location:	In the North Sea, approximately 32 nm southwest of Sumburgh, Shetland Islands	
Type of Flight:	Commercial Air Transport (Passenger)	
Persons on Board:	Crew - 2	Passengers - 17
Injuries:	Crew - None	Passengers - None
Nature of Damage:	To be assessed following salt water immersion	
Commande

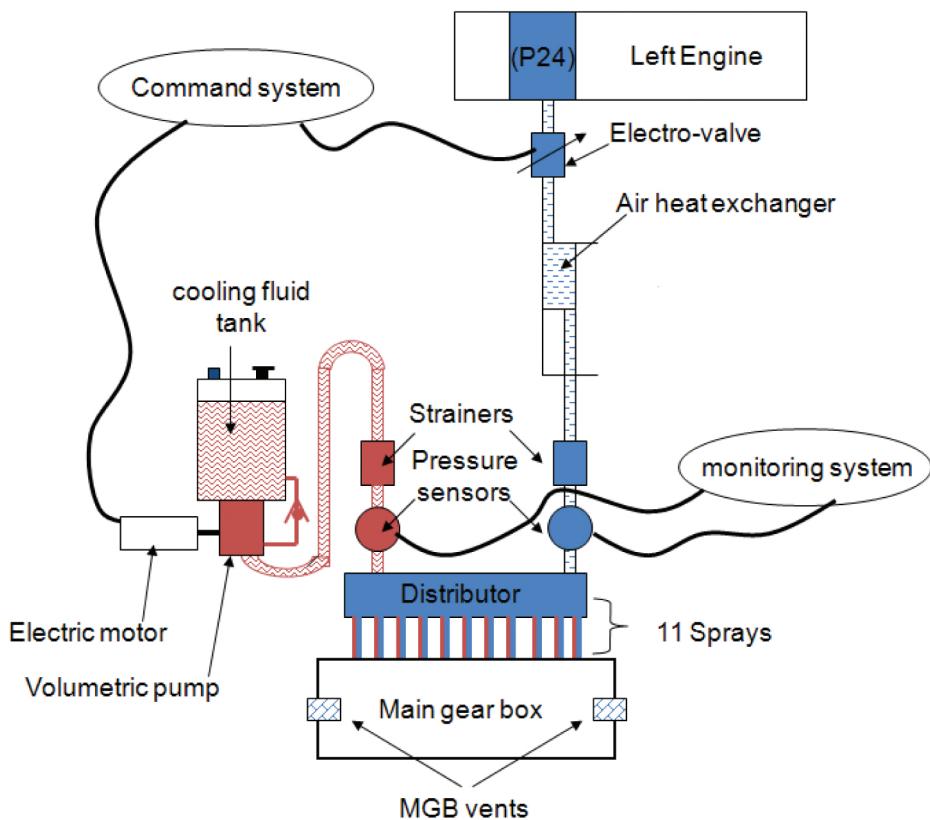
Figure 1

When the emergency lubrication system is activated an electro-valve, called the P2.4 valve, opens and bleed air from the left engine enters the system, after passing through an air heat-exchanger. At the same time, an electric pump supplies Hydrosafe 620 from the reservoir. There are two similar sensors that monitor the pressure in the Hydrosafe 620 pipes and bleed air lines; these sensors are mounted on the MGB. A MGB EMLUB caption will illuminate if low pressure is detected in either the Hydrosafe 620 pipes or the bleed air lines. This warning is inhibited for approximately 30 seconds after the system is activated, to allow the system to reach a steady state.

The low pressure signal is generated by either the bleed air or Hydrosafe 620 pressure sensors if the pressure does not exceed a specified pressure value, p_{on} , when the system is activated, or the pressure subsequently falls below a specified pressure, p_{off} .

Schematic of the Emergency Lubrication System

It is recommended that the European Aviation Safety Agency requires Eurocopter to review the design of the main gearbox emergency lubrication system on the EC225 LP Super Puma to ensure that the system will provide the crew with an accurate indication of its status when activated.

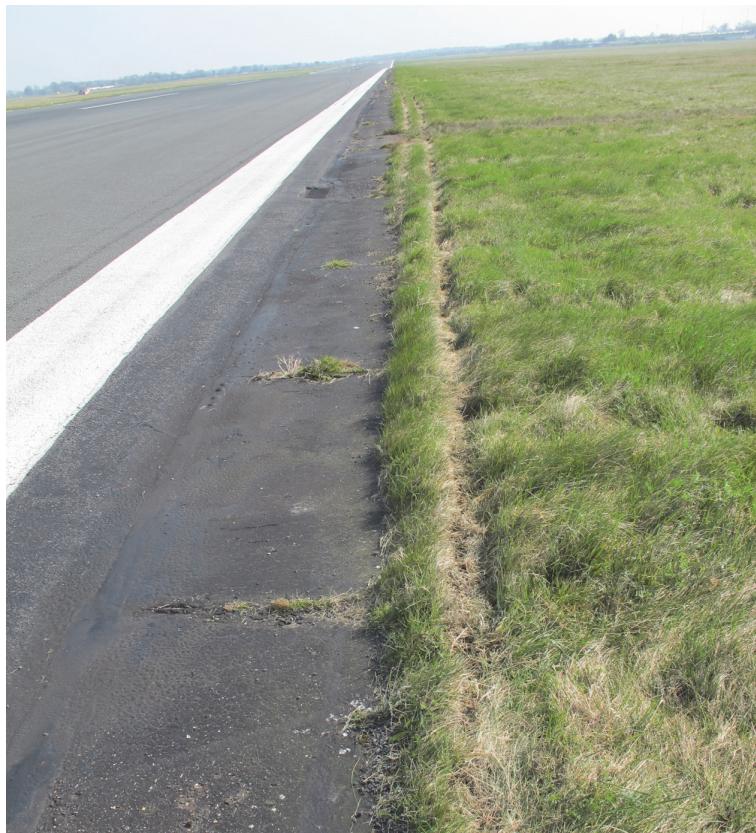
Figure 2

The airfield was inspected by the airport operator and the AAIB. Tyre marks from G-BWWT were found on the runway and grass, with a broken lens from a runway edge light. Tyre tracks from the right landing gear wheels are shown at Figure 2.

Photograph of runway excursion by right main landing gear

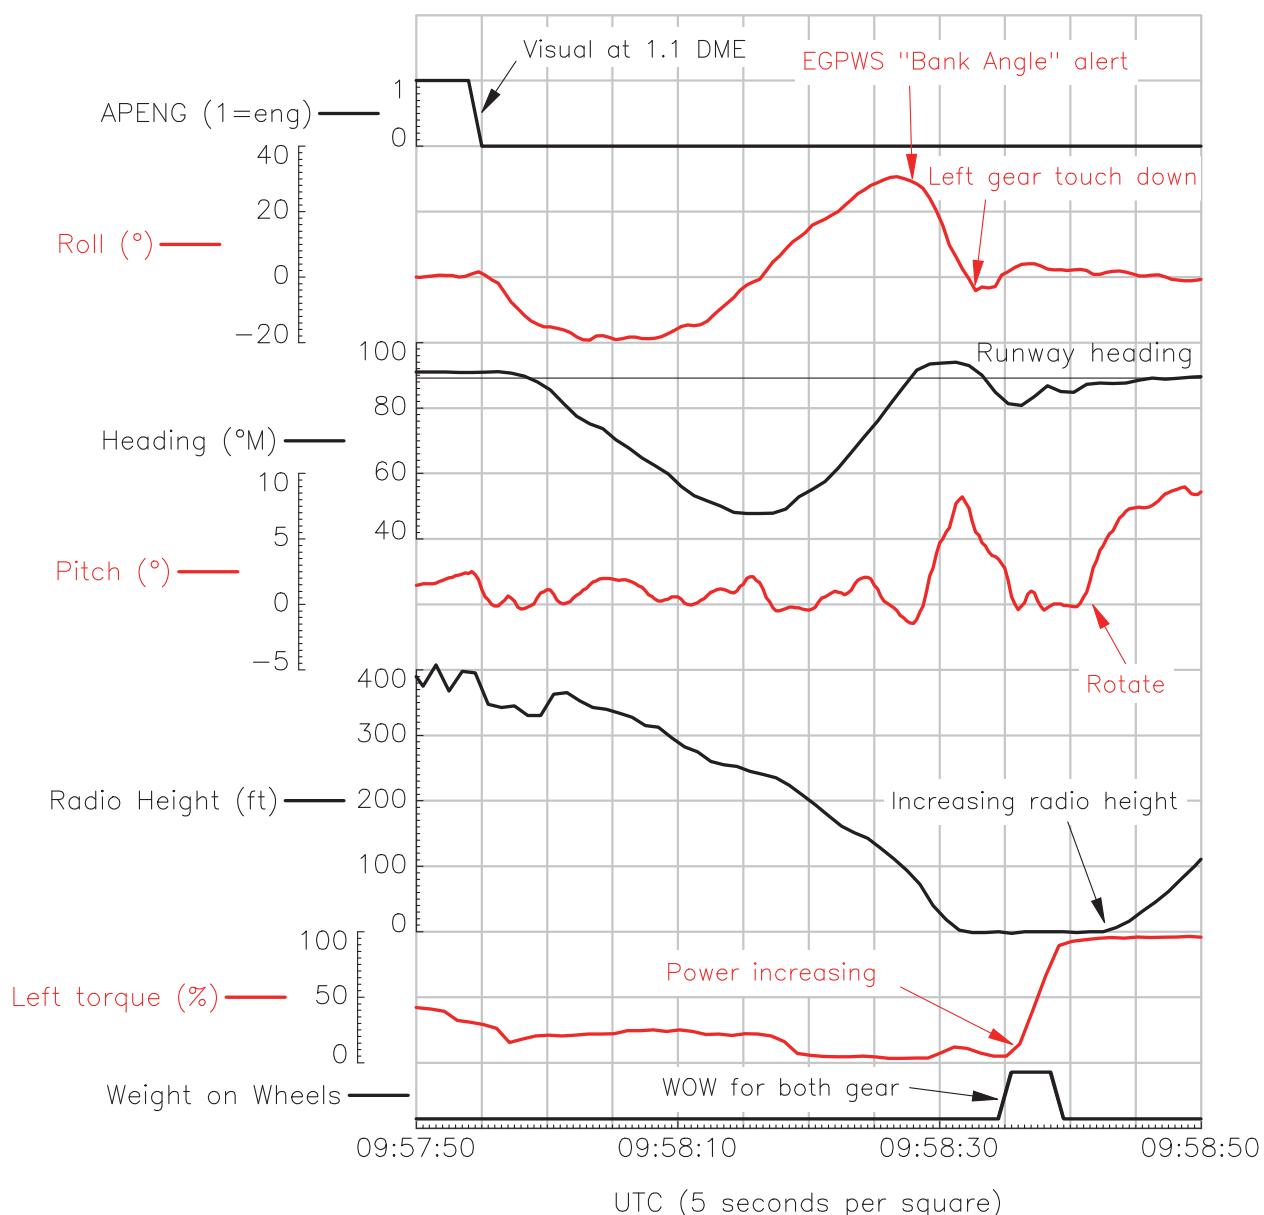
Figure 3
FDR plot of final approach

The aircraft was fitted with an FDR and a CVR but the CVR evidence was over-written before the AAIB had been notified of the incident. The FDR recording captured the event flight, including the first approach, shown in Figure 3.

The recordings showed that the A/P was engaged with a lateral mode of HEADING SELECT for the whole approach. The A/P pitch mode transitioned from ALT HOLD to VERTICAL SPEED for the descent but at approximately 460 ft aal switched back to ALT HOLD. After a further 10 seconds the autopilot was disengaged and control inputs to correct the aircraft's position were initiated. This is considered to be the point at which the crew became visual with the runway.

The aircraft then banked left 19°, at about 330 ft aal, followed by a right bank of 30°, at about 110 ft aal, which was transitioning to a left bank at the point of touchdown. The data indicated that the left gear touched down first with the aircraft on a heading of 093°M, to the right of the runway heading but turning towards it. Approximately two seconds later the right gear touched down and the heading was 081°M, to the left of the runway heading with the engine torque values starting to increase. Four seconds later the 'weight-on-wheels' parameter and pitch attitude indicated liftoff and the radio altimeter showed positive height after a further four seconds.

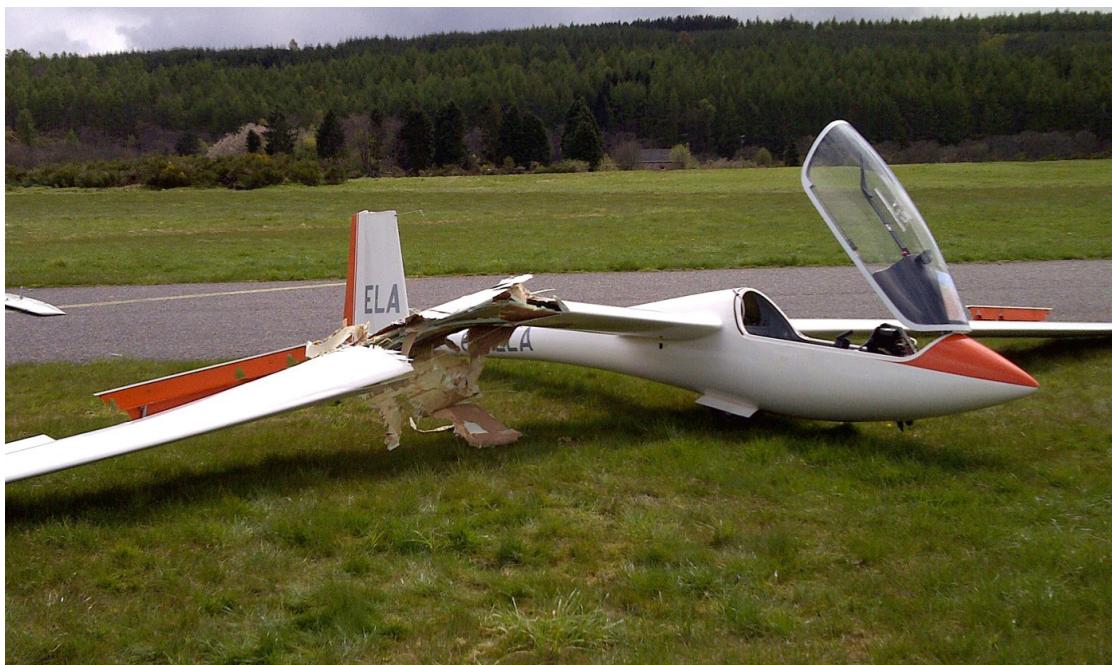
left at about the 10 o'clock position, and he instinctively applied full left rudder to avoid the microlight, but then there was a loud bang as the glider's right wing struck G-MZBA. When the dust cleared he found that his aircraft had come to rest on the northern side of the runway facing towards the north (Figure 2). He was not injured and was able to exit the glider unaided.

Figure 2
Damage to right wing of G-DELA
(photograph courtesy Martin Gallagher)
