5X007-0/05
November 2006

Investigation Report

Type of occurrence: Serious incident
Date: 12 March 2005
Location: Stuttgart
Aircraft: Transport aircraft
Manufacturer / Type: British Aerospace / BAe 146-300
Injuries to persons: No injuries
Damage: Aircraft not damaged
Other damage: None
Information Source: Investigation by BFU

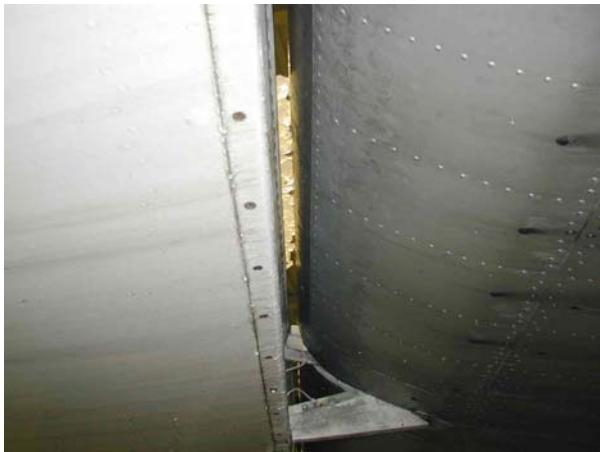
The airplane was examined immediately after the landing and significant amounts of frozen and swollen up de-icing fluid residues were found in the gap between elevator and horizontal stabilizer and in the area of ailerons and rudder.

Frozen residues between elevator and horizontal stabilizer on a BAe 146

- Several de-icing procedures with thickened de-icing fluids (Type II) caused an accumulation of dry fluid residues (polymer residues) in the gap between elevator and horizontal stabilizer.
- Due to atmospheric exposure these highly hygroscopic residues absorbed, from the surrounding air, a multiple of their own weight of water, became a gel-like mass and swelled-up to many times their original volume.
- With low ambient air temperatures the oversaturated gel froze increasing its volume to such an extent that it jammed the elevator and horizontal stabilizer.

The airplane's elevator and wings were cleaned according to the airplane manufacturer's specifications. During the flights conducted afterwards autopilot and controls functioned properly again. The operator's documentation showed that the airplane in question had the most de-icing procedures per cleaning cycle.

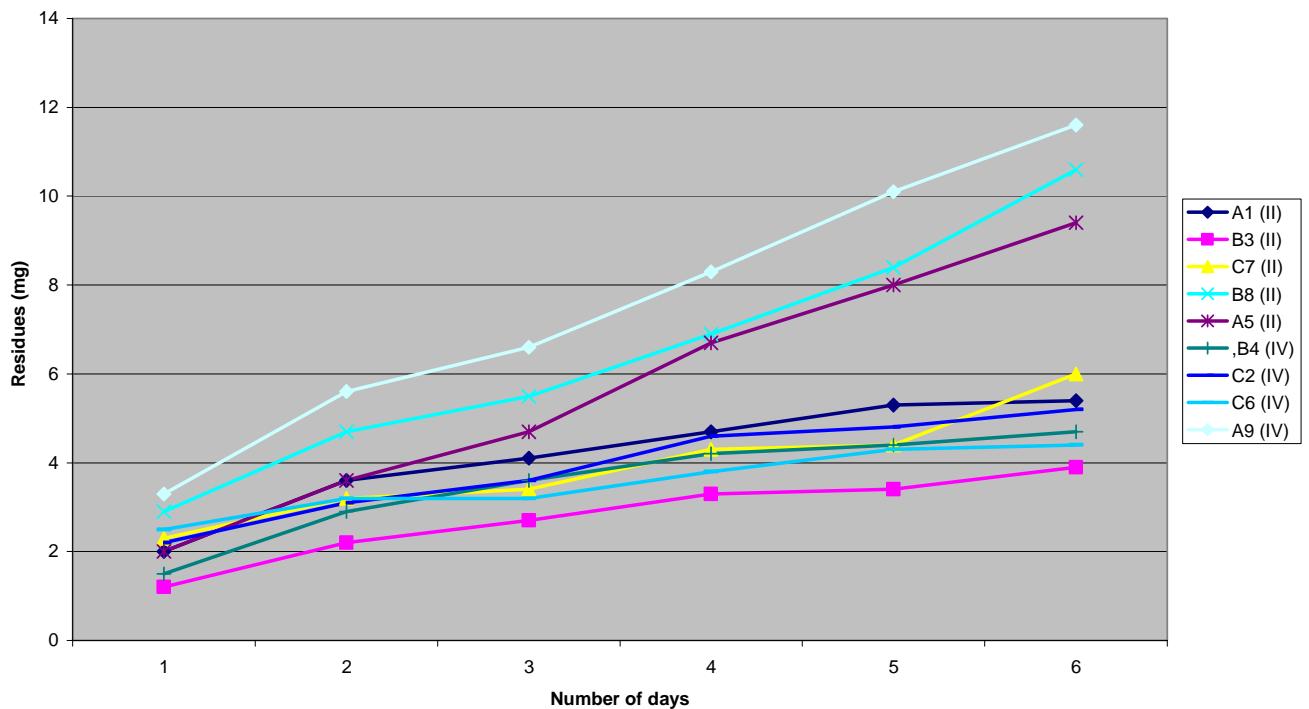
Residue - Type II / IV (100 %)

Comparison of the undiluted products shows that each de-icing procedure increases the amount of dried fluid residue. Furthermore, the test results show quite clearly that Type IV fluids do not generally produce more dried fluid residues than Type II fluids. Under consideration of water absorptivity the evaluation sequence may reverse totally like Type IV fluid A9 shows.

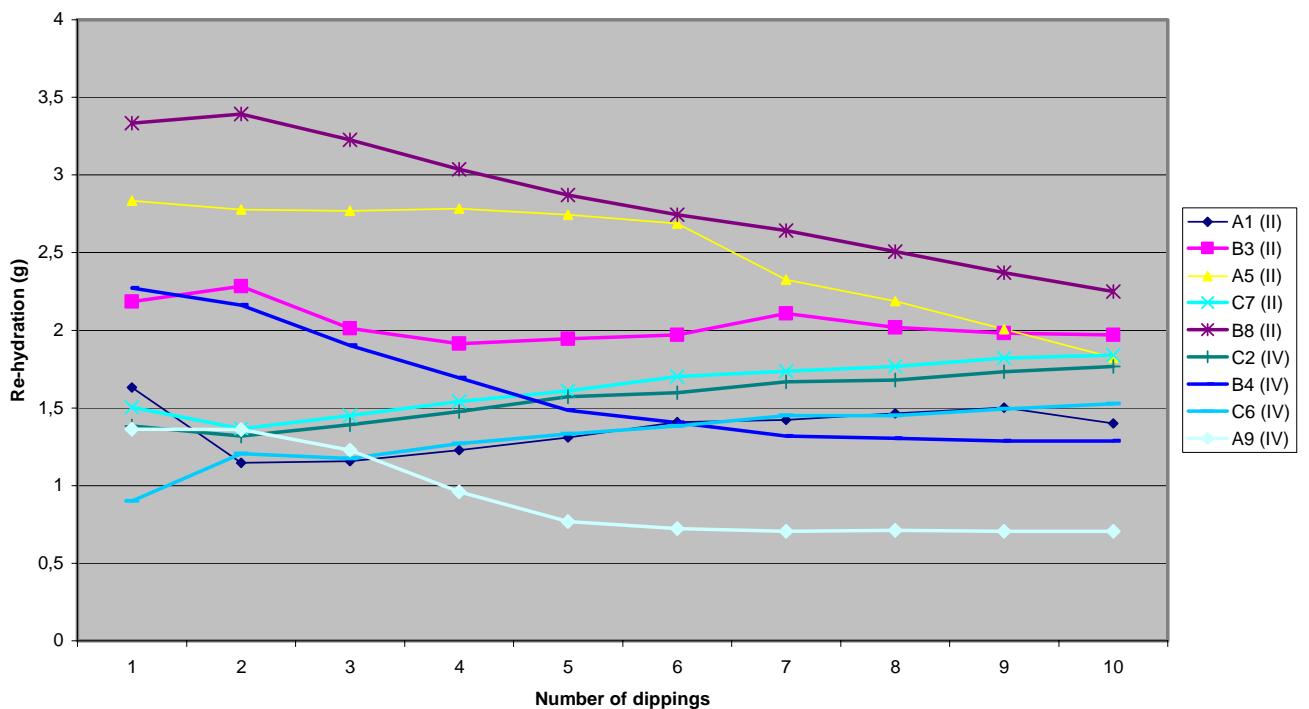
Rehydration - Type II / IV (100 %)

The quality factor is only then an evaluation factor for the product if water absorptivity is the basis for the evaluation. In this case, the product A9 would rank first. Since the control problems are caused by the freezing of the gel mass it is legitimate to favour the product with the least gel formation. In this case C6. It is remarkable, however, that with both evaluation criteria a Type IV fluid ranks first. Merely if the dried fluid residues are the evaluation criteria the Type II fluid B3 would rank first.

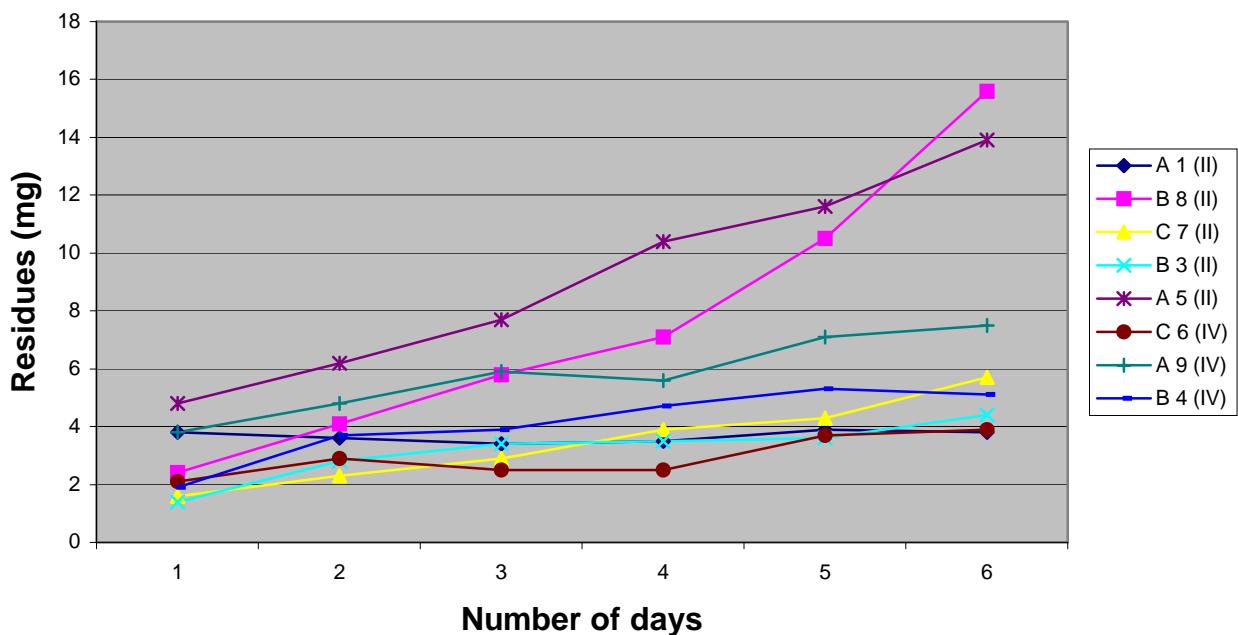
Residue - Type II / IV (50 : 50)

Another important realisation is the fact that dilution of the products does not reduce the amount of dried fluid residues. If anything, the opposite is the case like the product B8 shows. The performance of undiluted products and the outcomes of diluted and mixed product application, as discussed above,
