Investigation Report

Type of Occurrence:	Serious incident
Date:	4 April 2012
Location:	Near Lugano, Switzerland
Aircraft:	Airplane
Manufacturer / Model:	Boeing / 737-800
Injuries to Persons:	13 persons suffered minor injuries
Damage:	None
Other Damage:	None
Information Source:	Investigation by BFU
State File Number:	BFU FX003-12

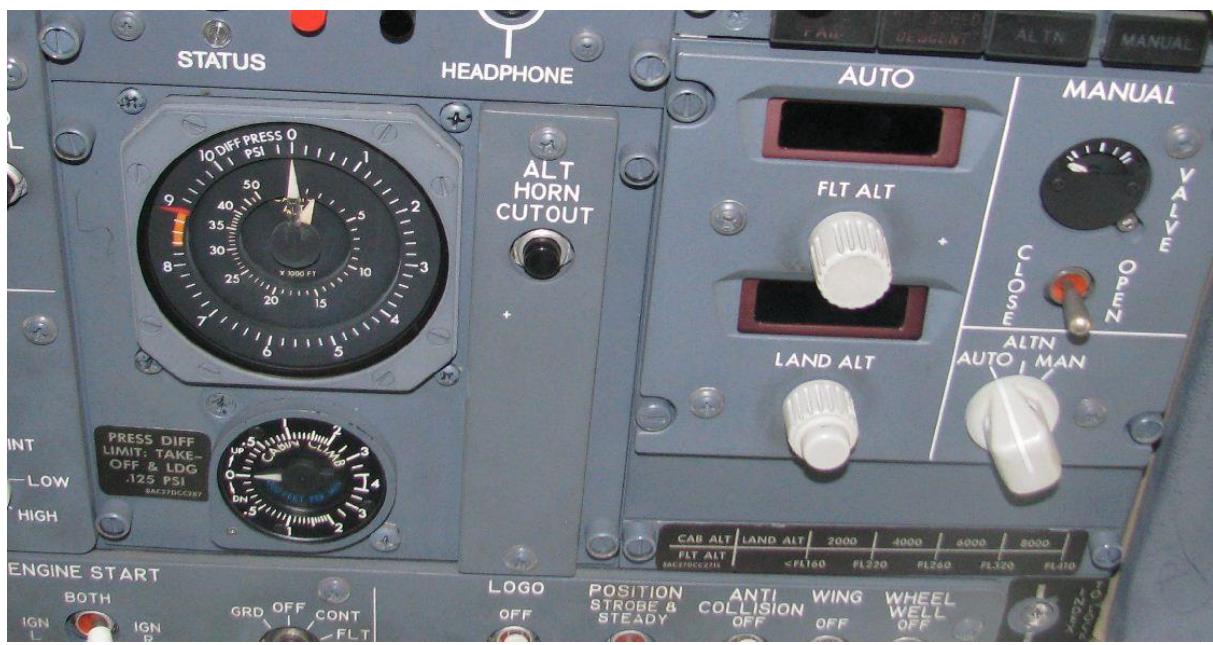
The operating and indication panel of the digital cabin pressure control system was part of the overhead panel in the cockpit. Indications for the cabin altitude and the differential pressure, the cabin rate of climb indicator (maximum 4,000 ft/min) and the outflow valve position indicator were installed.

Digital Cabin Pressure Control System

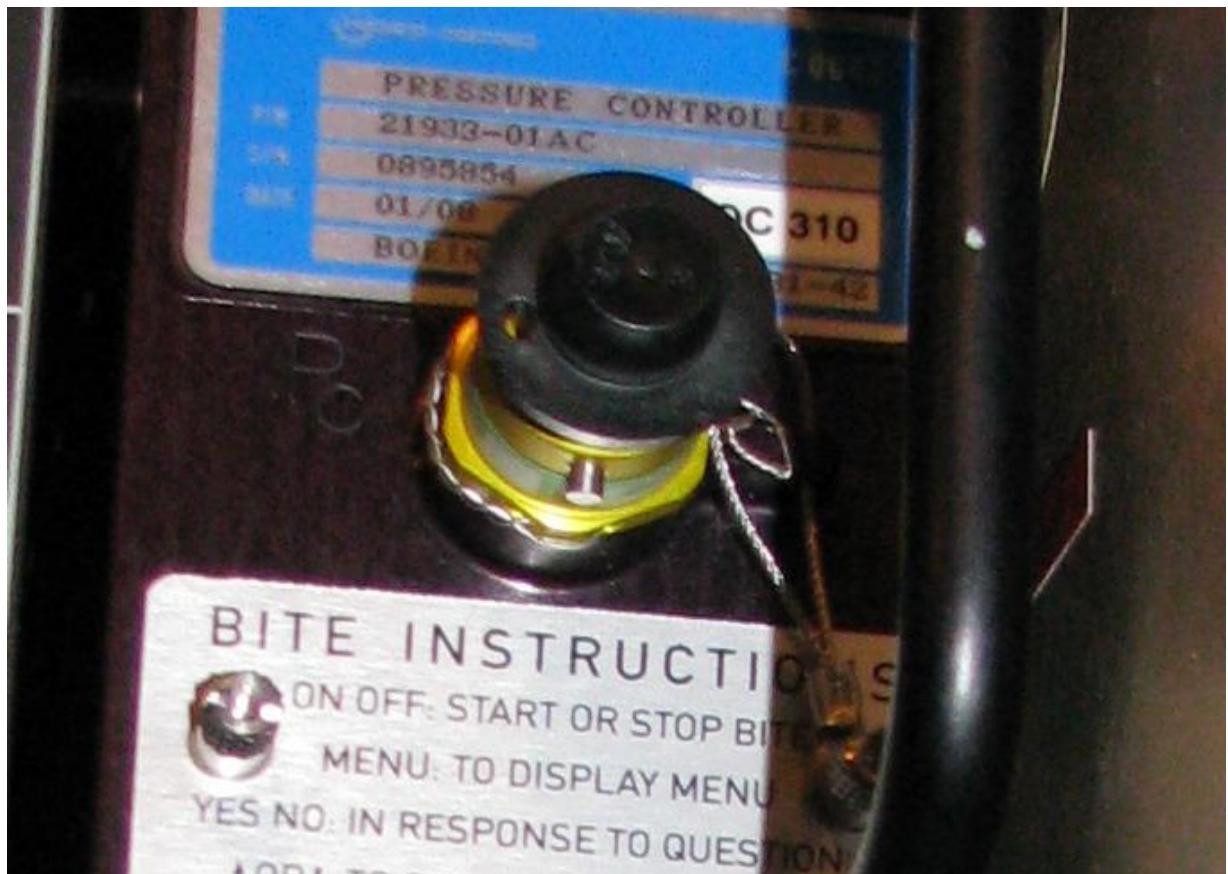
The two CPCs were located in the electronic equipment compartment behind the nose landing gear. The static port sensor on the CPC#1 was covered with a black shipping plug.

Cabin Pressure Controller #1 Static Port

In case a CPC with a covered static port is in control from the beginning of a flight, depressurisation in the cabin occurs early and gradually. If the control change from one CPC to the next occurs in high altitudes depressurisation is immediate and more intense. It is then highly likely that an emergency descent is the result. Due to the extension of air and gases in body cavities of occupants the development of Barotrauma is possible which may result in serious injuries.

The black shipping plug did not stand out from the black surface of the CPC housing. Colour and shape of the shipping plug were very similar to the thumbscrew holdown

- Due to an omission during the installation of the cabin pressure controller the shipping plug was not removed from the static port as required by written procedure.
- During the flight a pressure difference was measured and the OFV opened which resulted in rapid decompression.

The Federal Aviation Administration (FAA) should require Boeing to re-design the shipping plugs in a way which makes them more recognisable. The shipping plugs should also be coupled with an eye-catching tag.

Maintenance and Repair Organisations should only cover the static ports of a cabin pressure controller with a shipping plug which is clearly visible coupled with a tag.

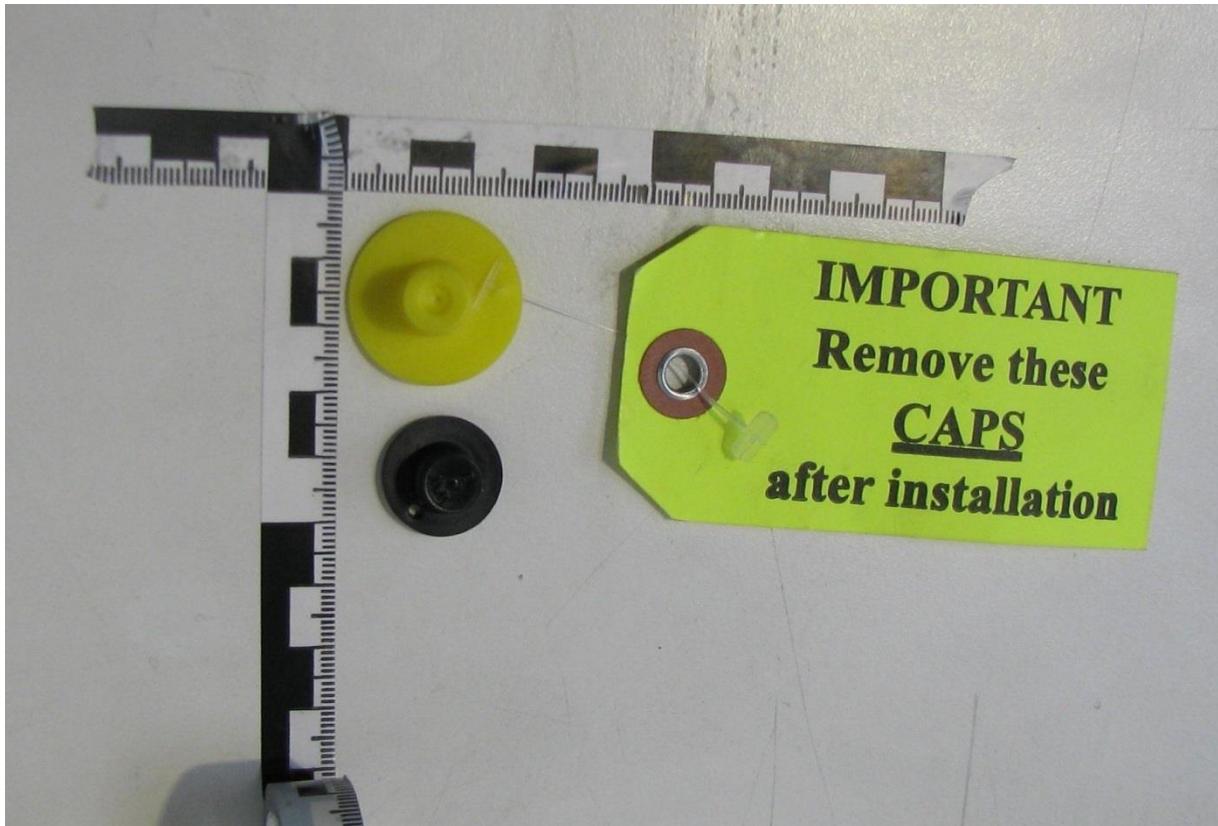
During the BFU investigation of the serious incident the maintenance organisation at Frankfurt Hahn Airport changed the two CPCs after the data had been downloaded. The replaced CPCs were equipped with shipping plugs which were yellow and larger than the ones found on the removed CPCs. They also carried a yellow tag with the sign: **IMPORTANT – Remove these CAPS after installation.**

Different shipping plugs of the component manufacturer

used to hold the avionic equipment in place. Nord Micro stated the drill hole in the shipping plug's side was meant to hold a tag. It is likely that the tag had fallen off. It could not be determined as to when the tag had fallen off. Such a tag can be viewed as a defence much as a shipping plug which is easily recognisable. In the case at hand it was not present and was insufficient, respectively.

The BFU is of the opinion that the shipping plug should be designed in a way that it stands out from its surroundings. This could be ensured by shape and colour. However, the BFU is of the opinion that it would be best if the shipping plug had a tag which is noticeable and long enough to cover the keys of the CPC which the maintenance personnel needs to use for the pressurisation system ground test. Mistakes would be easier recognised and eliminated and resulting consequences could be avoided.

Shortly after the event on July 2, 2012, Boeing began working with the supplier (Nord-Micro) to evaluate and address the cap color issue. As a result of these discussions, Nord-Micro implemented a process change to exclusively use yellow shipping plugs and orange shipping tags on cabin pressure controllers. The Boeing Certificate Management Office is ensuring the process change remains in place.

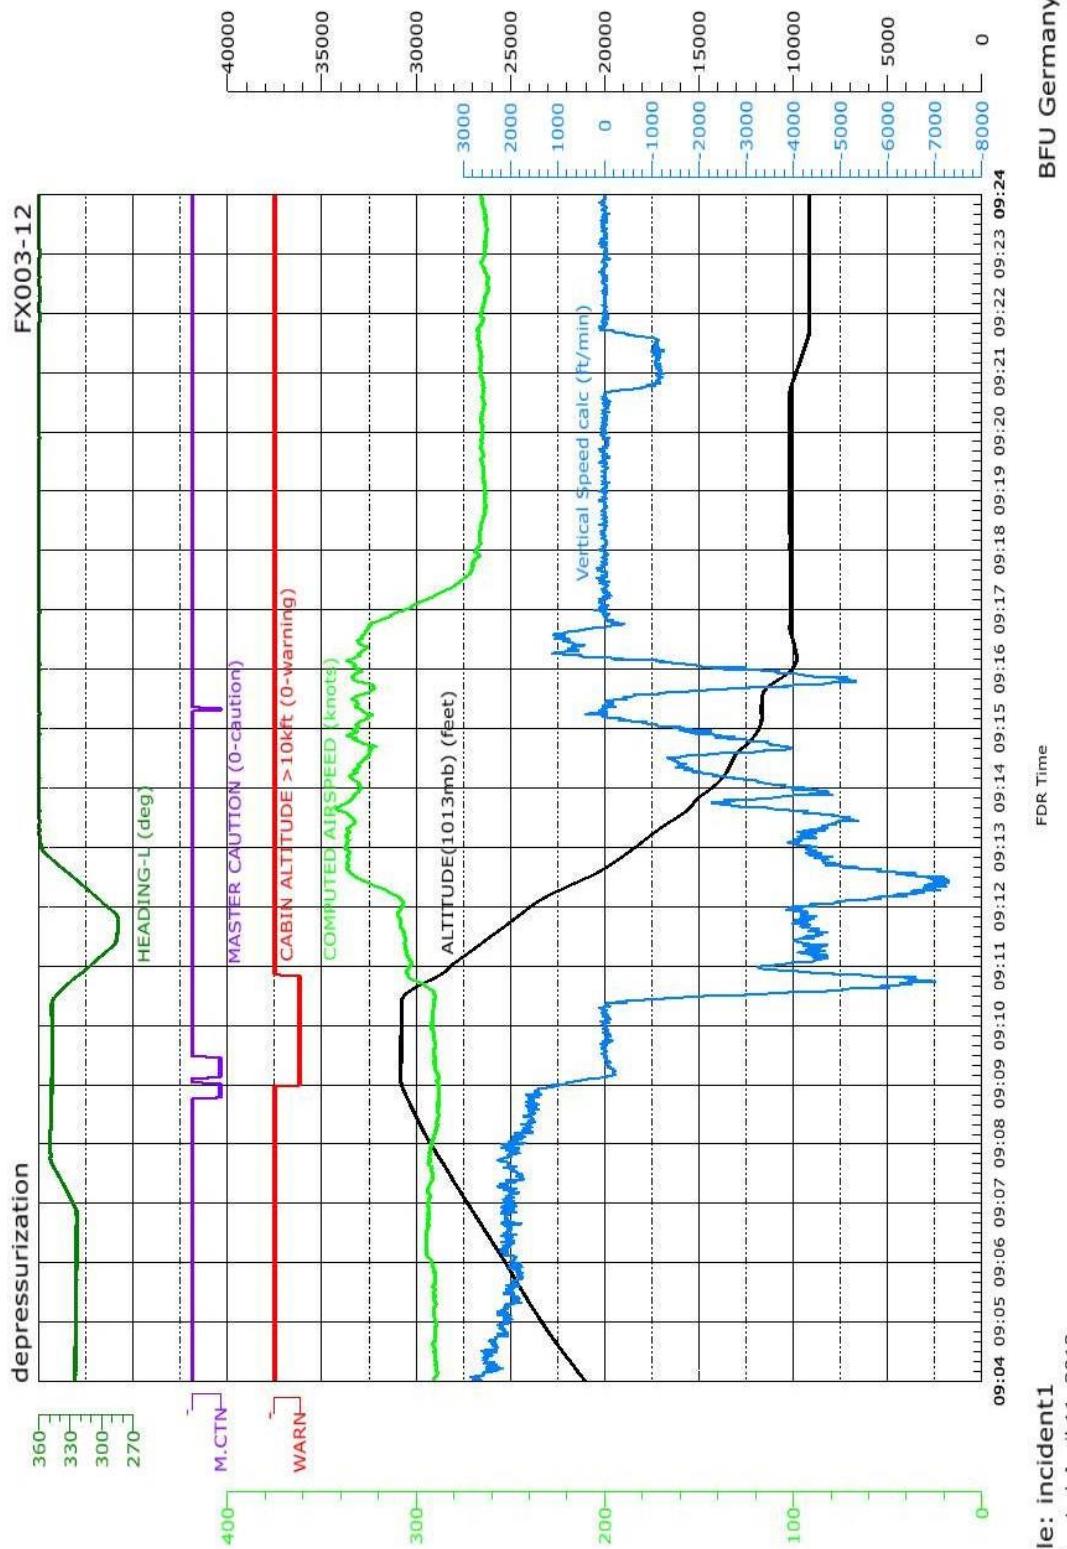
Excerpt FDR data

The data of the Flight Data Recorder (FDR) showed that at 1108:40 hrs the Master Caution and about 20 seconds later the cabin altitude warning (cabin altitude > 10,000 ft) was triggered. The warning ceased about two minutes later.

The data of the flight data recorder showed that at 1108:40 hrs the master caution and about 20 seconds later the cabin altitude warning (cabin altitude > 10,000 ft) was triggered. Further six seconds later the CPC recorded a cabin altitude of 13,500 ft at a rate of climb of 7,656.5 ft/min.
