Technical report

IN-049/2019

Incident involving two Boeing 737-8AS aircraft, registrations
EI-ENH and EI-DYR, on 11 September 2019 at Málaga
Airport

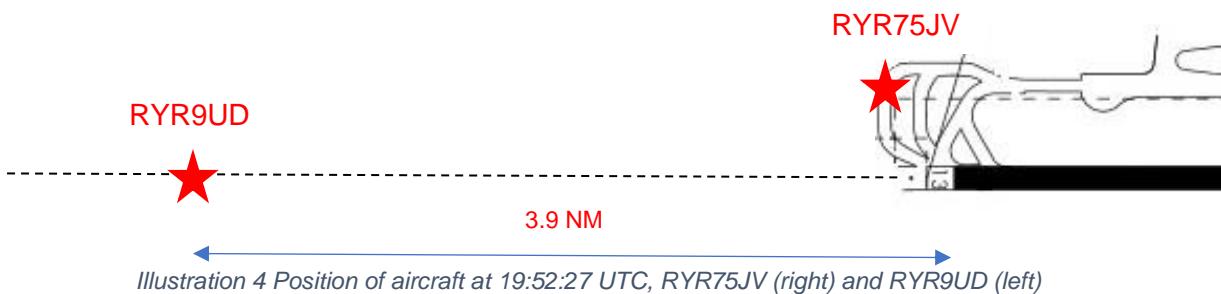
Illustration 4 Position of aircraft at 19:52:27 UTC, RYR75JV (right) and RYR9UD (left)

At 19:52:27 UTC, the trace shows aircraft RYR9UD established on final at 3.9 NM from the threshold of RWY13 with a ground speed of 168 kt. At that moment, the RYR75JV aircraft was at the HN-3 holding point signal.

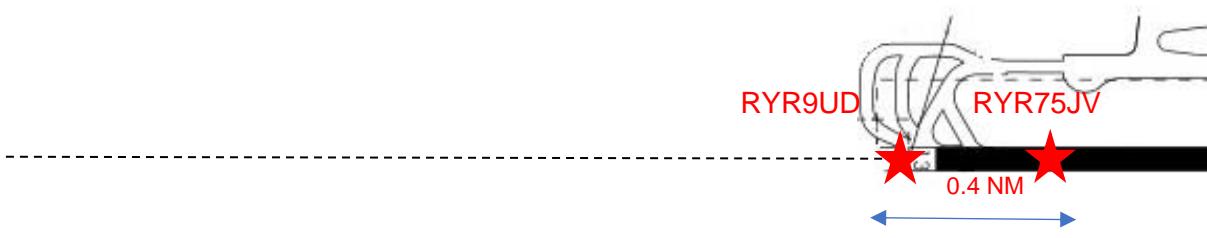
Illustration 7 Position of aircraft at 19:53:59 UTC

At 19:53:59 UTC, the trace shows aircraft RYR9UD established on short final at an altitude of 200 ft AMSL, and aircraft RYR75JV on its take-off run on RWY 13 at a speed of 94 kt (GS). The distance between the two aircraft was 0.4 NM.

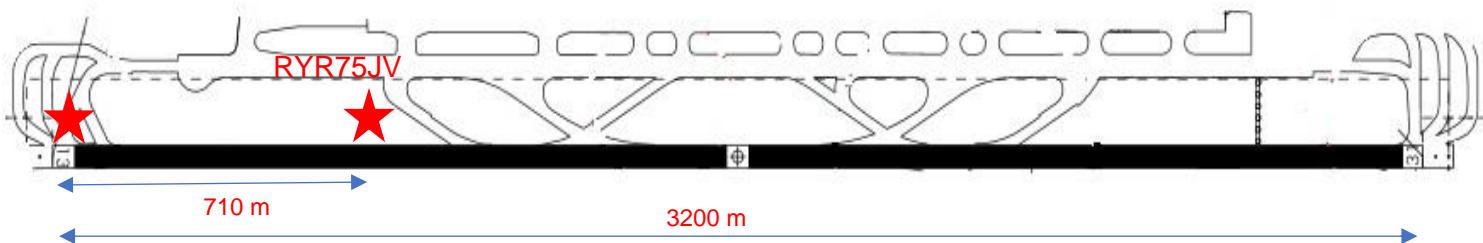
Illustration 8 Position of aircraft at 19:54:03 UTC

At 19:54:03 UTC, the trace shows aircraft RYR9UD over the threshold of RWY 13, travelling at an altitude of 100 ft AMSL and a speed of 150 kt (GS), and aircraft RYR75JV on its take-off run from the same runway at a speed of 111 kt (GS). The distance between the two aircraft was 710 m (0.38 NM).

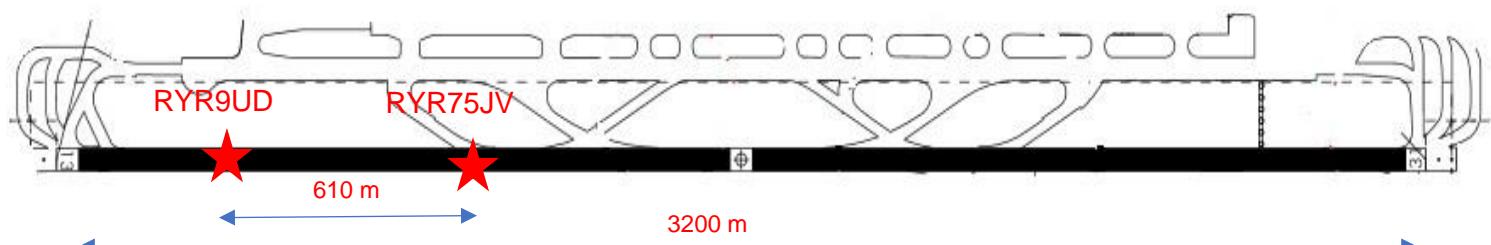
Illustration 9 Position of aircraft at 19:54:08 UTC

At 19:54:08 UTC, the trace shows aircraft RYR9UD over RWY 13 with its main landing gear not yet having made contact with the runway, and aircraft RYR75JV on its take-off run from the same runway, not yet having commenced rotation. The distance between the two aircraft was 610 m (0.33 NM)

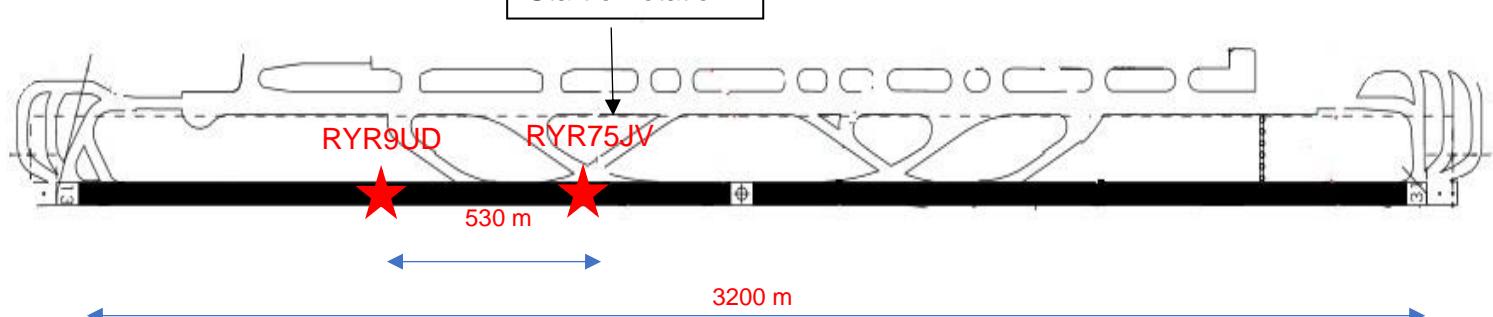
Illustration 10 Position of aircraft at 19:54:11 UTC

At 19:54:11 UTC, the trace shows aircraft RYR9UD over RWY 13 with its main landing gear not yet having made contact with the runway, and aircraft RYR75JV on its take-off run initiating the rotation manoeuvre (forward landing gear in the air and main landing gear on the ground). The distance between the two aircraft was 530 m (0.29 NM)

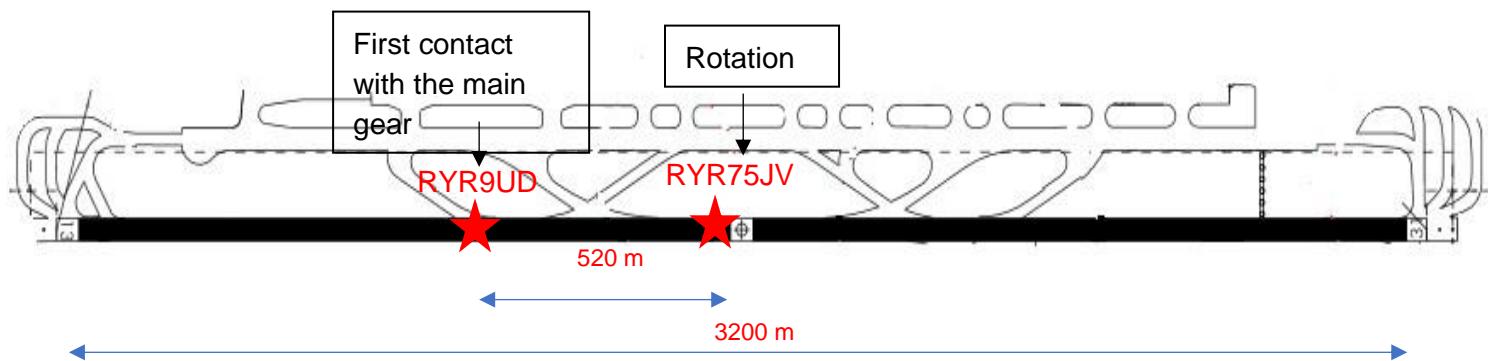
Illustration 11 Position of aircraft at 19:54:15 UTC

At 19:54:15 UTC, the trace shows aircraft RYR9UD over RWY13 with its main landing gear on the runway, and aircraft RYR75JV finishing the rotation manoeuvre on its take-off run (forward landing gear in the air and main landing gear on the ground). The distance between the two aircraft was 520 m (0.28 NM), the shortest separation recorded between them.

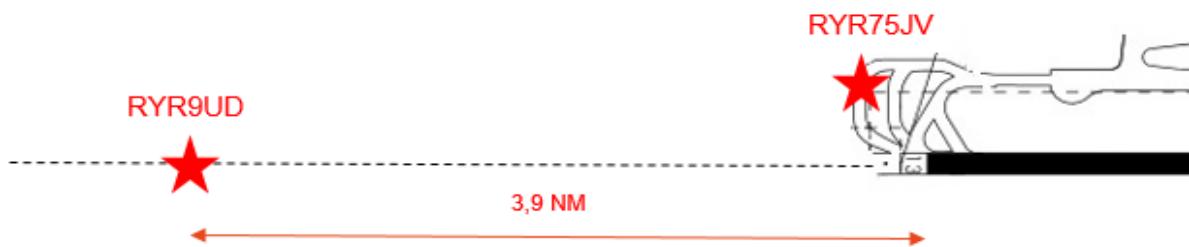
At 19:52:27 UTC, he instructed aircraft RYR75JV to line up on the runway and hold, when, at that moment, the approaching RYR9UD aircraft was established on final at a distance of 3.9 NM from the threshold of RWY 13. The following image shows the relative positions of the aircraft:

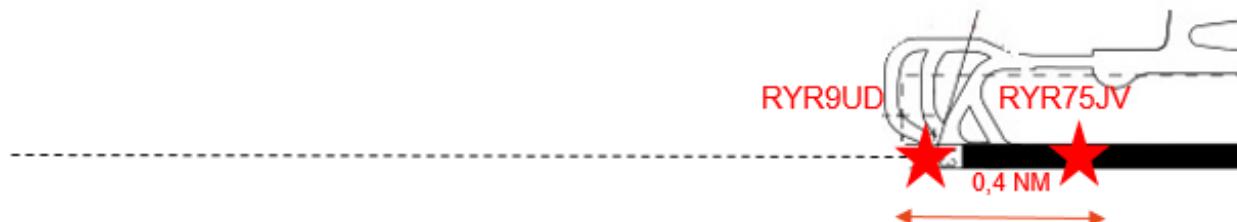
However, at 19:53:59 UTC, the LCL TWR LEMG controller cleared the RYR9UD aircraft to land with the preceding traffic in view on runway 13 when it was established at 200 ft of altitude AMSL, and aircraft RYR75JV was on its take-off run on RWY 13 at a speed of 90 kt (GS). The distance between the two aircraft was 0.4 NM.

The landing was authorised when the aircraft was practically above the runway threshold, allowing it to cross said threshold while the outbound aircraft was still on the runway. Moreover, there was no degree of assurance that the regulatory separation could be maintained, as the aircraft on approach was travelling faster than the aircraft on take-off, increasingly reducing the separation between the aircraft. The air traffic controller failed to anticipate the required separation between the aircraft.

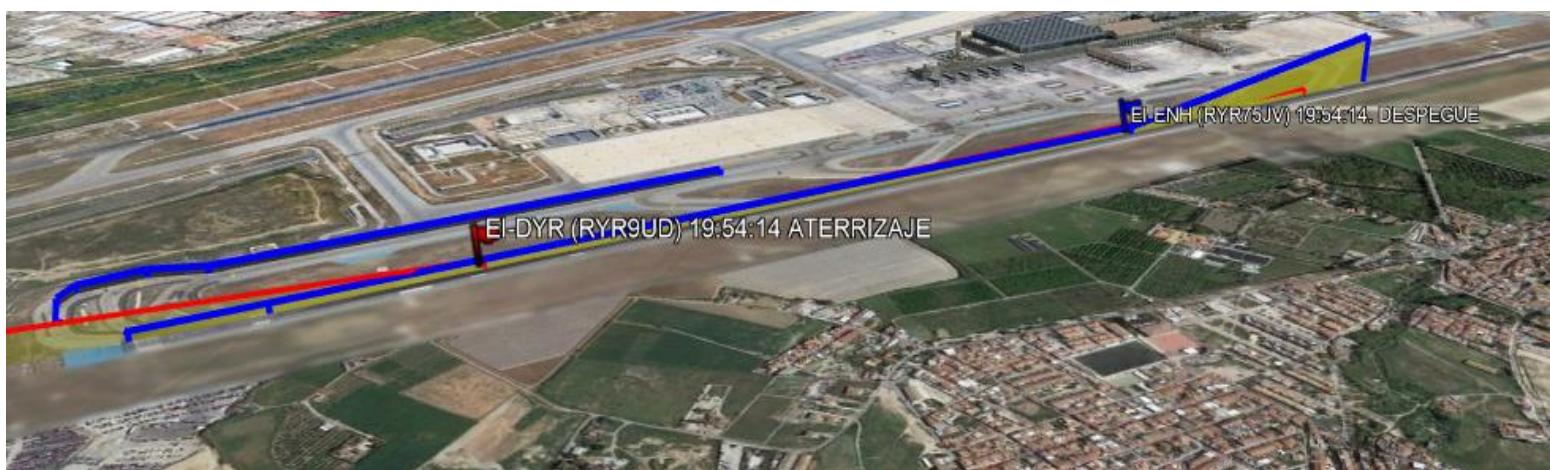
Illustration 18 Aircraft trajectories at the moment of touchdown

From the data obtained from the flight recorders we have been able to determine the exact moment at which the landing aircraft, with registration EI-DYR, makes contact with the runway for the first time with its main landing gear. This instant (19:54:14 UTC) has been represented in the following graphic, where the trajectory of the inbound aircraft is indicated in red, and that of the outbound aircraft is indicated in blue.

The landing EI-DYR aircraft touched down on the runway with a ground speed of 141 kt. For its part, the EI-ENH aircraft was on its take-off run executing the rotation manoeuvre, with a ground speed of 157 kt. The distance between the two aircraft was 520 m (0.28 NM). This was the point of minimum separation between the two aircraft.
