Report

IN-032/2018

Incident involving a Boeing 737-800, registration EI-FHZ,
operated by Norwegian Air International, at the Alicante Airport
(Spain) on 7 June 2018

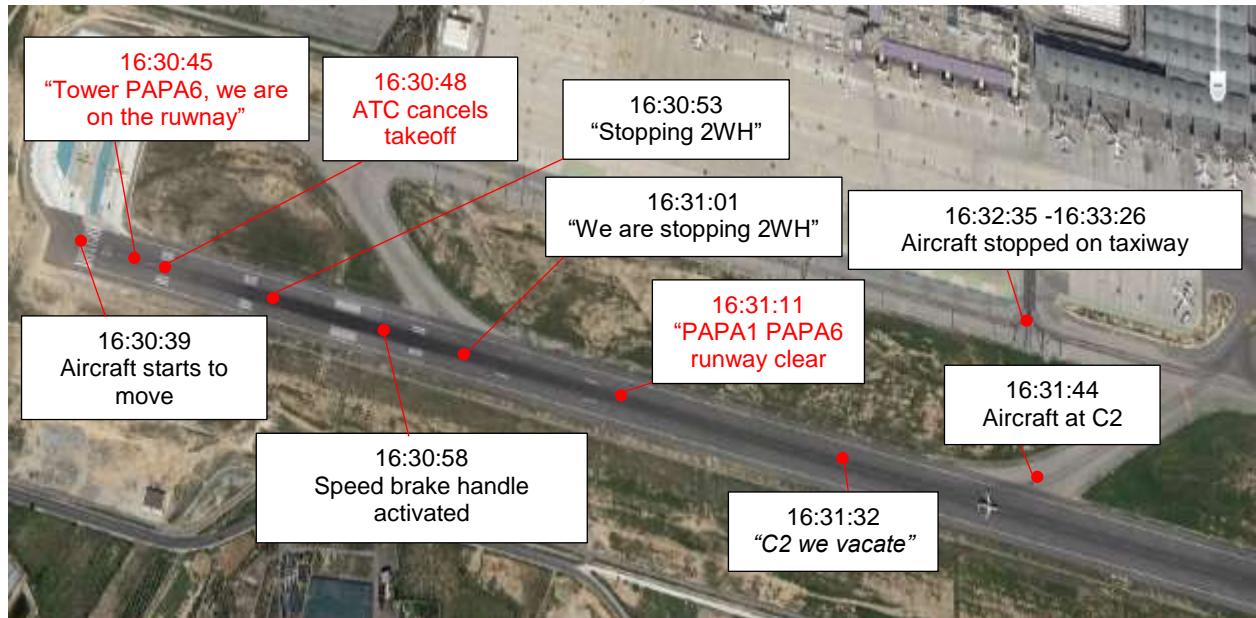
Figure 2. Positions of aircraft during takeoff run

The various locations of the aircraft on the runway during the takeoff run are shown in the figure below. Also included are the positions of the aircraft during some of the reports made by PAPA6 and TWR (text in red).

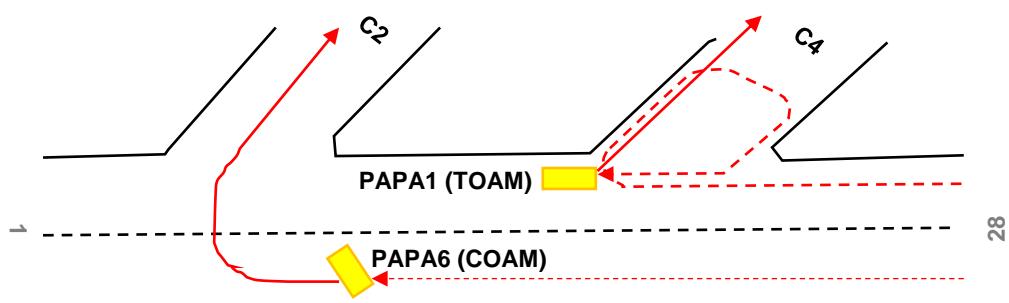
Figure 3. Position of cars PAPA1 and PAPA6 during the event

"They began the check at the same time, with the COAM (PAPA6) driving on the left side of the runway and the TOAM (PAPA1) on the right so as to completely check the runway and taxiways. The TOAM found something and had to stop to pick it up. He continued driving and thus was further ahead.

Figure 3 (not to scale) shows their positions on the runway and their routes before and after the incident (as they indicated during their interviews).

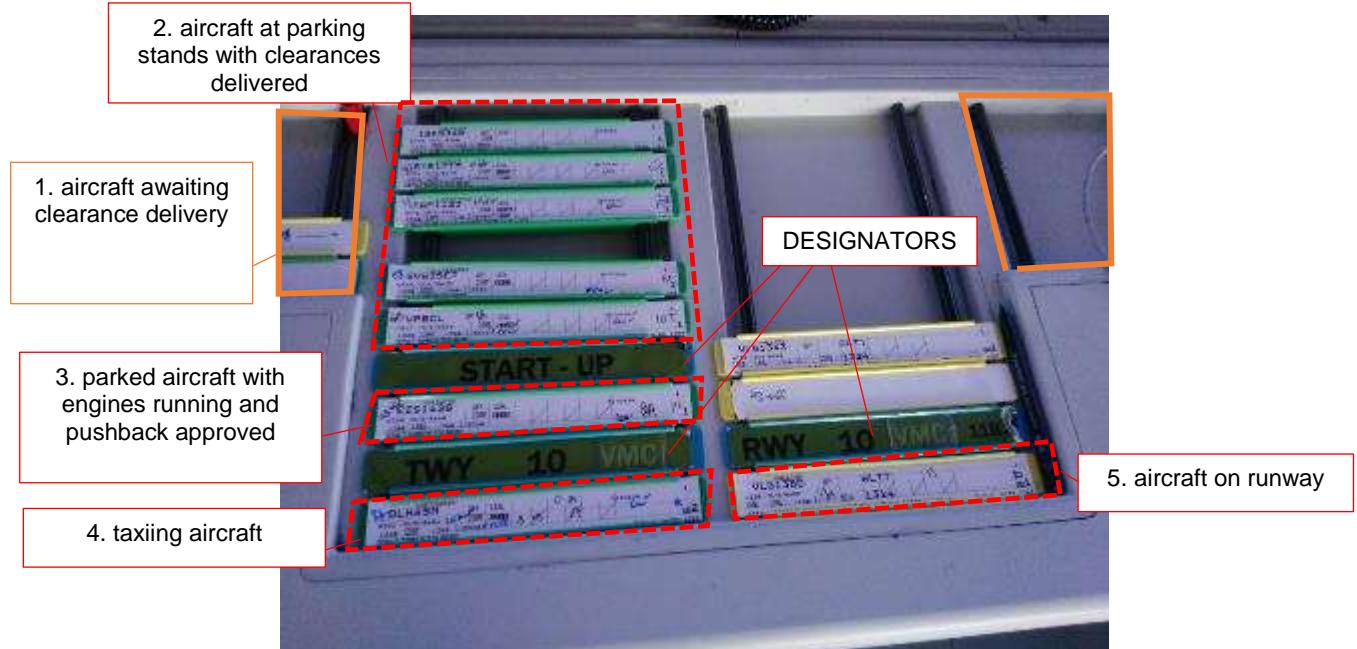
Figure 5. Strip management on the bay (for departing aircraft)

As for the board, the statements were consistent in that the strip for IBK2WH was placed on the tracks, meaning the controller had the strip in his hands. Moreover, he would have had to write the takeoff time on it, meaning that at some point his eyes must have focused on the bay, and specifically, on the area of the runway designator, but without taking in the information it was showing (despite the presence of the strip for the vehicles, in a conspicuous color, immediately above). The section below (2.4.2) analyzes the reasons that might have caused the controller to ignore this information.

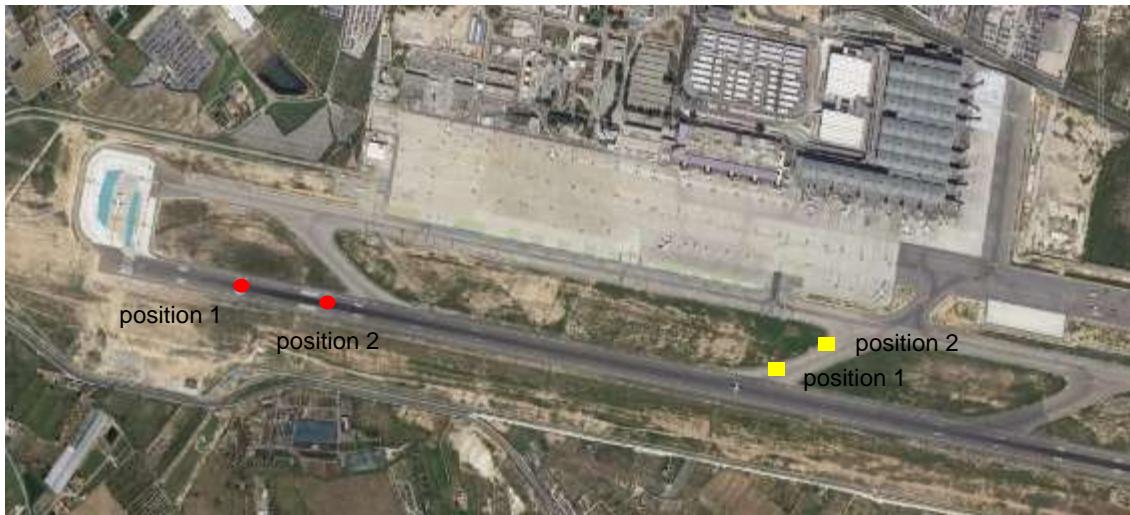
Figure 6. Relative positions between aircraft and PAPA6

- Position 2 (t=5.6 s): the vehicle has traveled 130 m since t=0s, equivalent to a speed of about 83 kph. It is practically outside the runway strip. At this point, the aircraft is passing the point where A2 intersects the runway, having traveled 220 m. The straight-line distance between the two is 1270 m. Correlating this information with the QAR data shows that this moment corresponds to 16:30:58, and the aircraft had a GS of 86 kt.
