## SL 2020/14

## REPORT ON THE AIR ACCIDENT AT OSLO AIRPORT GARDERMOEN, NORWAY ON 18 DECEMBER 2018 WITH BOEING 787-9 DREAMLINER, ET-AUP OPERATED BY ETHIOPIAN AIRLINES

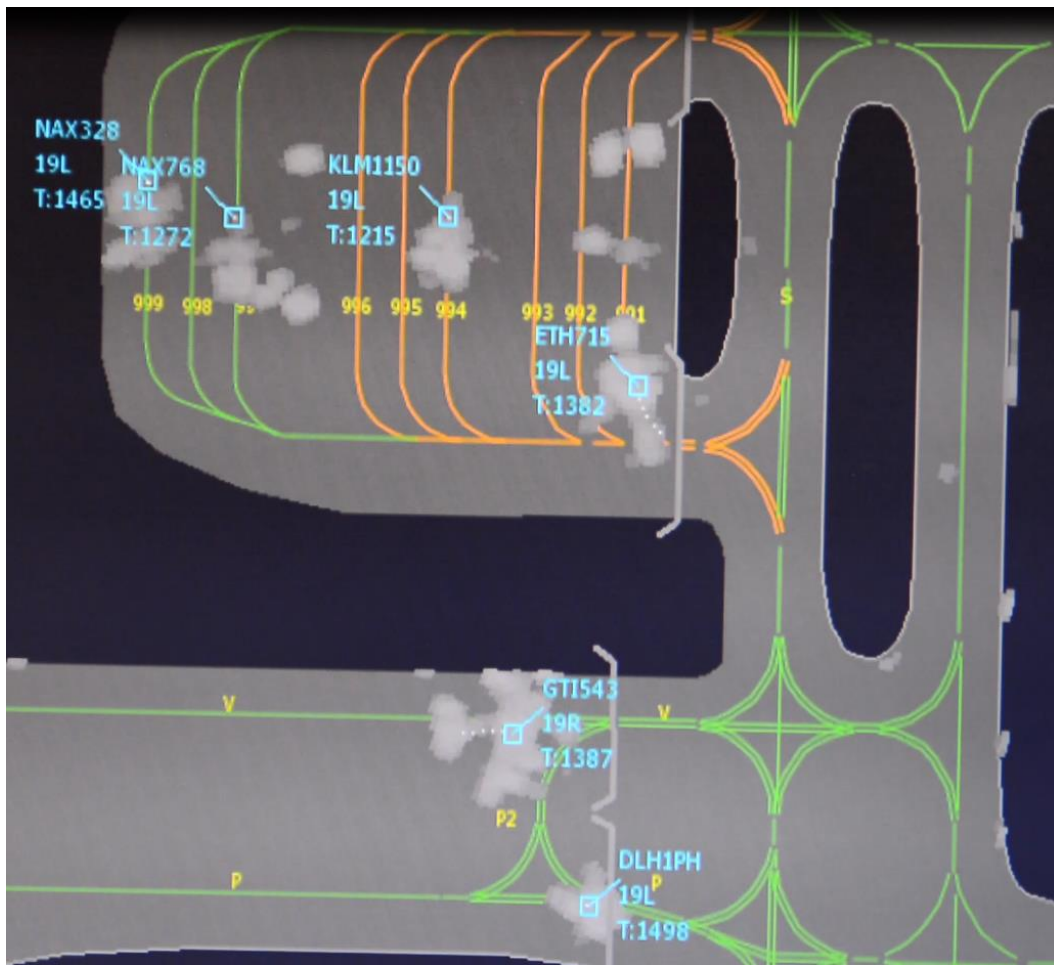
Figure 1: Ground radar screen shot of ETH715 as the aircraft is about to taxi into de-icing stand 991. Three other aircraft were at the “Bravo North” de-icing platform at the time (two aircraft belonging to Norwegian and one to KLM). In addition, the de-icing coordinators have information about the type of aircraft. Source: Avinor. Photo: AIBN

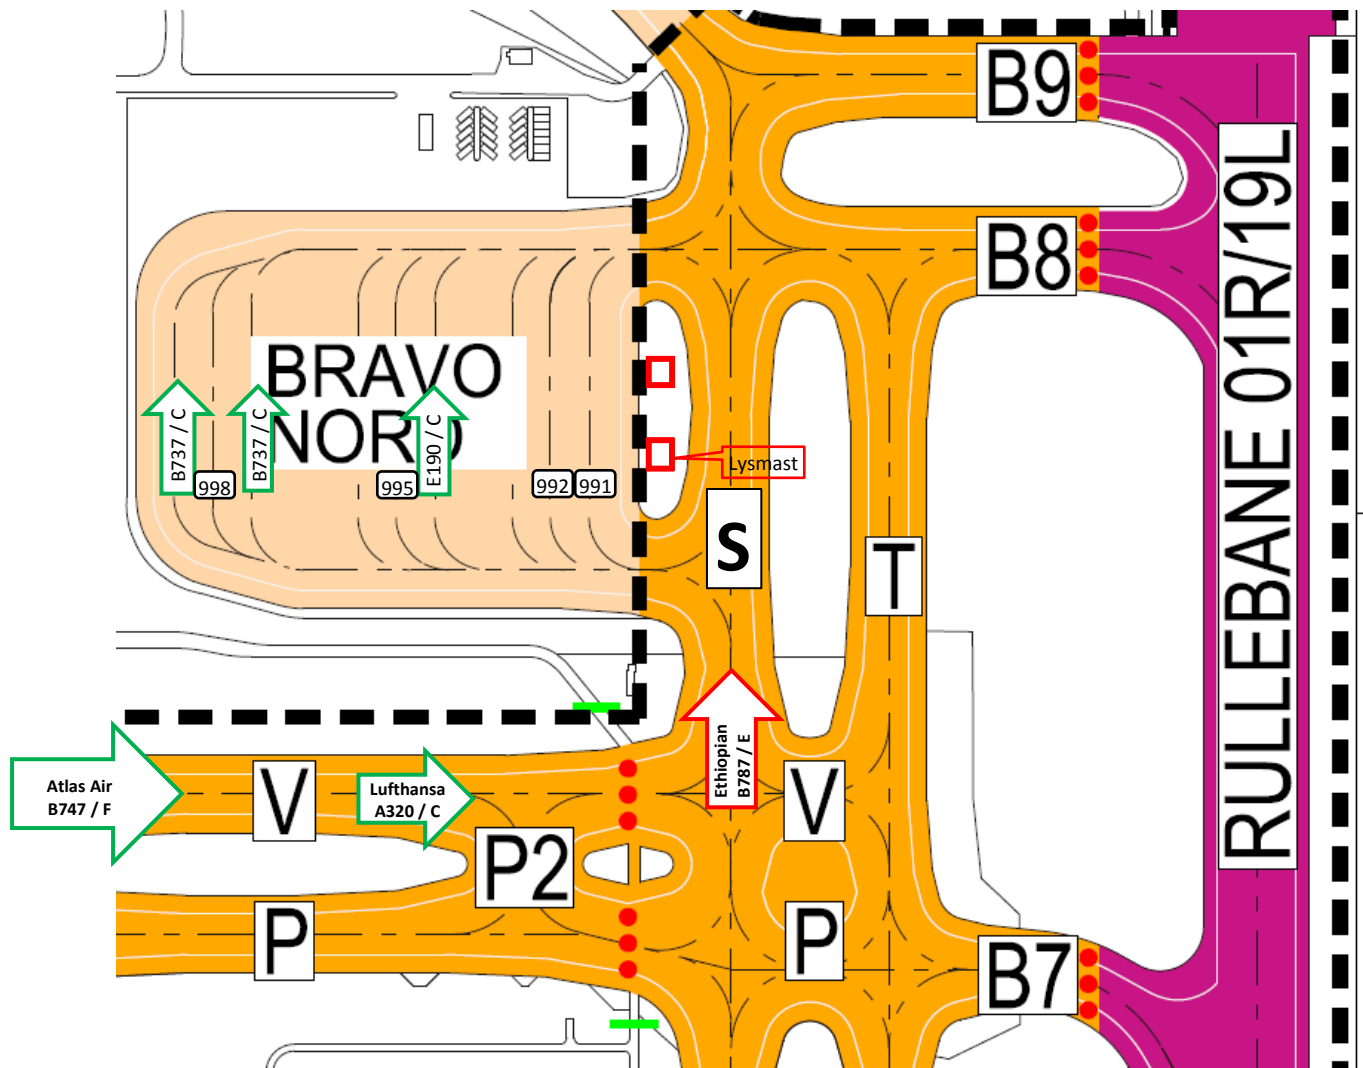
- 1.1.9 The de-icing coordinators concurred and verbally agreed that the two wide-body aircraft (Ethiopian and Atlas Air) should be assigned de-icing stands 992 and 995, respectively<sup>6</sup> (see Figure 2).

- 1.1.12 When the Ethiopian aircraft approached the de-icing area, the crew contacted the de-icing coordinator (the position of the aircraft is shown in Figure 2):

Figure 2: The de-icing platform "Bravo North". The position of the aircraft at the time when de-icing coordinator 2 instructed ETH715 to taxi to de-icing stand 991. Only de-icing stands 992, 995 and 998 are suitable for aircraft larger than Category C, such as the Boeing 787. Source: Avinor. Illustration: AIBN

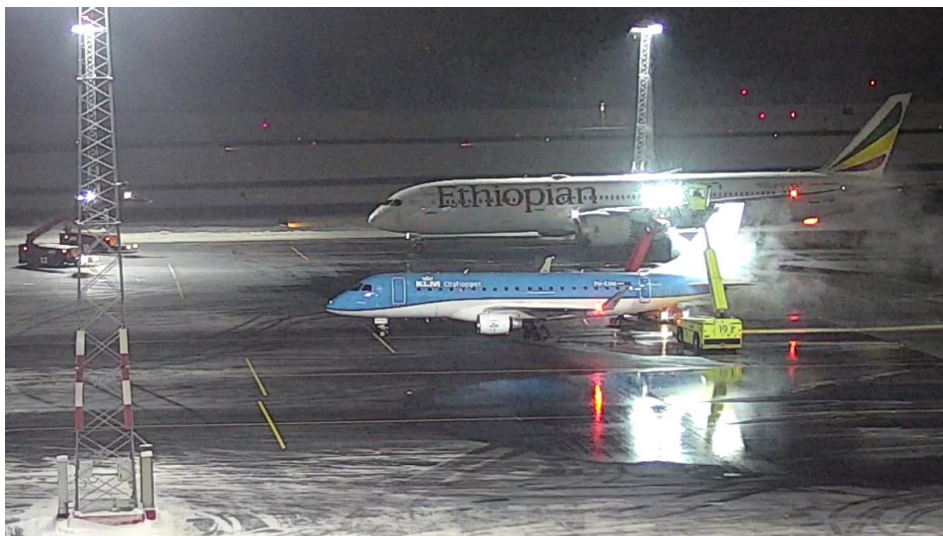
Figure 3: Position at 19:10:05 hours when ET-AUP collided with the light mast. Source: Avinor

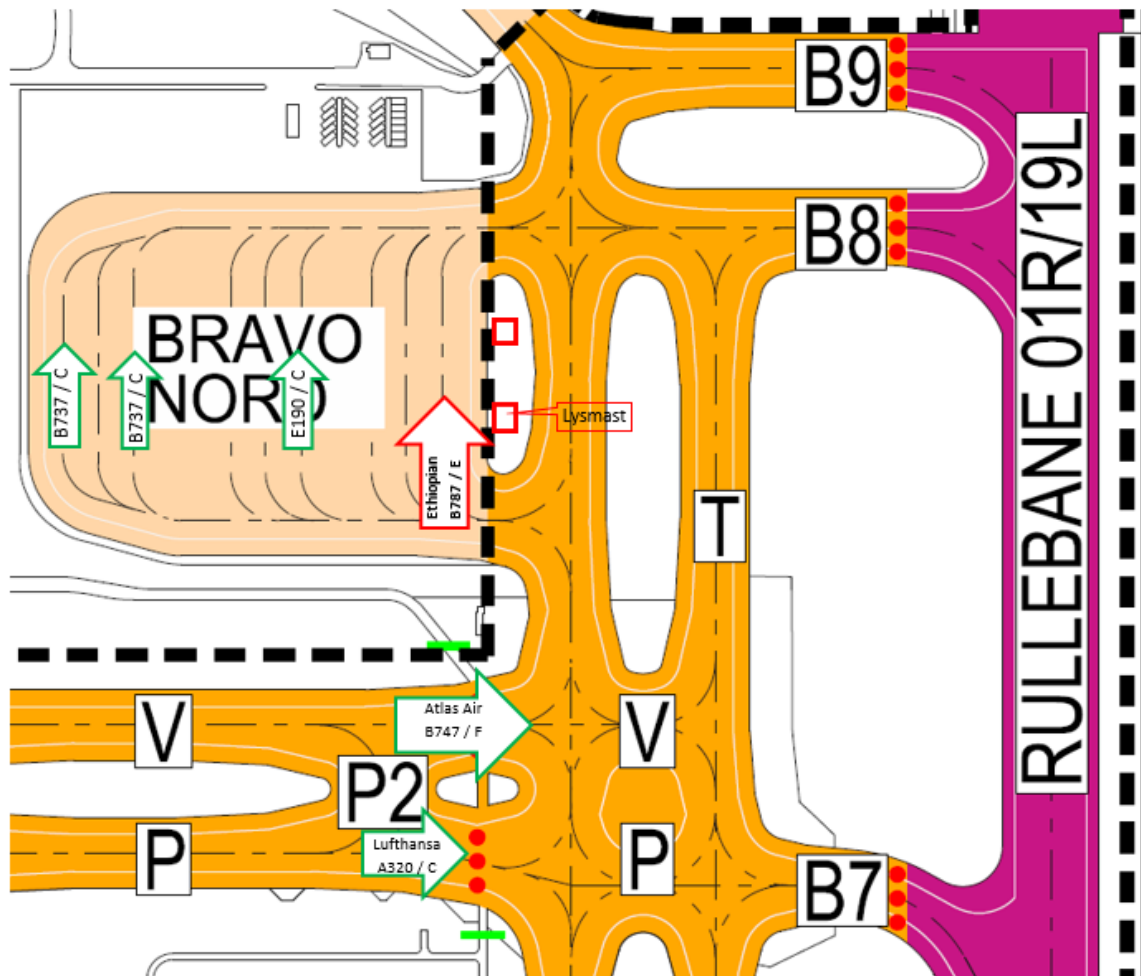
Figure 4: The de-icing platform "Bravo North". The position of the aircraft at the time of collision, according to the ground radar. Source: Avinor. Illustration: AIBN

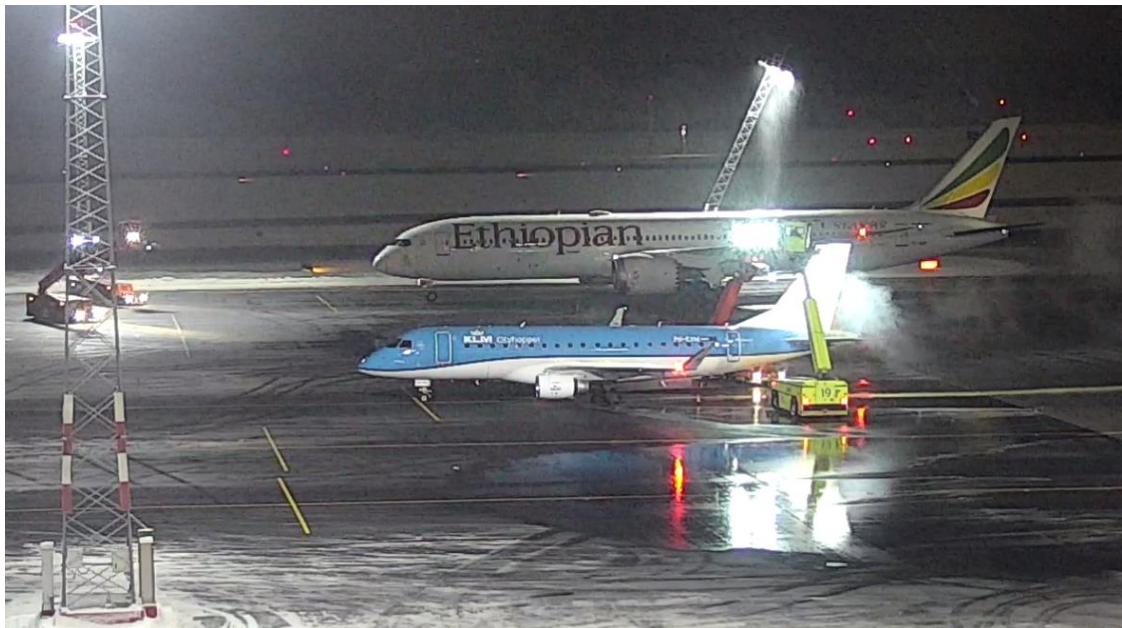
Figure 5: Position at 19:10:09 hours when ET-AUP had stopped approx. four meters after the collision. Source: Avinor

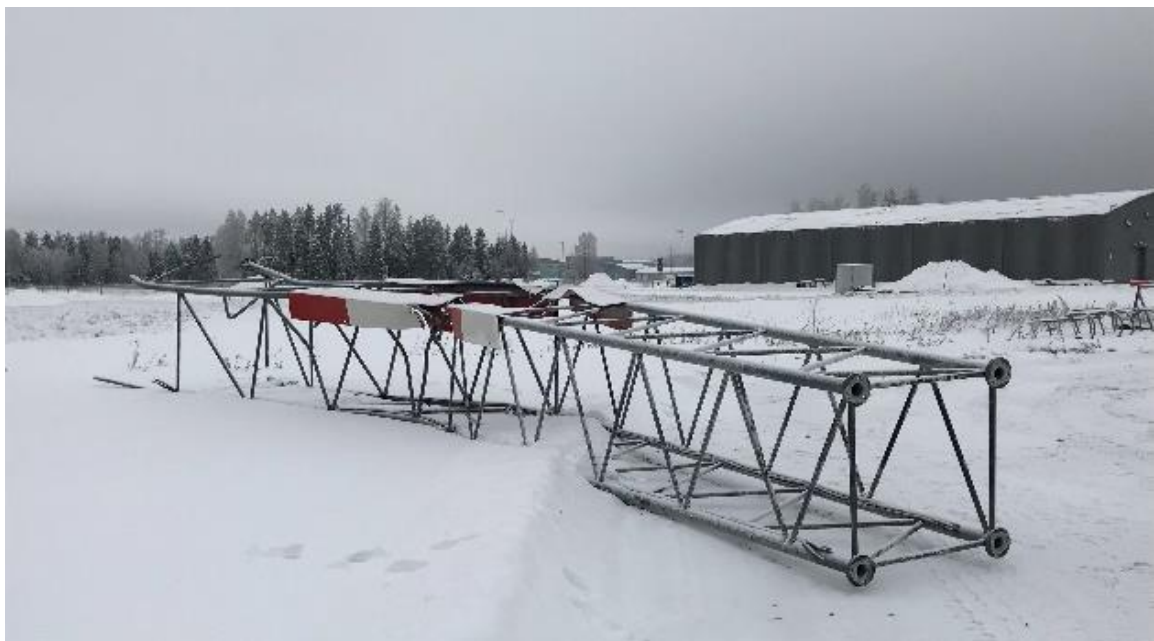
The light mast was significantly damaged and had to be replaced with a new one (see Figure 6).

Figure 6: Damage to the light mast (after dismantling). Photo: AIBN

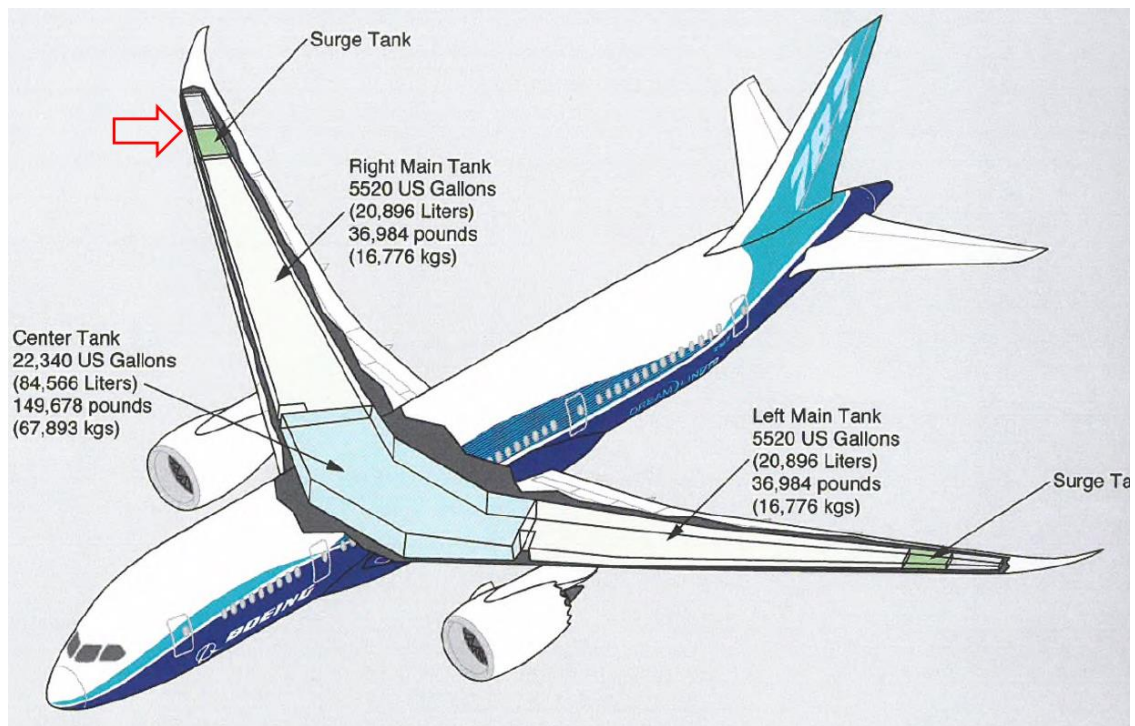
Figure 7: Fuel and surge tank positions on a Boeing 787-9. The red arrow shows where the aircraft was damaged (see Figure 10, Figure 11 and Figure 12 for more details about point of impact). Source: Boeing. Illustration: AIBN

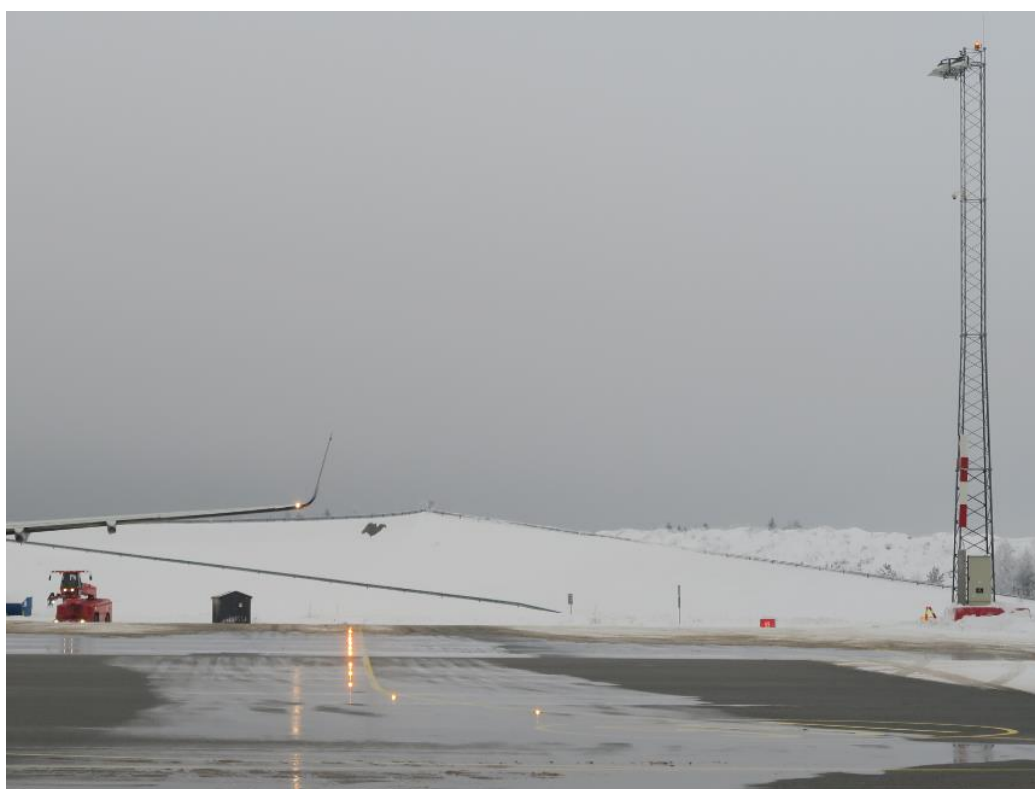
- 1.12.1.1 The Gardermoen de-icing platforms have lights in the tarmac along the guide lines leading to all de-icing stands (see Figure 9). From the establishment of Gardermoen as the main airport in 1998 and until 2019, it has been possible to activate individual lights for each guide line. Due to the design of the control panel, it proved impractical to activate individual rows of light.

Figure 9: Shows the center line lights in the tarmac leading up to de-icing stand 991. The photo was taken the day after the accident. Photo: AIBN

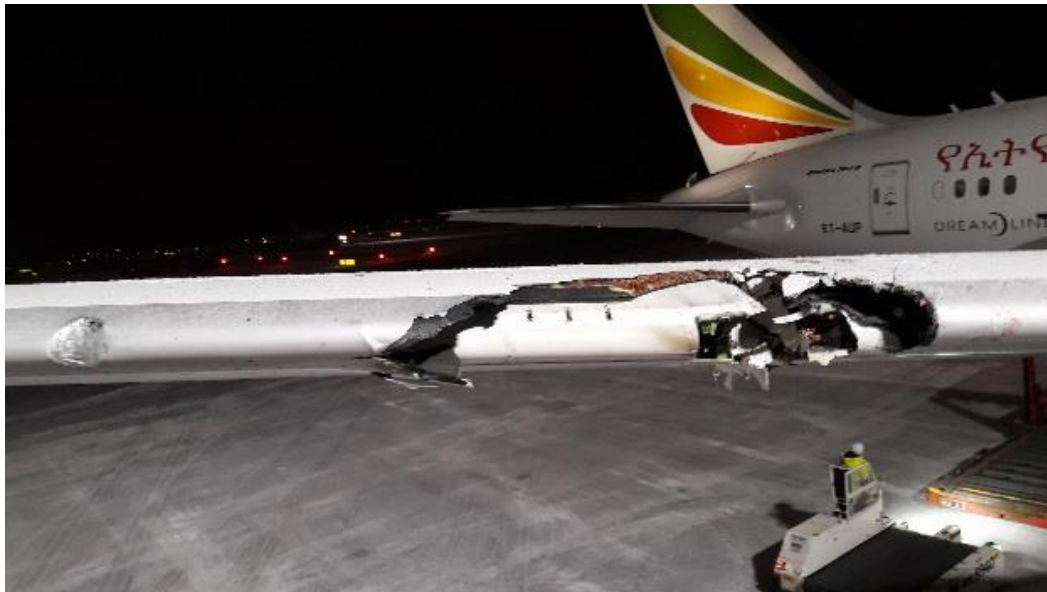
- 1.12.2.1 The ET-AUP suffered substantial damage to its right wing (see Figure 10). The point of impact was at the front of the surge tank (see Figure 11). The surge tank was not punctured (see Figure 12).

Figure 10: Damage to the right wing. Photo: Ethiopian aeronautical engineer

- 1.12.2.2 Ethiopian Airlines requested an inspection and repair report from Boeing. Extensive repairs of ET-AUP were necessary. The aircraft remained at Gardermoen for about one month before it was airworthy again.

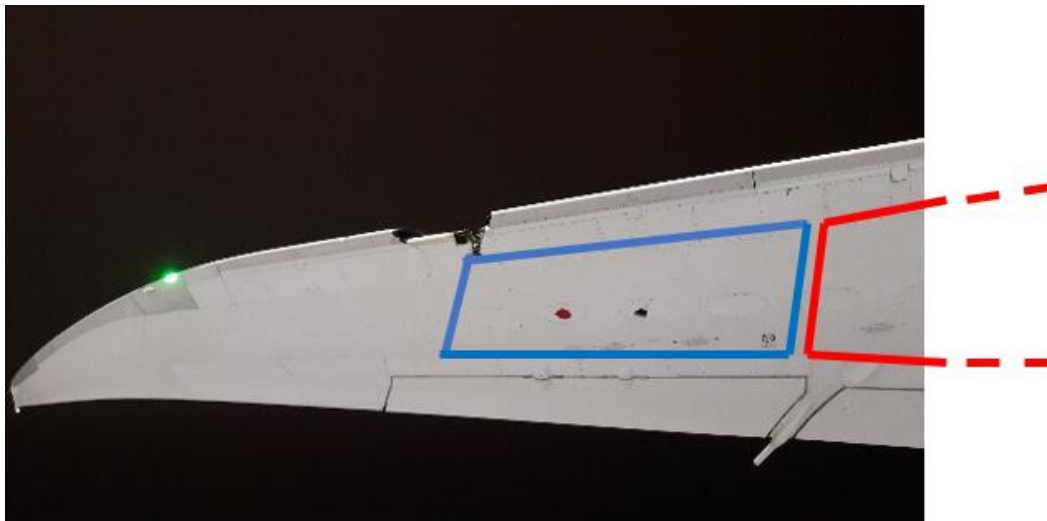
Figure 11: Position of the damage on the right wing. Blue marking: Indicates the position of the surge tank. Red indication: Indicates the position of the wing tank. Photo and illustration: AIBN
