Collision with terrain following an engine power loss involving Cessna 172M, VH-WTQ

12 NM (22 km) north-west of Agnes Water, Queensland on 10 January 2017

ATSB Transport Safety Report
Aviation Occurrence Investigation
AO-2017-005
Final – 17 October 2019

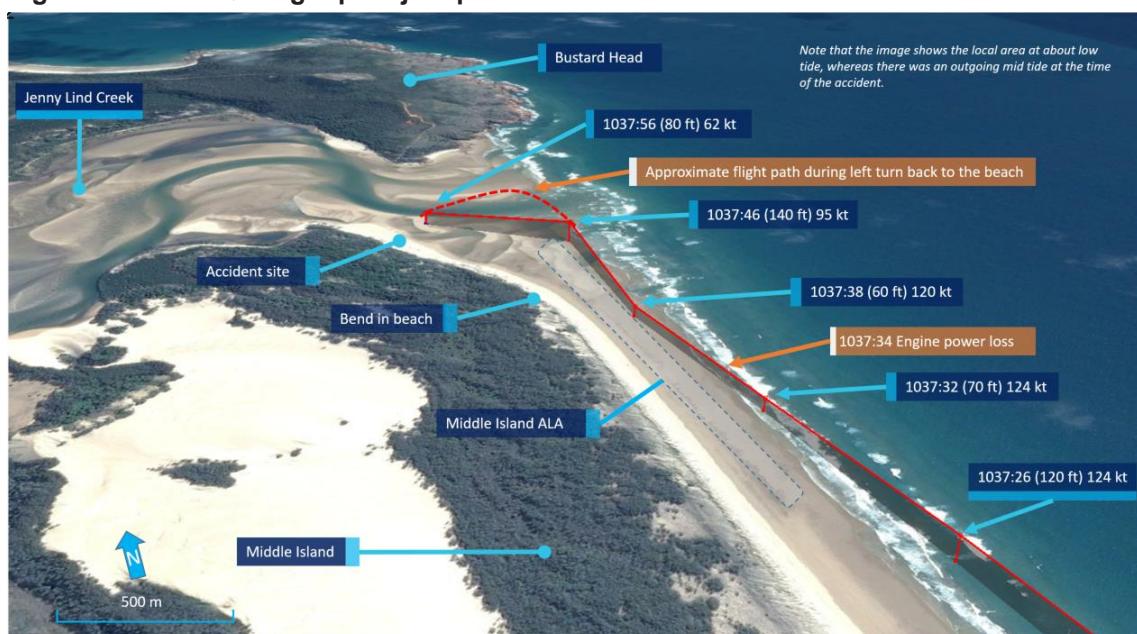
Figure 2: VH-WTQ's flight path just prior to the accident

Figure 2 shows the last 36 seconds of recorded GPS data (represented by the red line). As indicated in the figure, at 1037:26, the aircraft was approaching the southern end of the landing area and still descending.

This image shows the altitude and position data from the last five recorded data points prior to impact. The red lines are direct connections between each recorded data point and do not represent the aircraft's actual flight path between points. The landing area is based on reviewing the GPS data for many previous landings; most landings to the south would use the northern end of the area. The Google Earth image was taken in May 2016, and reflects conditions with a lower tide than at the time of the accident.

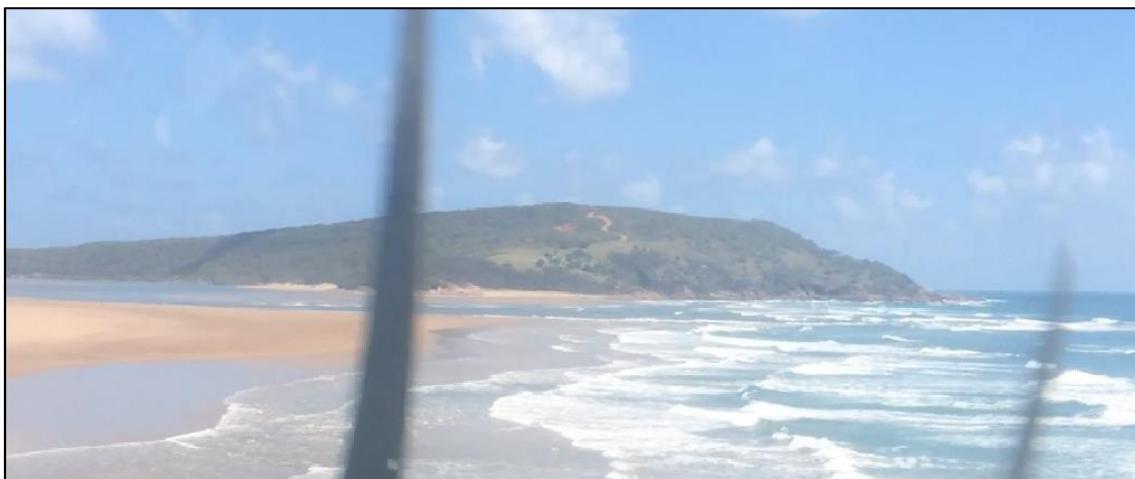
Figure 3: A still image taken from the video footage at the time of engine power loss (1037:34)

The video footage indicated that, at 1037:34, the engine sustained a sudden power loss. At the time of the power loss, the aircraft was above the water and close to the beach abeam the landing area. The aircraft was at about 60 ft (see *GPS information*) and had a groundspeed of about 124 kt (about 230 km/h). Figure 3 provides a still image from the video footage of the view outside the aircraft at the time of the engine power loss.

The image shows Bustard Head in the background (to the north). The vertical, black areas are the propeller blades captured by the video footage. Source: Queensland Police Service.

The pilot stated that, just prior to the power loss, he had pulled back the throttle slightly. He recalled that as soon as he did this the engine suddenly stopped, and he realised that there had been a total power loss. He later described the power loss as being similar to the mixture control being pulled back.

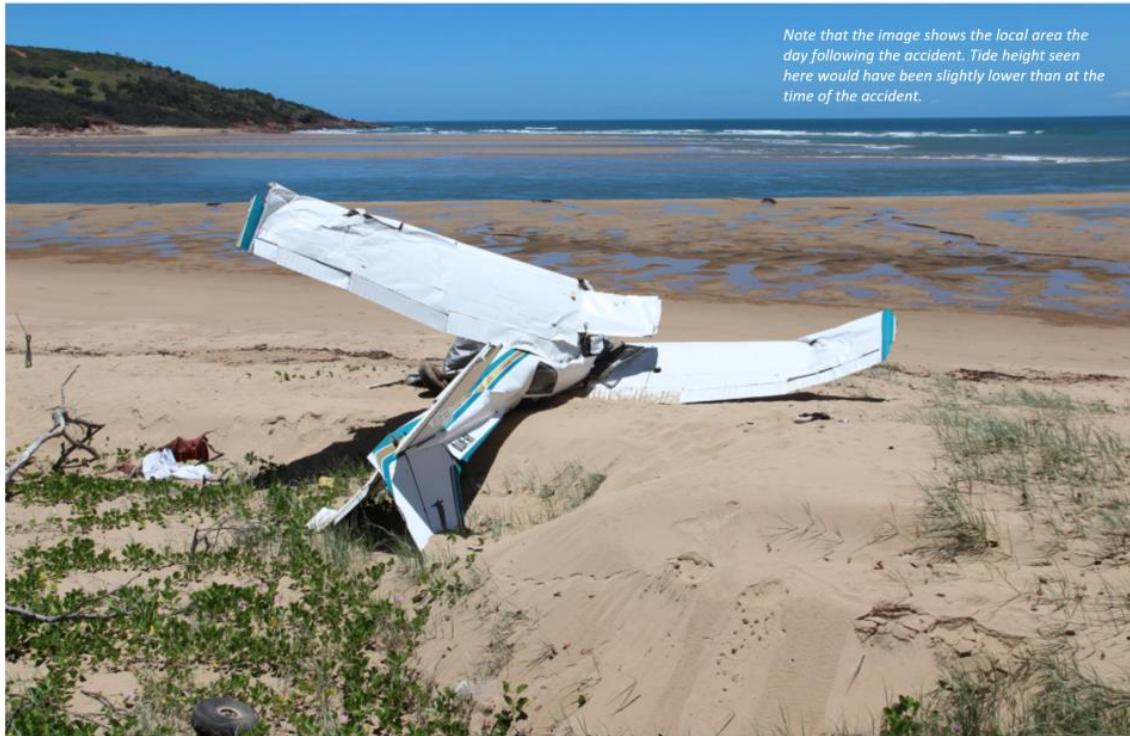
Figure 5: Accident site, facing north-east with Bustard Head in the background

One of the rear-seat passengers was fatally injured and the other three occupants sustained serious injuries during the impact. The aircraft was destroyed. Figure 5 shows the aircraft wreckage (see also *Wreckage and impact information*).

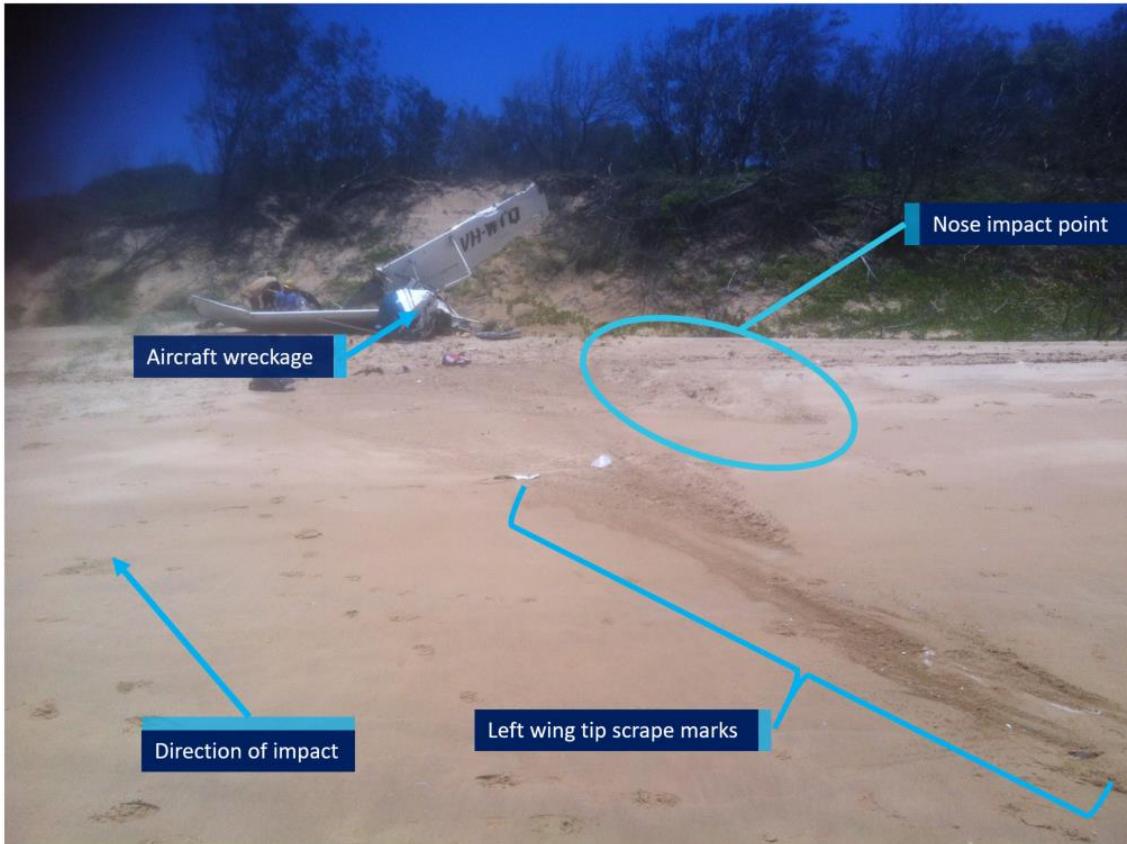
Figure 8: VH-WTQ accident site showing impact marks

The distance between the nose impact point and the main wreckage was about 5 m on a magnetic bearing of 210°. The wreckage distribution and distance from the impact point indicated that the aircraft impacted terrain in a significant nose-down and left-wing low attitude. The aircraft came to rest facing in the opposite direction to flight.

This image also shows the sand dunes behind the beach, in the direction where the aircraft was headed prior to impact.
Source: Wyndham Aviation chief pilot.

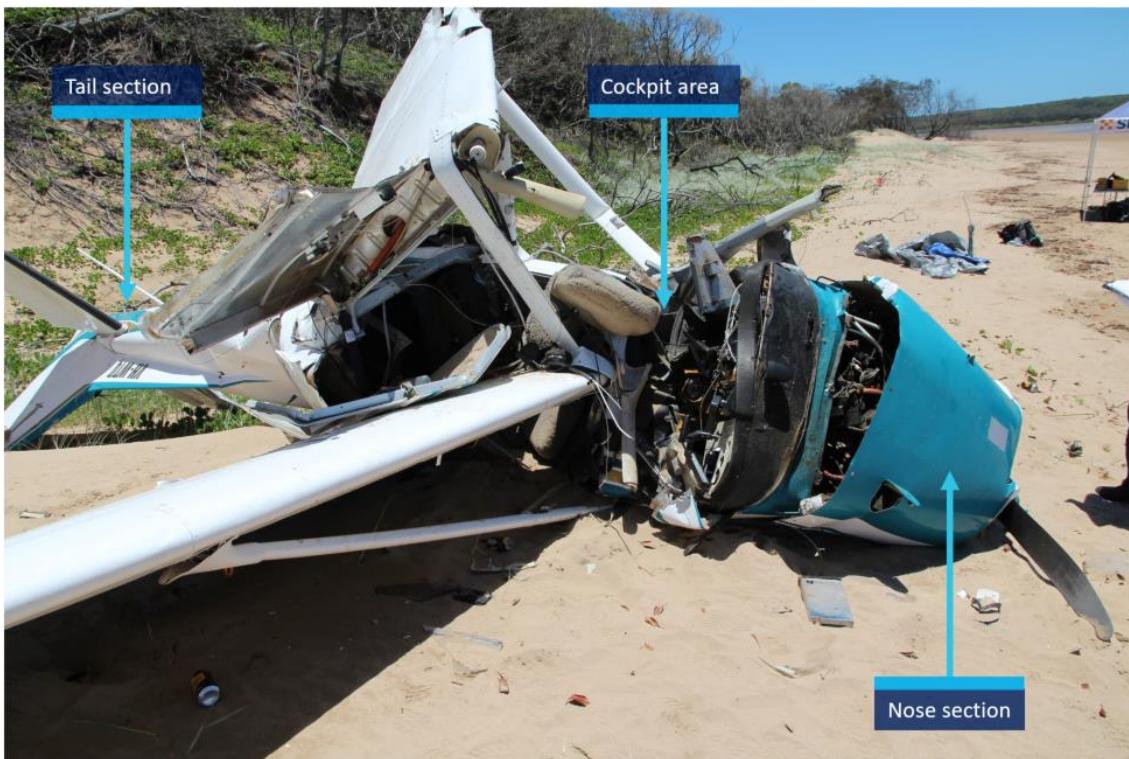
Figure 9: VH-WTQ aircraft wreckage viewed from the right

The aircraft was significantly disrupted by ground impact forces. The main fuselage structure had fractured at the rear of the engine firewall and just aft of the rear passenger seats. The cabin area was twisted and compressed and both wings had separated from the fuselage structure at the wing root (Figure 9).

The aircraft structure was examined for pre-impact defects, with none identified. All of the aircraft and its components were accounted for at the accident site. There was no indication of any fire.

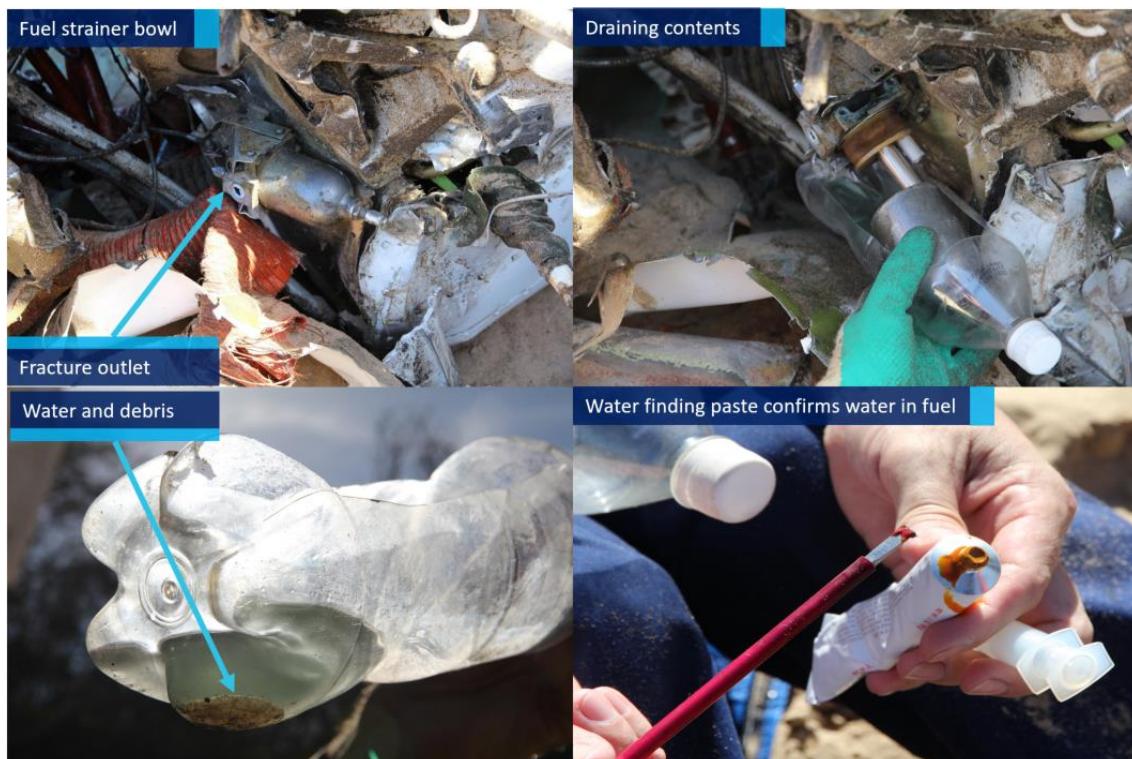
Figure 10: Fuel strainer bowl and contents showing signs of water and debris

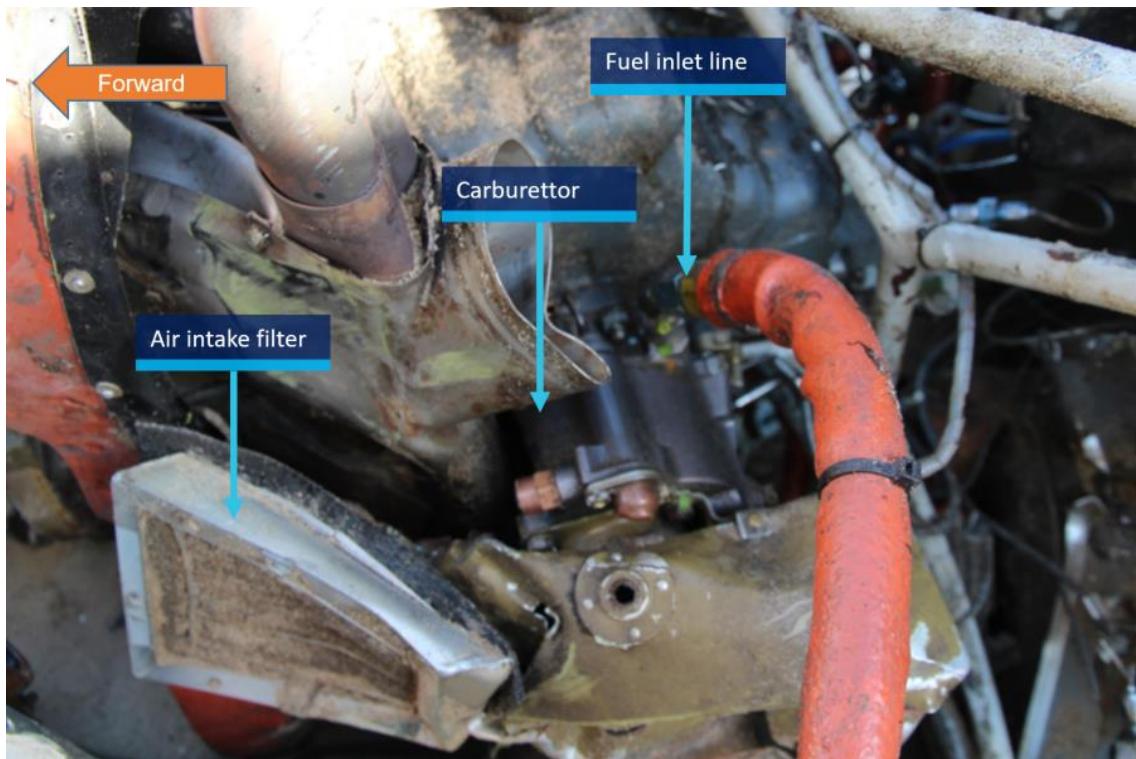
Figure 11: Carburettor and air intake assembly

The carburettor was oriented about 80° on its right side with the fuel inlet facing upwards. It was removed from the engine and inspected, with no defects noted.

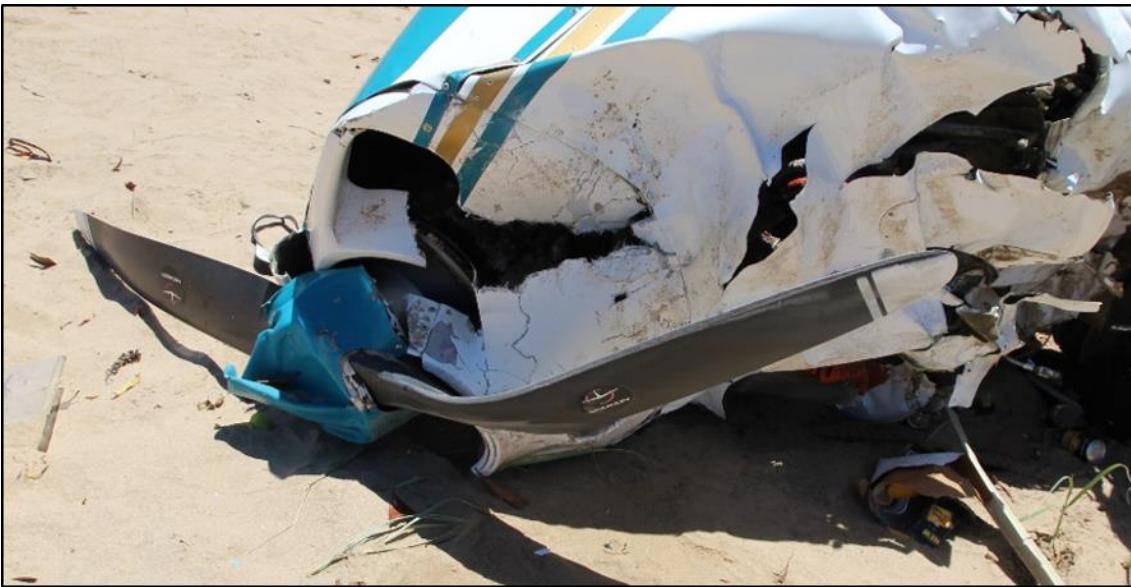
The propeller was examined on site for evidence of correct and secure fitment, with no issues identified. The propeller blades were examined for evidence of rotation damage at the point of impact. Only minor abrasion damage was observed on the blades with no other indications of rotation (Figure 14). That damage was consistent with very low or no power being delivered by the engine at impact.

Figure 14: Propeller blades showing slight paint abrasion damage

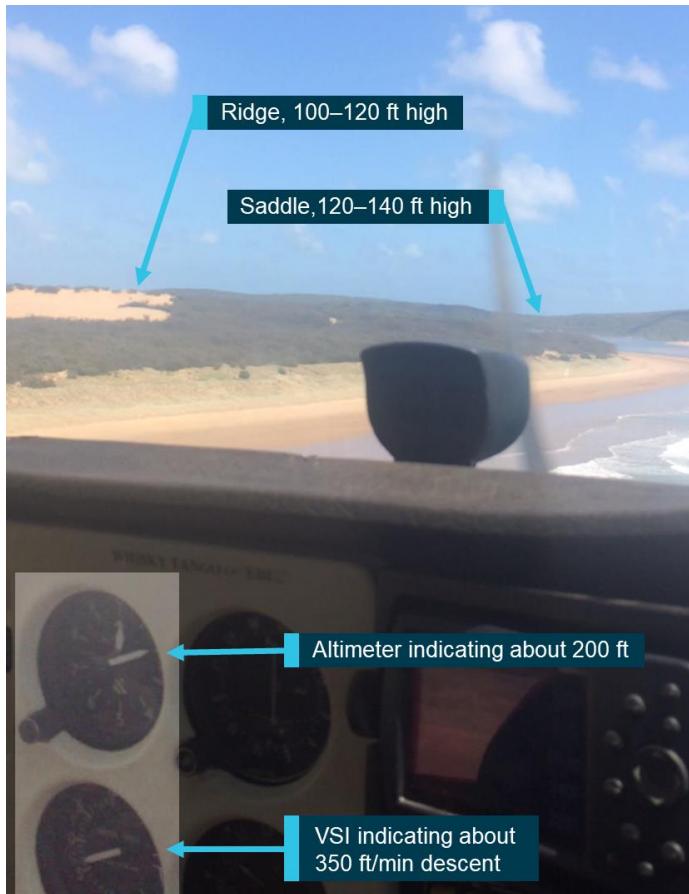
Figure B3: Still image from mobile phone video at 1037:26 (altimeter enhanced)

The image shows nearby terrain features: a ridge 100–120 ft high on nearby Middle Island, and a distant saddle 120–140 ft high. An enhanced section of the image shows the altimeter indication at that point, which is about 200 ft and the vertical speed indicator (VSI) showing a 350 ft/min descent.

With regard to the altimeter indications in the video footage, the last view of the altimeter prior to the engine power loss occurred at 1037:26, when the altimeter indicated about 200 ft (Figure B3). This was significantly higher than the recorded GPS data at the same time (120 ft), and also higher than the transponder altitude and the altitude indicated by an analysis of terrain features in the video footage at the same time.

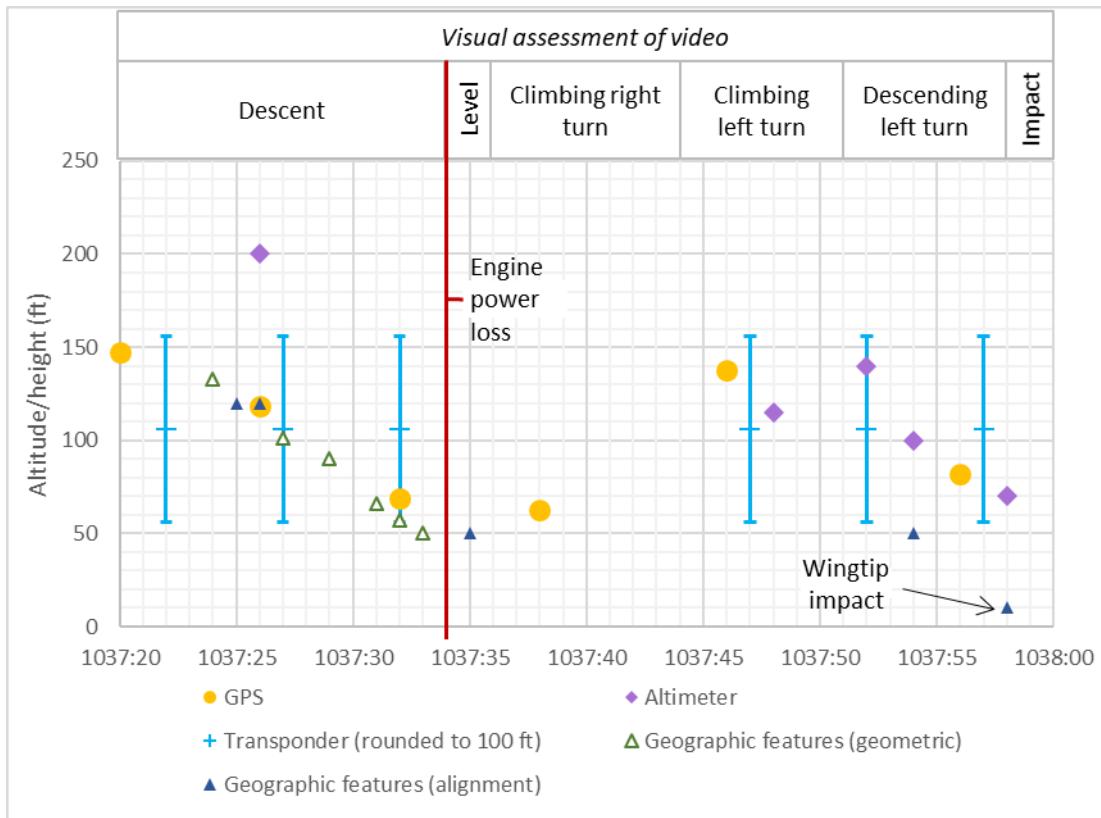
Figure B5: Summary of information about the aircraft's altitude from 1037:20 until impact

The GPS altitude and the altimeter both appeared to be higher than the aircraft's actual altitude in the last 10 seconds of flight (after the engine power loss). This is consistent with the GPS's reduced accuracy in manoeuvring flight, and possibly with the altimeter being affected by sideslip during that period.
