Final Report

On the accident on **1st June 2009**
to the **Airbus A330-203**
registered **F-GZCP**
operated by **Air France**
flight AF 447 Rio de Janeiro - Paris

Bureau d'Enquêtes et d'Analyses
pour la sécurité de l'aviation civile

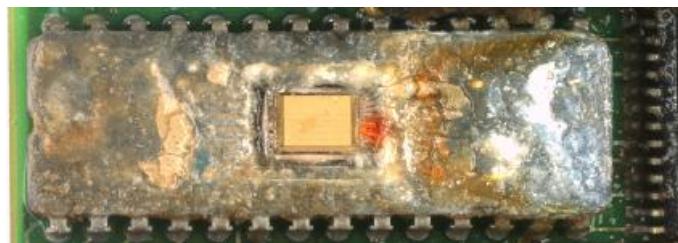
The two computers were examined. The memory components containing the data were damaged. One of the components had been torn out and the other suffered from internal short-circuits. The work was brought to a conclusion.

Figure 30: Memory component from one of the FCDC

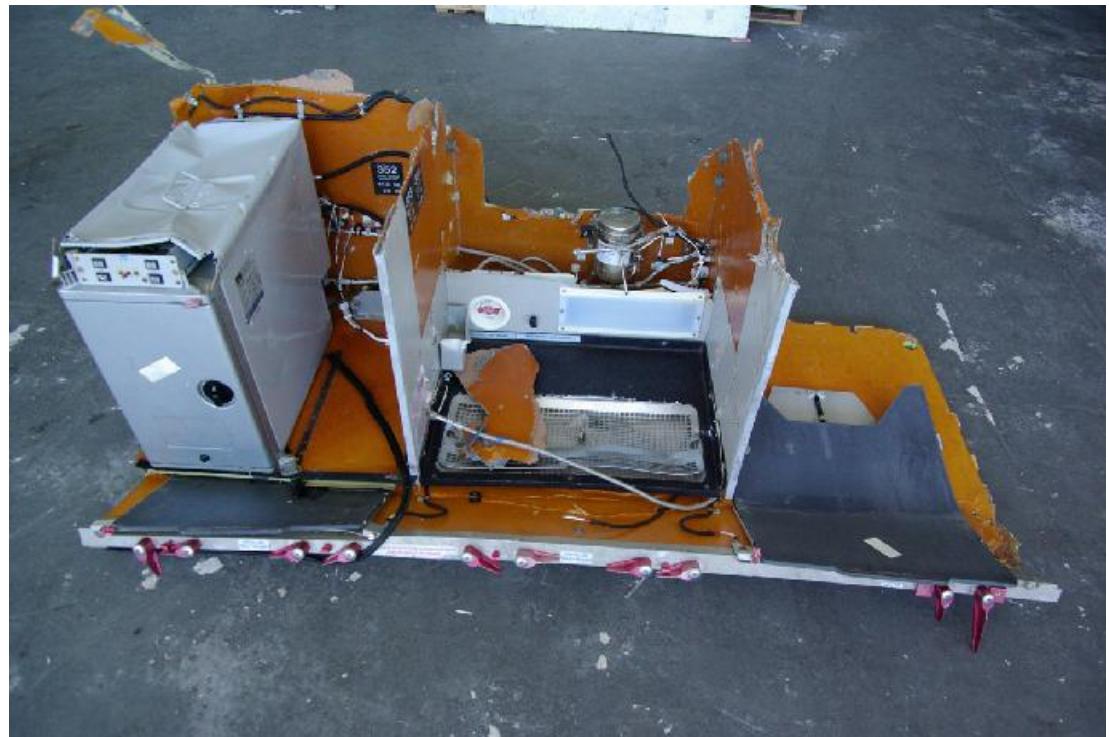
The overhead luggage rack attachment fittings had deformations that are due to vertical compression and to a forward movement of the luggage racks.

Figure 35: Part of Galley G3: downwards deformation at the level of the galley's heavy parts

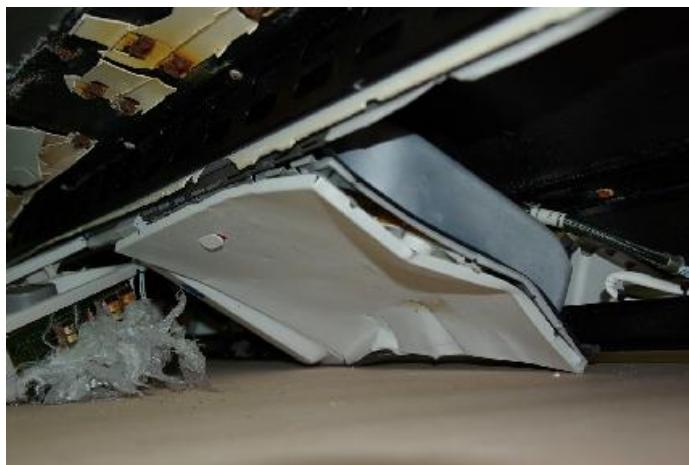
Figure 40: Passenger oxygen container recovered closed:
the deformations on the cover matched those on the box

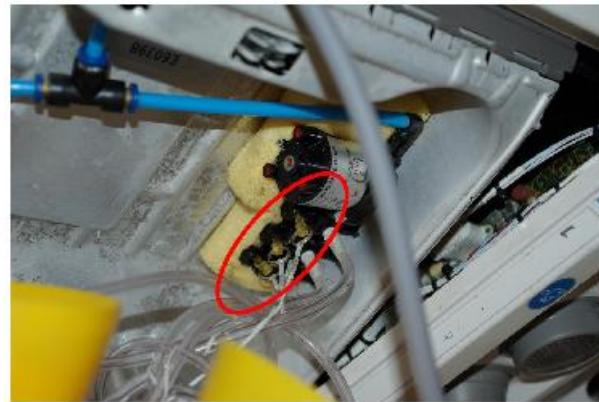
In normal operation, the oxygen is sent to the mask when the passenger releases the system's lock-pin by pulling on the mask. Several pins were found in place, closing the oxygen circuit.

Figure 41: Passenger oxygen container recovered open; the three pins are in place
The oxygen masks were not released: there was no depressurisation in flight.

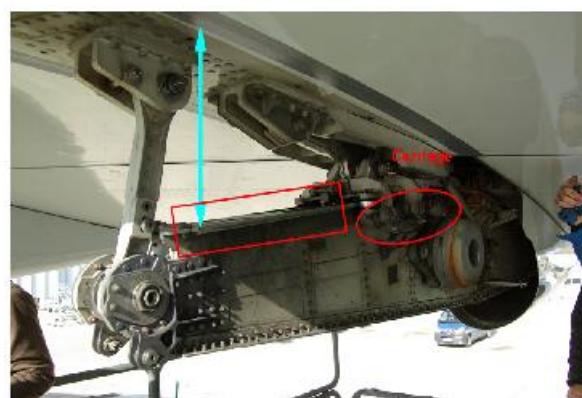
Several parts of the flap extension mechanism fairing were found. There were marks on two of them (positioned at the level of flap track N°3), made by the flap extension track on impact. Analysis of these marks (morphological and dimensional examinations) and comparison with an identical aeroplane made it possible to determine that the flaps were in the "retracted" position (see photo below) at the time of impact with the water (measurement of the distance between the track and the lower surface of the flap, position of the carriage on the track).

Figure 42: Flap extension mechanism (or flap track) No. 3 in retracted position

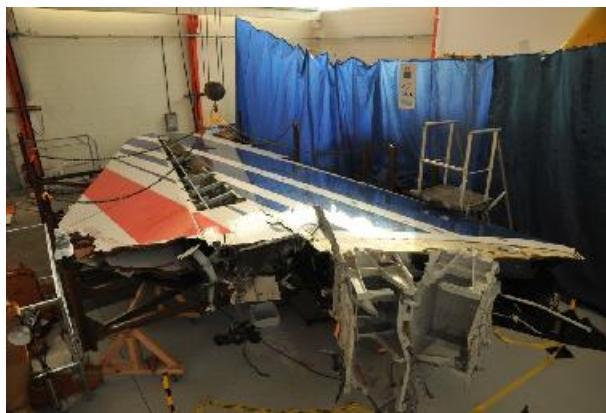
- The forward attachment (male and female lugs) and the lower part of the side panels (lug reinforcements) were missing;
- The centre and aft attachments were present: male and female lugs and parts of the fuselage frames.

Figure 44: Fin – In the foreground the base of the fin with the central and forward attachment lugs

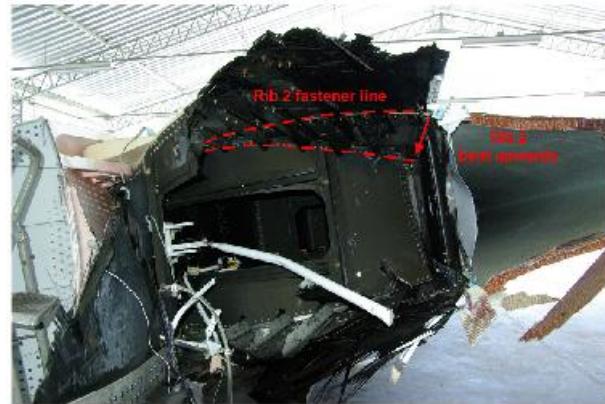
- Failure of the leading edge right- and left-hand panels
- Longitudinal cracking of the leading edge stiffener
- HF antenna support (attached to the forward spar): failure of the lower part, crumpling indicating bottom-upwards compression loads.

Figure 45: Rib 2 bent upwards as a result of bottom-upwards compression loads

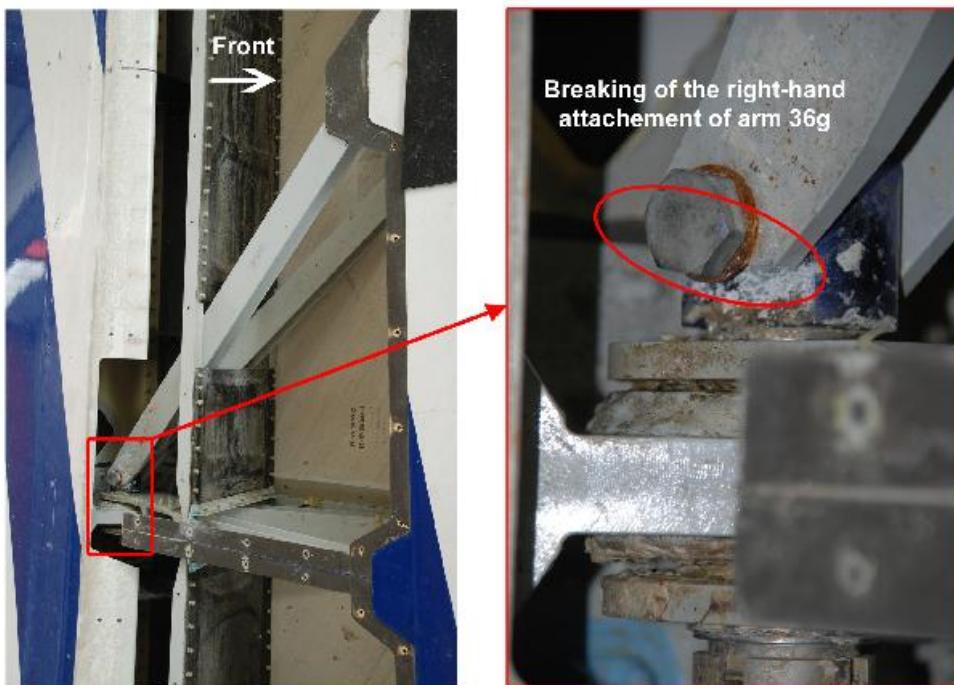
The size of this arm is calculated to withstand a maximum load of 120,000 N, corresponding to a relative acceleration of 36G of the rudder in relation to the vertical stabilizer.

Figure 47: Arm 36G, right view: failure of the rudder attachments

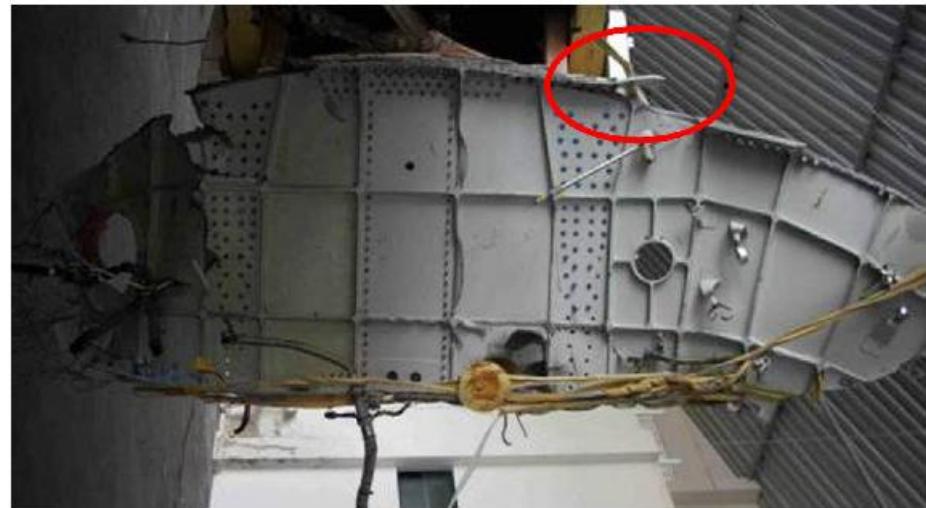
The fuselage was sheared along the frames and centre and aft attachment lugs by loads applied bottom-upwards.

Figure 48: Frame 87: shearing of the frame and fuselage skin along the frame

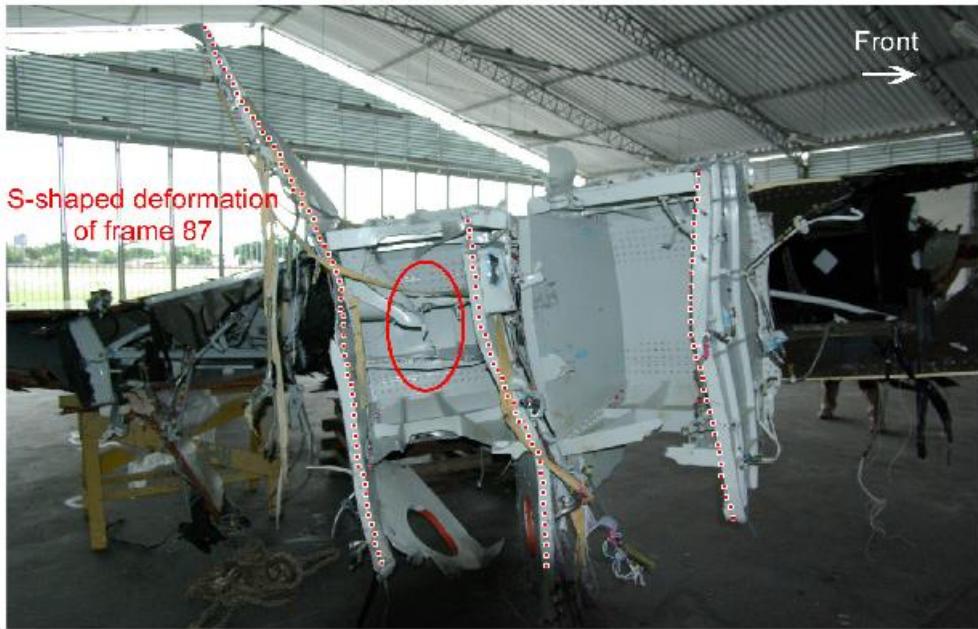
The part of frame 87 that can be seen had undergone S-shaped deformation: the left-hand side forwards, and the right-hand side backwards. The horizontal stabiliser actuator supports were deformed and broke in a backwards movement from the front. These observations indicate a backwards movement of the trimmable horizontal stabiliser.

Figure 50: Frames 84 to 87: S-shaped deformation of frame 87, with frames 84 and 85 pushed in backwards; failure of the horizontal stabiliser actuator supports between frames 86 and 87 (red circle)

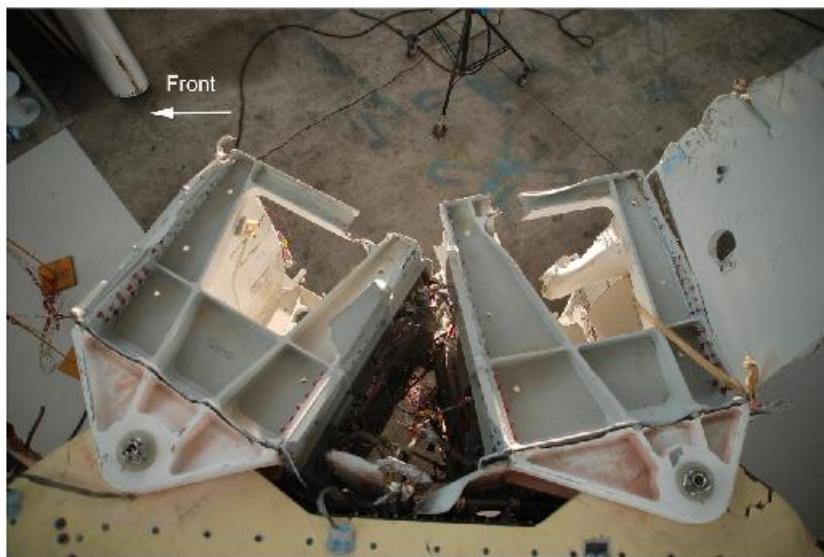
The centre attachment had pivoted backwards with the parts of the frames and web frames that were attached to it. The aft attachment had pivoted forwards with the parts of the frames and web frames that were attached to it.

Figure 51: Fin centre and aft attachments

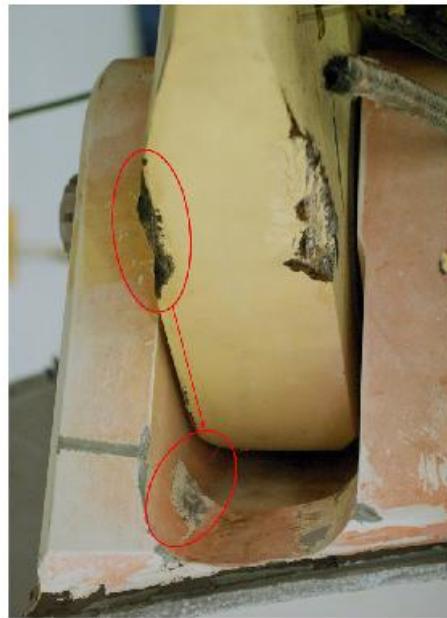
The aft attachment lugs (male on the fin and female on the airframe) had marks indicating a backwards movement of frames 86 and 87 as a whole.

Figure 52: Rear view of the left-hand aft lug: there were marks showing a backwards pivoting of frames 86 and 87

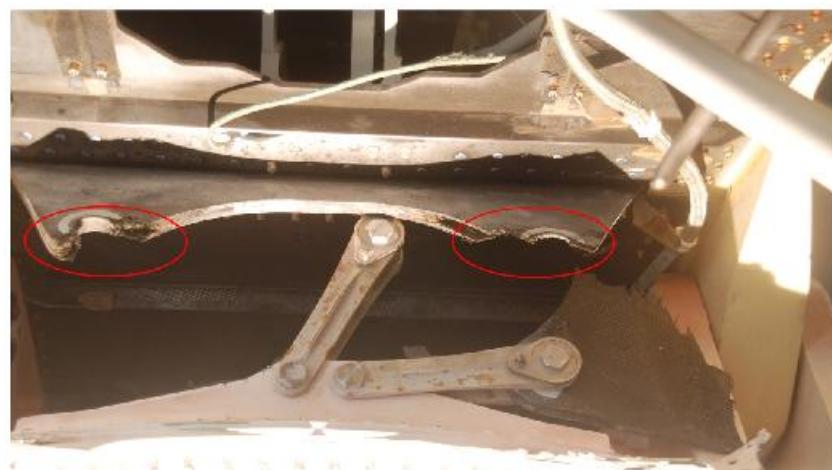
Figure 53: Tensile failure of the centre spar at the level of the attachment of the lateral load pick-up rods

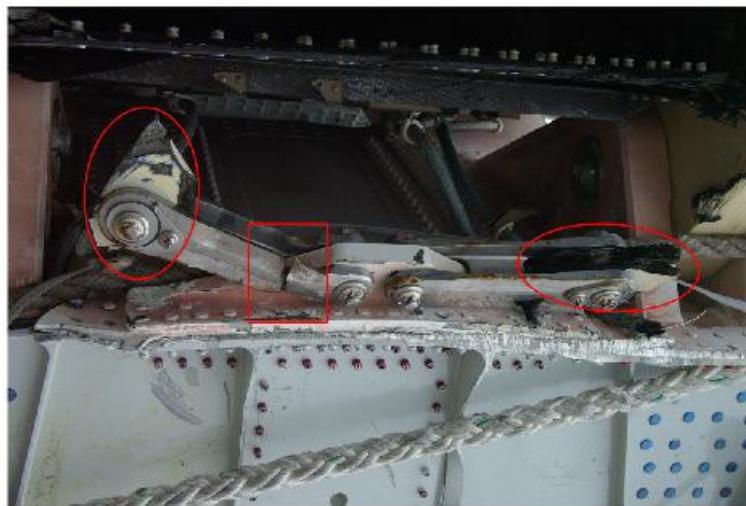
Figure 54: Compression failure of the aft spar at the level of the attachments of the lateral load pick-up rods and failure of the left-hand rod by buckling

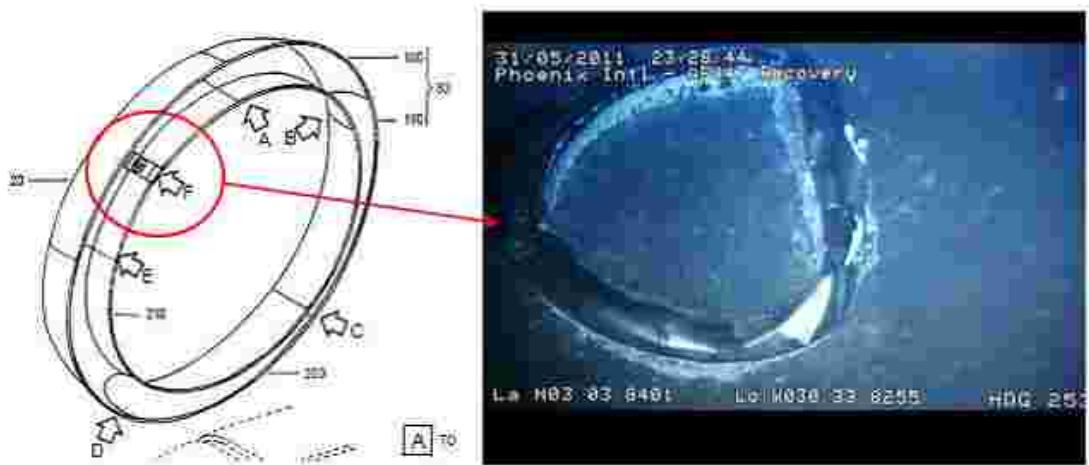
The left engine air entry leading edge had significant deformation on its lower part.
