Report

A-029/2017

Accident involving a Boeing 737-800 aircraft, registration EI-FJJ, operated by Norwegian Air International, at FL190 in the vicinity of the CLS VOR/DME (Valencia) on 18 October 2017

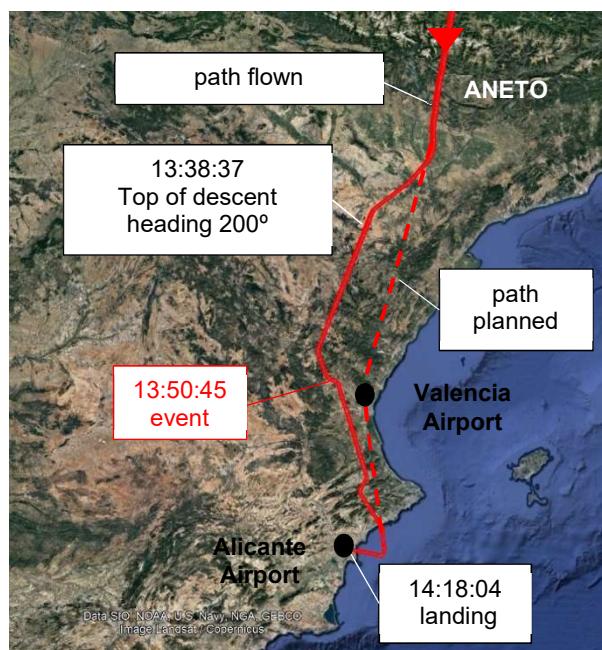
Figure 1. Flight path in the Barcelona ACC airspace

The planned route (dashed line in Figure 1) had the aircraft descend on a practically southerly course to Alicante over Valencia, but due to bad weather throughout the east and northeast of the Iberian Peninsula, the crew requested a change in route (solid red line in Figure 1), which ATC authorized.

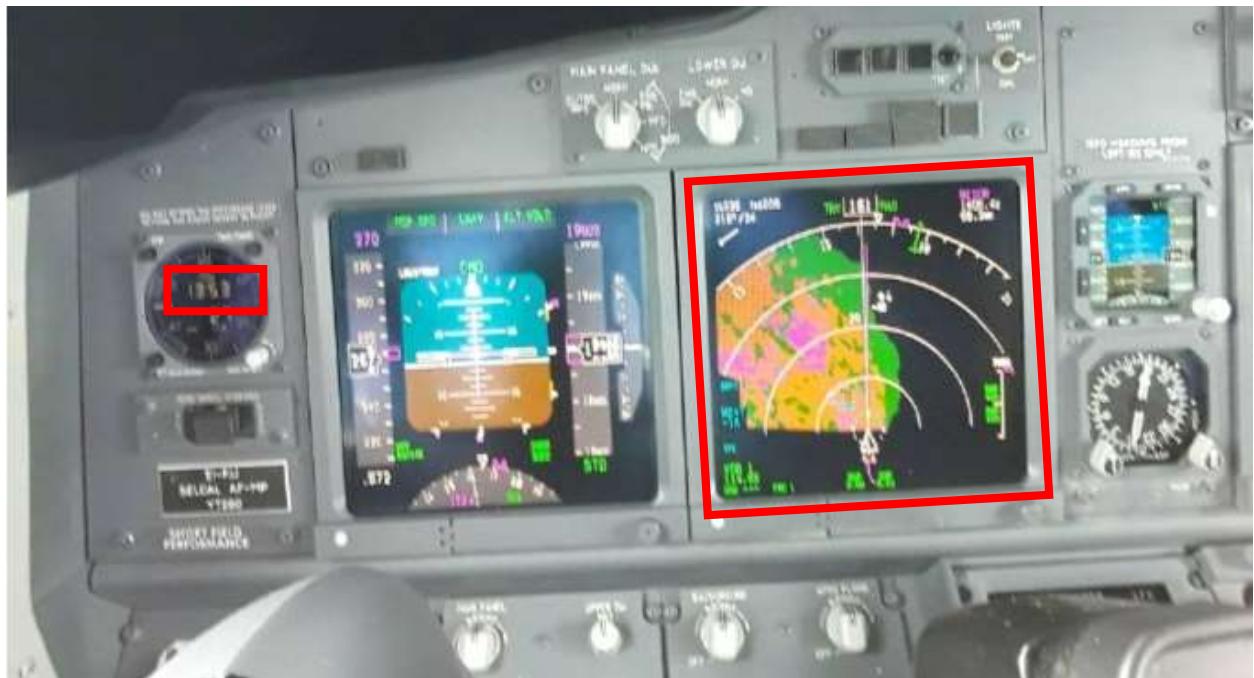
Figure 2. Photo taken by the crew at 13:53 (2 min after the event)

The information displayed on the aircraft's weather radar was, as per the crew's statement, similar to that shown in the photo in Figure 2 (right display). This photo was taken by the crew 2 minutes after the event, and it shows a radar return that indicates clouds with intense rain and turbulence³.

³ Rain is shown in red, yellow and green, with red indicating the highest intensity and green the lowest. The magenta indicates strong turbulence.

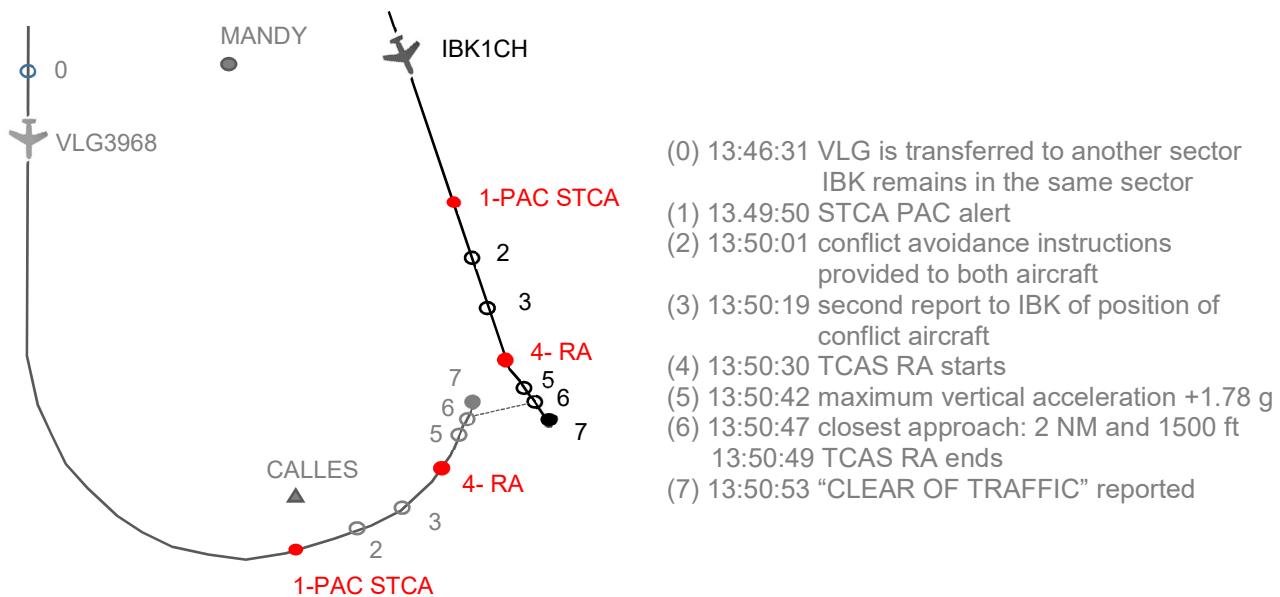
Figura 3. Relative positions of the aircraft during the event

The STCA PAC⁷ alert between the two aircraft was activated when they were 10.8 NM and 600 ft apart. Both were descending to FL210 (21700 ft and 21100 ft), with VLG above IBK. Each aircraft was in contact with a different sector.

At 13:50:13, the aircraft were 7.1 NM and 900 ft (21300 ft and 20400 ft) apart and descending, with VLG remaining above IBK, which was still on heading 163°. The controller amended his previous instruction to VLG to descend and instructed it to hold its current flight level ("*Amend instructions and hold FL210, 210*"), which the crew immediately acknowledged.

The aircraft were 6.2 NM and 900 ft (21100 ft and 20200 ft) apart, both descending. IBK, which was below VLG, was flying with level wings on heading 163° (although the crew were inputting a new heading) when it received the following communication from ATC:

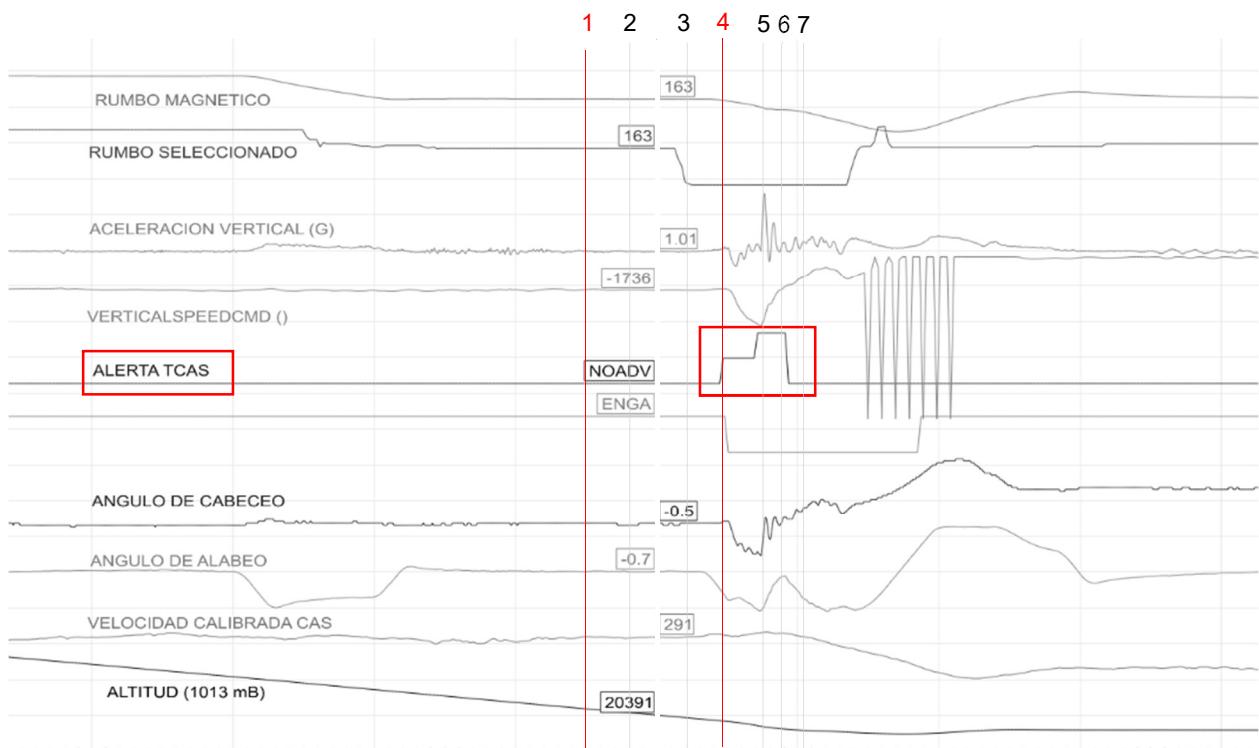
Figure 4. Parameters from IBK during the event

t=0	Activation of the TCAS RA DESCEND DESCEND, which was active for 9 s. The aircraft was 4.5 NM and 700 ft away (20600 ft and 19900 ft) from VLG, which was above IBK. The aircraft was at 292 kt with a left bank angle of 18° and descending at 1656 fpm. The value of the vertical acceleration was in the normal range (1.04 g).
t=+1	Autopilot and autothrust disengaged. Crew reported “TCAS RA TCAS RA” to ATC.
t=+2-8	The bank angle and vertical speed increased during this period. The pitch angle increased from -0.4° to -3.2°. Vertical acceleration fluctuated, with maximum values between 0.81 and 1.11 g. At t=8 s, the two aircraft were 2.8 NM and 800 ft apart, with both aircraft descending.
t=+9	End of DESCEND DESCEND advisory. The aircraft had increased its vertical speed to -3336 fpm and its bank angle was -27.1°. Its speed was 294 kt and the pitch angle had recovered to -0.9°.
t=+10	Activation of TCAS RA LEVEL OFF, which was active for 8 s. The maximum bank angle, -28.5°, was reached at this time. During the 8 s that the LEVEL OFF advisory was activated, the crew leveled the wings.

t=+11	Maximum vertical speed of -3536 fpm registered, which would start to decrease from this moment on.
t=+12	Maximum vertical acceleration recorded: 1.78 g (5). The aircraft were 2.3 NM and 1500 ft apart.
t=+17	Point of closest approach: 2 NM and 1500 ft (6).
t=+19	TCAS LEVEL OFF advisory cleared. The aircraft was on course 145° with a bank angle of -9°, a vertical speed of -1448 fpm and a CAS of 293 kt.

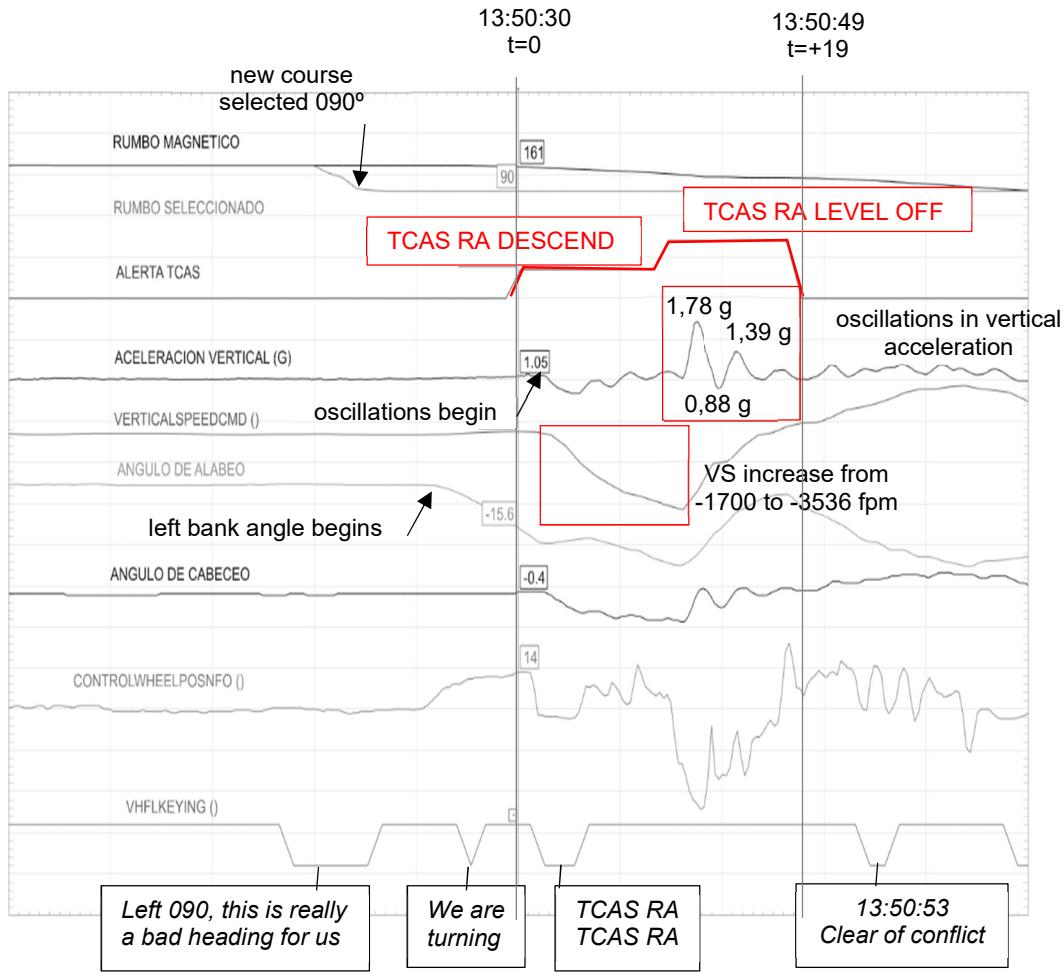
Figure 5. Timeline of TCAS RA

- A descent at a rate that reached -3536 fpm.
 - This value exceeded the -1500 to -2500 fpm range recommended by Eurocontrol and EASA guidelines to carry out TCAS maneuvers.
- A descent as the aircraft increased the left bank angle to -28.5°, as a result of the instruction issued 29 s earlier by ATC.
 - As regards the compatibility of banking while executing a TCAS maneuver, EASA and Eurocontrol guidelines state that the bank must be stopped to achieve a descent rate that is as precise as possible. In contrast, the ICAO states that the ATC and TCAS instructions should be followed to the extent possible. The fact that the aircraft was turning could have affected the crew's ability to adjust the descent rate.
