CZ-17-1037

FINAL REPORT

**Investigation of causes of an air accident
ULL EV97 EuroStar SL
reg. mark OK-UUU72
2 km E of Nížkov
on 24 October 2017**

Prague,
November
2018

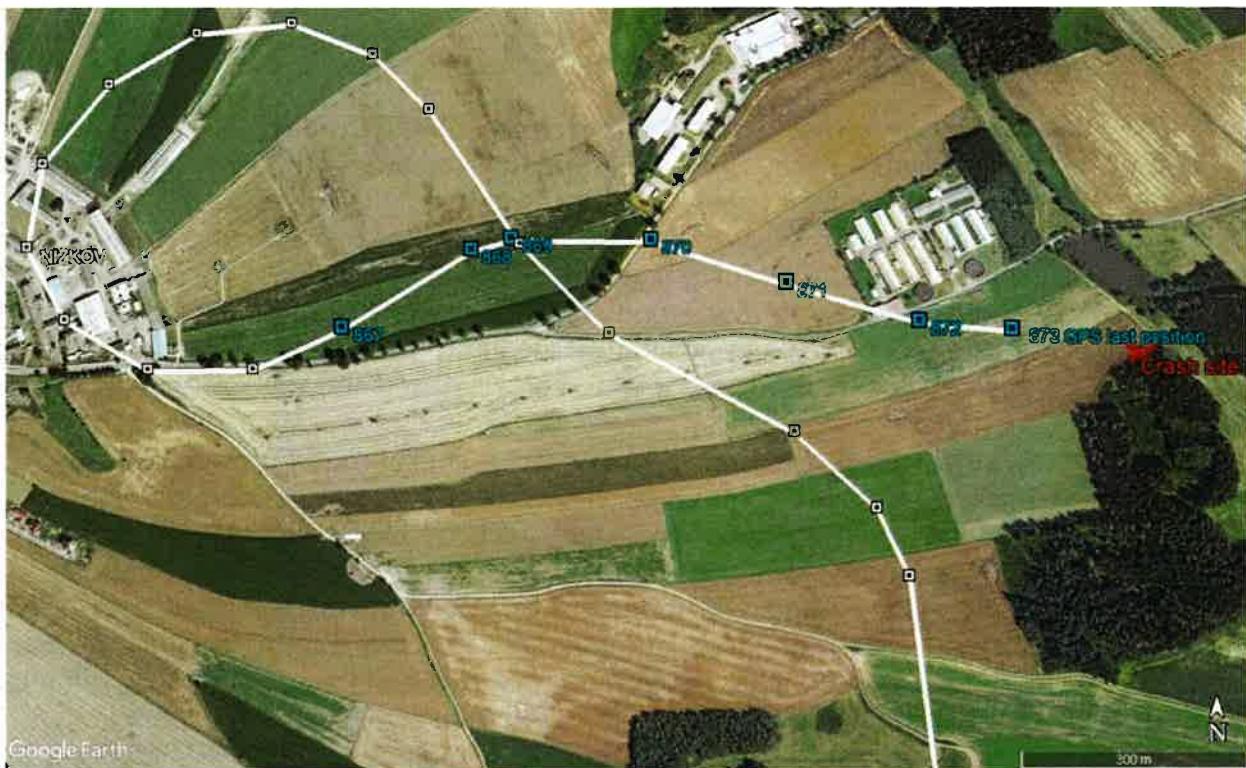
Fig. 1 Approach over Nižkov

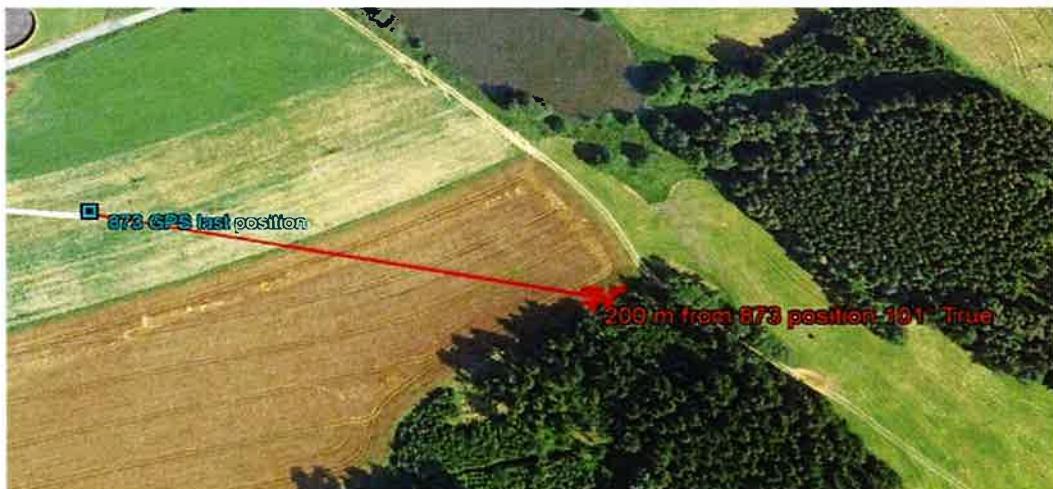
Fig. 2 Approach details from the last recorded point 873 by GPS Garmin 695

The pilot performed a turn over Nižkov and subsequently began to decrease the flight speed from 139 km/h GS-GPS all the way down to 98 km/h GS-GPS. At 10:38:27, the pilot overflew with the UL aeroplane at 2,035 ft ALT-GPS the power towers holding the high-voltage lines at 1,923 ft ASL.

During the overflight of this obstacle, the UL aircraft flight speed dropped from 105 km/h GS-GPS to 98 km/h GS-GPS. The UL aeroplane then continued in flight configuration without flaps down with backwind (310°/11 km/h) in the course 101° for about 200 m more. Upon retracting the backwind component of 8 km/h from the speed 98 km/h GS-GPS, the flight speed would be as follows:

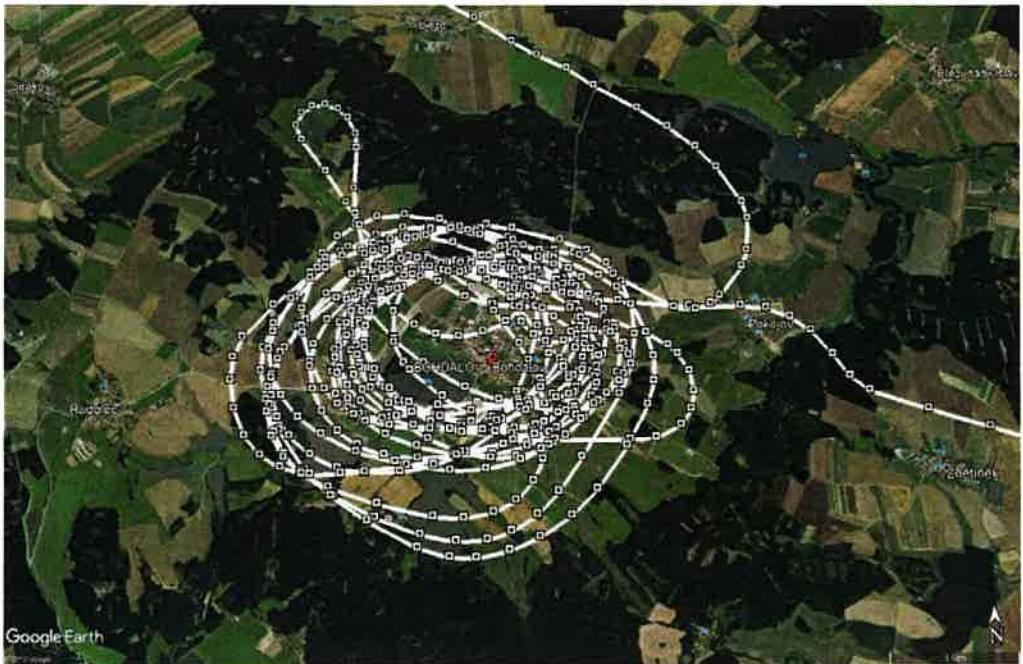
At 09:35:40, the pilot started a series of left-hand turns due to deteriorating weather in Bohdalov. After 55 minutes of flying in circles over Bohdalov, the pilot evaluated the weather conditions and opted for precautionary landing. At 10:31:28, the UL aeroplane departed from Bohdalov and continued flying towards Nížkov. While flying towards Nížkov, the UL aeroplane crew noticed a man driving a tractor in a field and decided for precautionary landing close to him. The landing took place in fog, in flight configuration without flaps down and with a greater weight than authorised. The course of the flight was recorded by the GPS Garmin 695 navigation device. Flight parameters were used for a graphical representation of significant flight phases during AA investigation. All ALT-GPS and GS-GPS were read from the data recorded by Garmin 695. The recorded ALT-GPS was compared with the LKKU AMSL. While the UL aeroplane was taxiing on RWY02C before take-off, Garmin 695 recorded ALT-GPS, AMSL lower by 20 ft than the AMSL of measured and compared points on RWY02C.

Fig. 3 Course of the flight over Bohdalov

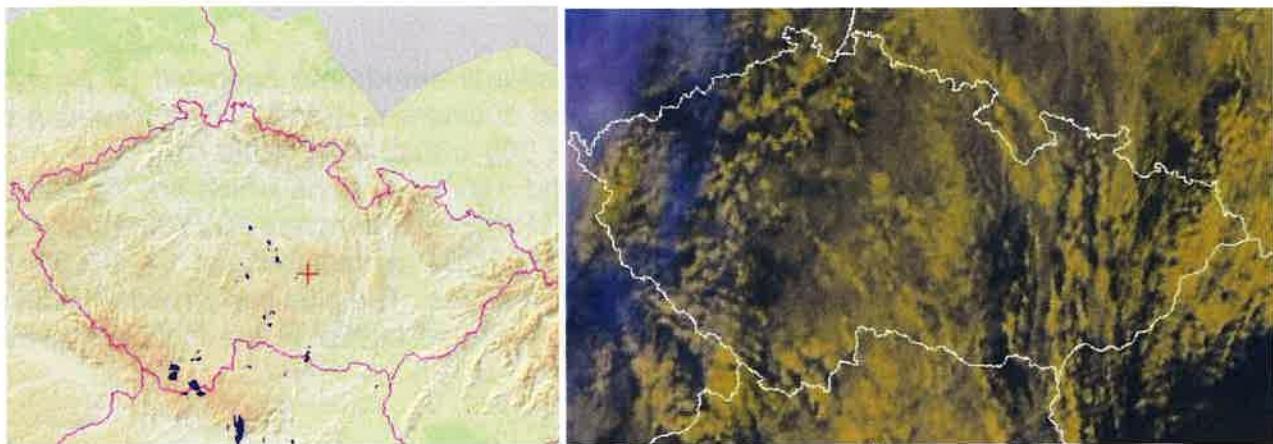
The following charts provide information from SYNOP reports submitted by the land weather stations closest to the flight route, Fig. 4 shows the radar shots.

Fig. 4 Radar and satellite shots of 24 October 2017 (the position of Žďár nad Sázavou is marked in red, low and middle-level clouds are marked in yellow)

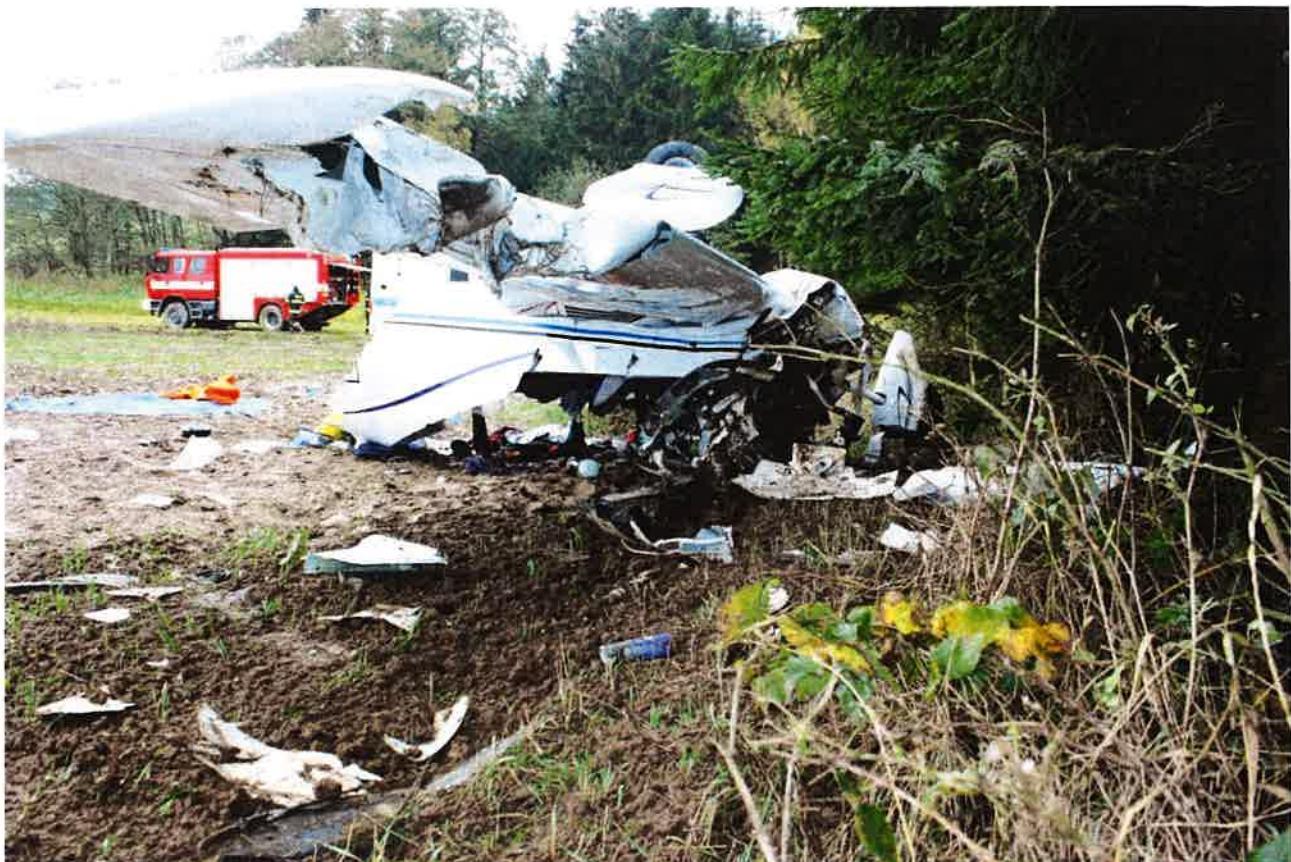
The UL aircraft was totally destroyed by the fall. The engine and engine cradle were torn away and wedged in under the deformed front part of the fuselage. The leading edges of both wing halves, the cockpit, HR and RUD were seriously damaged.

The UL aeroplane AA location is located at the borderline of a forest and a field approx. 35 m from Gigantský rybník (pond), in the vicinity of an access field road. The approach trajectory led across the high-voltage power line with steel towers with height of approx. 9 m above the ground; the line leads exactly between the recorded points No. 872 and No. 873 from the navigation device GPS Garmin 695. The first hit by the UL aeroplane was – considering the flight trajectory – very likely into the tree crowns with the leading edge of the right half of the wing. It was probably followed by rotation of the UL aeroplane to the right accompanied by the hit of the left half of the wing into the trees again. After the impact, the UL aeroplane turned over around the longitudinal axis and fell to the ground on its back from an altitude higher than 10 m on the engine part of the fuselage. The engine part of the fuselage was deformed symmetrically and the engine was forced out of its embedding and wedged into the cockpit. The leading edge of the right half of the wing bore significantly less noticeable traces of a direct hit into an obstacle than the left half which showed traces of a heavy damage to the leading edge following the impact into the trees. Both the wing halves had the flaps retracted and the lever controlling the flaps was in the retracted position. The control sticks were slightly bent. The foot controls were deformed by the impact and moved in the direction inwards into the cockpit. The values on the engine gauges were all 0. The altimeter was set to the value of 1,023 hPa. The altimeter was damaged due to the impact and the altitude indication did not correspond with the actual AA altitude. The power unit control lever was in the fore position. The carburettor preheating was on. The circuit breakers on the panel in the cockpit were forced out of their slots, some were missing. Avionic Master Switch was in the OFF position. The propeller blades were broken off at the cap. The HR and RUD tailplanes were seriously damaged. After the AA, only approx. 26 l of fuel was pumped out from the aeroplane tank.

Fig. 5 Crash site location and UL aeroplane debris.
