MINISTÉRIO DAS OBRAS PÚBLICAS, TRANSPORTES E COMUNICAÇÕES
GABINETE DE PREVENÇÃO E INVESTIGAÇÃO DE ACIDENTES COM AERONAVES

AIRCRAFT INCIDENT SUMMARY REPORT

Date/Time:	2010 / 04 / 04 @ 19:55 UTC ¹	Proc. Nr.:	03 / SUM / 2010
Operator:	Aer Lingus Teoranta	Type of Incid.:	ATM
Id. of aircraft: Airbus A-320, registration EI-DEK			
Local: NAVIX (Transition point from Lisbon CTA to Sta. Maria OCA)			
Type of flight:	Transport Passengers	Phase of flight:	Cruise
People on board:	Crew / Pax: unknown	Injuries:	Nil
Aircraft Damage: Nil			
Other Damage: Nil			
Synopsis: The aircraft was flying from Tenerife (TFS) to Belfast (BFS) and received, by datalink, an oceanic clearance for FL360. Approaching NAVIX point, Sta Maria oceanic control requested Lisbon ACC controller (Madeira sector) to ask EIN-843 if he could accept FL370, to which he answered affirmative and has been instructed to climb to that Flight Level. When the pilot contacted Sta Maria Radiotelephone, in order to confirm clearance changes, he was informed that his clearance was for FL360. While this misunderstanding was clarified between controllers, the aircraft was approaching entry point (NAVIX) and the Captain, being not allowed

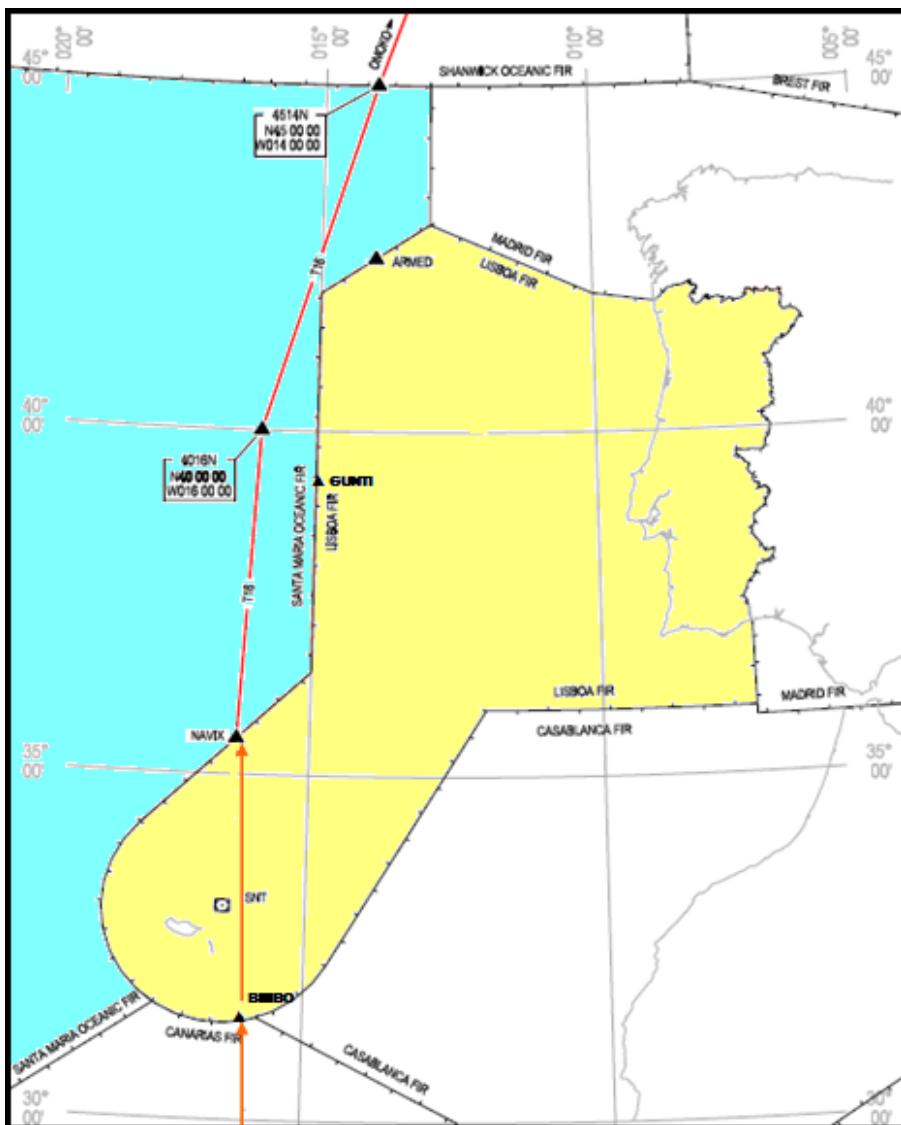
Picture Nr 1

Irish Company Air Lingus flight EIN-943 departed Tenerife (GCTS), in Canary Islands, with destination Belfast (EGAA), in Northern Ireland. Leaving Canary FIR, through "BIMBO" point, the flight would overfly airspace controlled by Lisbon ACC Madeira sector (CONLIS) and Atlantic control of Sta Maria (CONTATL), following the route (*orange*) signalled on the map (*picture nr 1*).

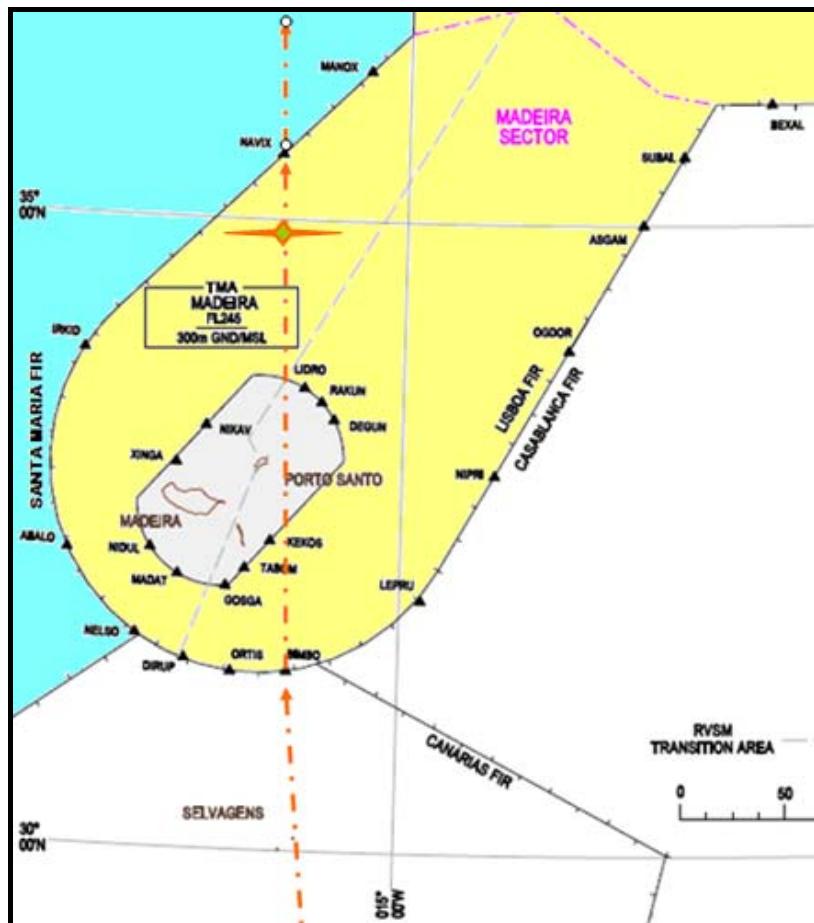
Picture Nr 2

At 19:48:31, the aircraft still 47NM to NAVIX (*picture nr 2*), Sta Maria controller (ATCO SMA) called Madeira sector controller (ATCO LIS) asking him to contact EIN-943 in order to know if he could accept FL370, because the flight would be crossing with MEDIC-01, who was to be cleared to cruise at FL360 and there was no guarantee, at the moment, that a horizontal conflict would be avoided.

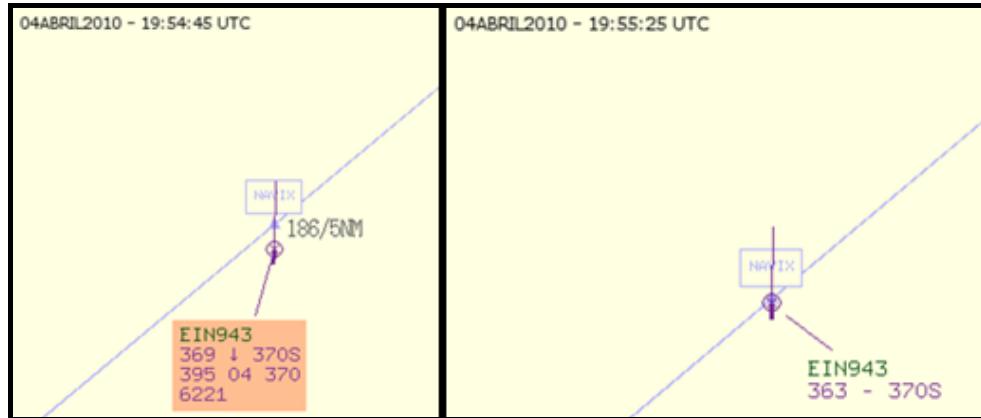
Picture Nr 3

Back in contact with ATCO LIS (19:54:37) EIN-943 informed his oceanic clearance was for FL360 and, as he was approaching entry point, he was descending to FL360. ATCO LIS informed he was "seeing" (on radar) traffic at FL360 and instructed EIN-943 to return to FL370, while trying to clarify the situation with ATCO SMA. EIN-943 replied *he would not enter OCA without being cleared for that level and he was starting a hold at NAVIX, returning to FL370*, giving time for the situation to be clarified (picture nr 3).

EIN-943 initiated a right turn and, only by 19:57, after receiving a new clearance for FL370, resumed navigation to next point ($40^{\circ}\text{N } 016^{\circ}\text{W}$), exiting holding after 45° turn.

Reaching NAVIX the aircraft entered a right turn holding pattern.

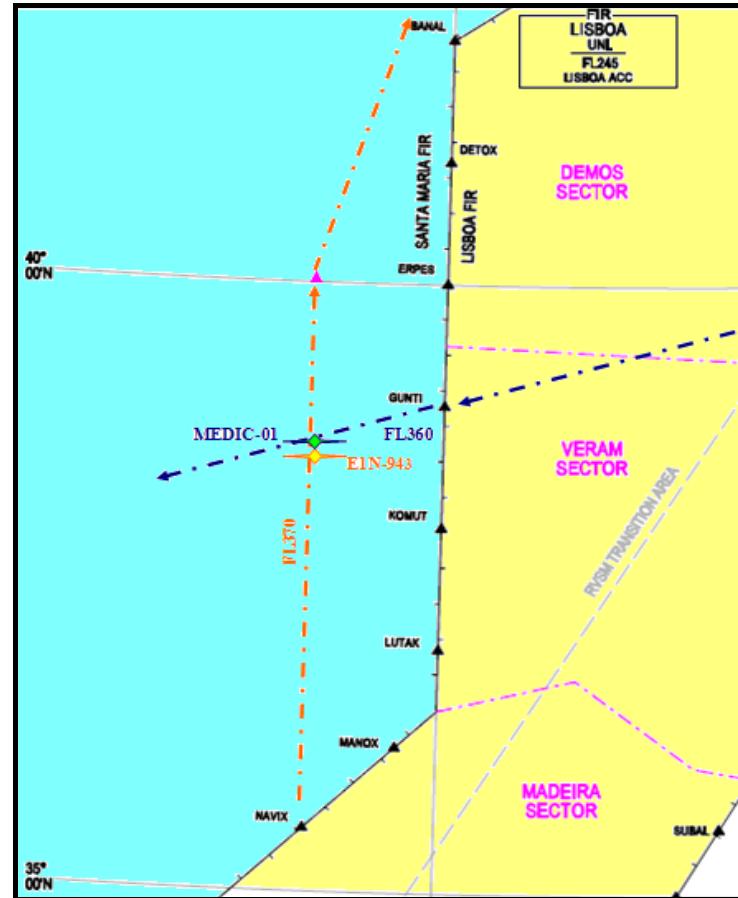
Picture Nr 4

Before this position was attained ($\pm 80\text{NM}$ before). EIN-943 got a TCAS/TA, with traffic crossing from his right to his left, 1000ft bellow and 2NM ahead (picture nr 4).

It was MEDIC-01 from GUNTI to $38^{\circ}\text{N } 020^{\circ}\text{W}$, at FL360, the same that originated Flight Level change proposal, issued by CONTATL.

When approaching 40°N, EIN-943 had a TCAS/TA due MEDIC-01 crossing 2NM in front and 1000ft below (FL360).

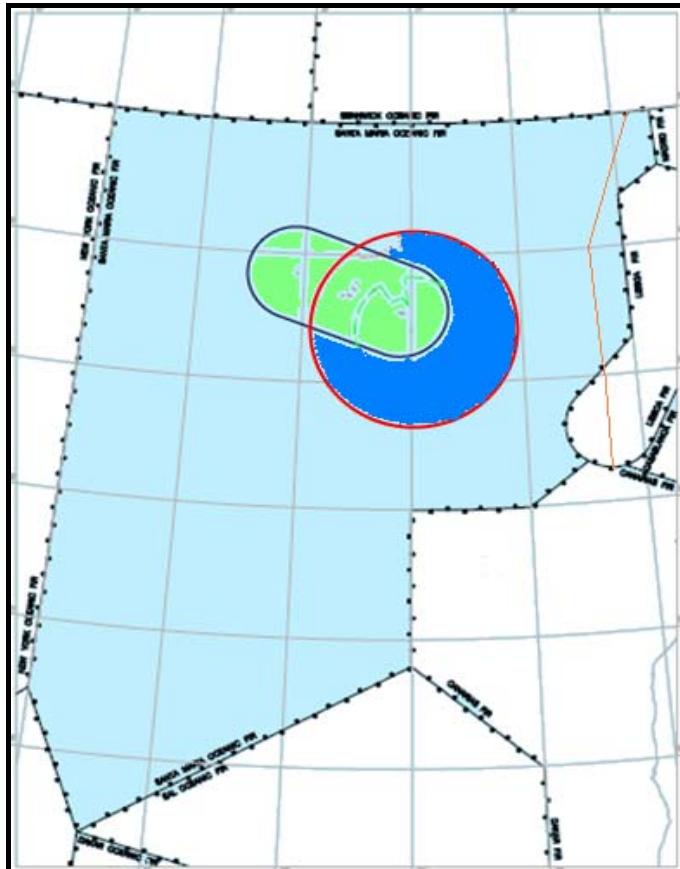
Picture Nr 5

Additionally, there's a small area where radar coverage is available (*dark blue area, in picture nr 5, represents radar coverage – about 250NM radius at FL300 with centre in Sta Maria*) and VHF radio communications and effective control becomes possible, with pilots talking directly with controllers.
