FINAL REPORT

AAIU Synoptic Report No: 2008-004

Aircraft Type and Registration:	(i) B737-8AS, EI-DCZ (ii) MD-83, OE-IKB
No. and Type of Engines:	(i) 2 x CFM 56-7B (ii) 2 x PW JT8D- 219
Aircraft Serial Number:	(i) 33815 (ii) 49448
Year of Manufacture:	(i) 2005 (ii) 1986
Date and Time (UTC):	23 September 2007 @ 19.51 hrs
Location:	Reporting Point 'BANBA', off the SE coast of Ireland.
Type of Flight:	Both Public Transport.
Persons on Board:	(i) Crew - 6 Passengers - 179 (ii) Crew - 6 Passengers - 164
Injuries:	None
Nature of Event:	AIRPROX, loss of required vertical and lateral separation of aircraft.
Commander's Licence:	Both JAA ATPL's
Commander's Details:	(i) Male, aged 52 years (ii) Male, aged 43 years
Commander's Flying Experience:	(i) 13,800 hours of which 3,000 were on type (ii) 7,500 hours of which 1,100 were on type
Notification Source:	General Manager, ATC, Shannon Airport.
Information Source:	AAIU Field Investigation

SYNOPSIS

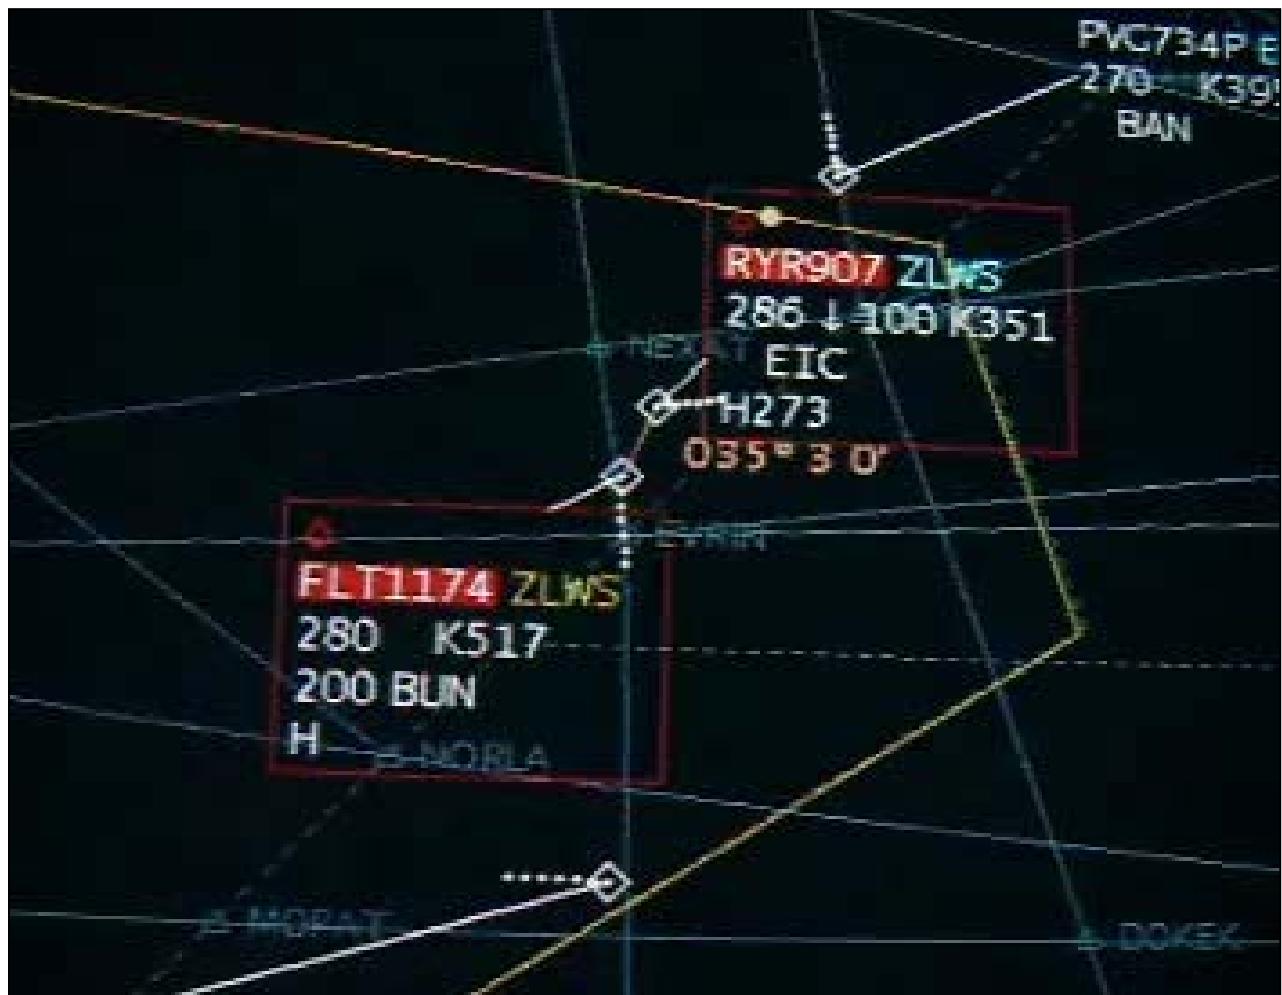
Appendix C

- With 4 NM between the aircraft and RYR 907 Mode C reading FL286 and FLT 1174 Mode C reading FL280, FLT 1174 reported to ATC that he was following ‘**TCAS resolution**’ and commenced descent. (**Appendix C**)

STCA is an automated ATC safety net that alerts controllers to potential conflicts that may be coming up within several minutes between aircraft returns on the radar display. It is fully operational in Irish controlled airspace. STCA recognises an aircraft under ATC control by reference to its Mode A code (a mode of operation of SSR equipment that provides a selected code reply -non altitude- when interrogated). Conflict alert warnings will only be given for two aircraft where at least one is being controlled from an ATC unit equipped with STCA. When the system detects a potential conflict, an audio alarm, red SSR labels and a discreet tabular area on the radar display giving the call sign or call sign/SSR code, alerts the radar controller. These three warnings occurred in the subject event. (See **Appendix C**)

Radar image showing STCA labels in Red
