FINAL REPORT

*AAIU Report No. 2001-007
AAIU File No. 2000/0052
Published 25 August 2001*

Aircraft Type and Registration: Eurocopter EC – 120 G-BZIU

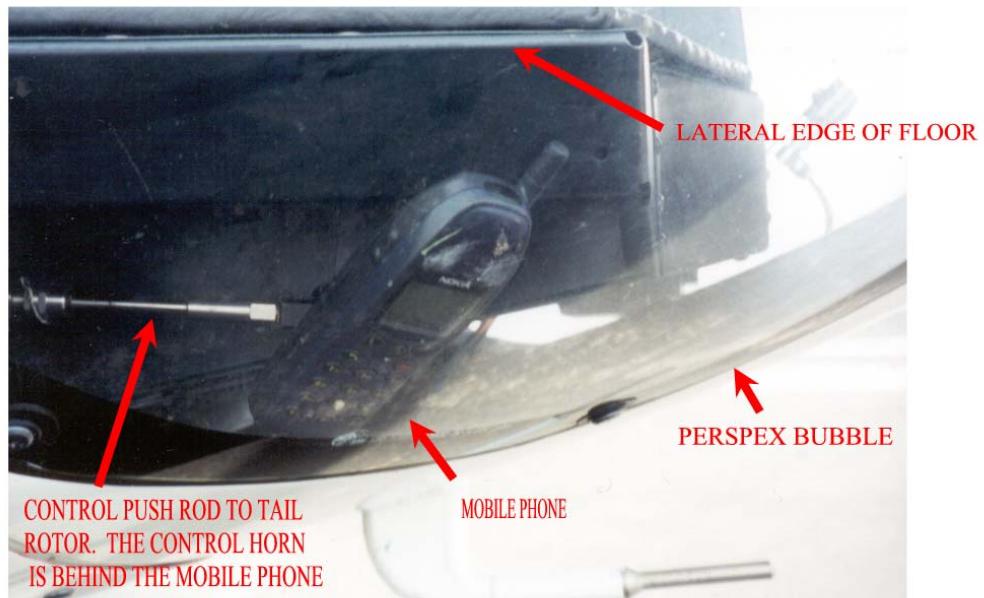
PHOTO 1

The final landing was observed by an AAIU Inspector who arrived on-scene as the pilot was exhausting the surplus fuel. On inspection of the helicopter after landing, a mobile phone was found to be wedged between the horn of the yaw control and the perspex bubble window at the front of the helicopter, on the starboard side. See Photo 1 of Appendix A. The phone was firmly wedged, and the maximum degree of movement to the right was a pedal position 10 mm right of centre.

THIS VIEW SHOWS THE MOBILE PHONE JAMMED BETWEEN THE PERSPEX BUBBLE AND THE CONTROL HORN. AS VIEWED FROM THE LOWER RIGHT SIDE OF THE HELICOPTER

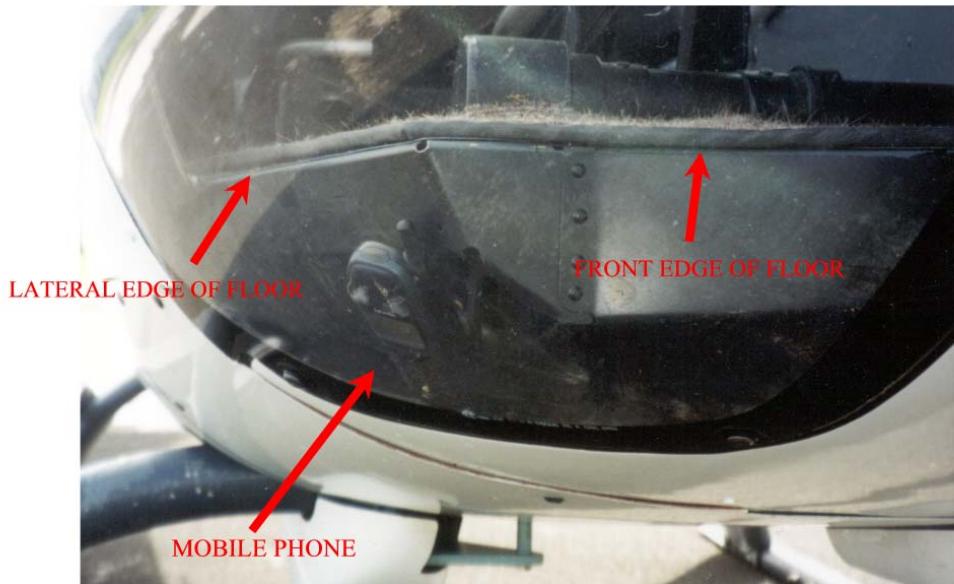
PHOTO 2

- 3.3 The design of the floor, in particular the lateral gap between the floor and the bubble, and the absence of a raised edge on the floor, facilitates the entry of loose objects into the underfloor area.

- 3.4 The pivot bar of the yaw pedals would stop loose items sliding directly forward and falling off the forward edge of the floor, but there is no protection of the lateral gap. If the pilot inadvertently dropped an object, or if it slipped from his right side pockets, while flying, this could also lodge in the underfloor area, again entering through the lateral gap. This layout can be seen in Photos 2 and 3 of Appendix A.

THIS VIEW SHOWS THE MOBILE PHONE JAMMED BETWEEN THE PERSPEX BUBBLE AND THE CONTROL HORN. AS VIEWED FROM THE FRONT OF THE HELICOPTER, LOOKING REARWARD

4.2 The manufacturer of the EC-120, Eurocopter, should consider the feasibility of modifying the EC-120 in the forward floor area, with the objective of eliminating the possibility of loose objects entering the underfloor area and jamming the flight controls. **(SR 15 of 2001)**

In response to Safety Recommendation 15 of 2001, “*In order to prevent any foreign object from sliding into the space between the pedal unit and the canopy, Eurocopter will issue as soon as possible a mandatory recommendation. This modification consists in adding covers between the floor and the canopy in order to eliminate such problem.*”
