FINAL REPORT

AAIU Synoptic Report No: 2008-012
AAIU File No: 2007/0082
Published: 3/7/2008

Aircraft Type and Registration:	Schweizer 300 CBi ¹ , G-CDTK
No. and Type of Engines:	1 x Lycoming HIO-360-G1A
Aircraft Serial Number:	0216
Year of Manufacture:	2005
Date and Time (UTC):	12 September 2007 @ 15.15 hrs
Location:	Clonshanny, Co. Offaly
Type of Flight:	Private
Persons on Board:	Crew - 1 Passengers - 1
Injuries:	Crew - 1 Passengers - 1
Nature of Damage:	Helicopter suffered severe damage
Commander's Licence:	PPL (H) USA
Commander's Details:	Male, aged 38 years
Commander's Flying Experience:	107 hours, of which 25.5 hours were as pilot-in-command
Notification Source:	Tullamore Gardaí
Information Source:	AAIU Field Investigation

SYNOPSIS

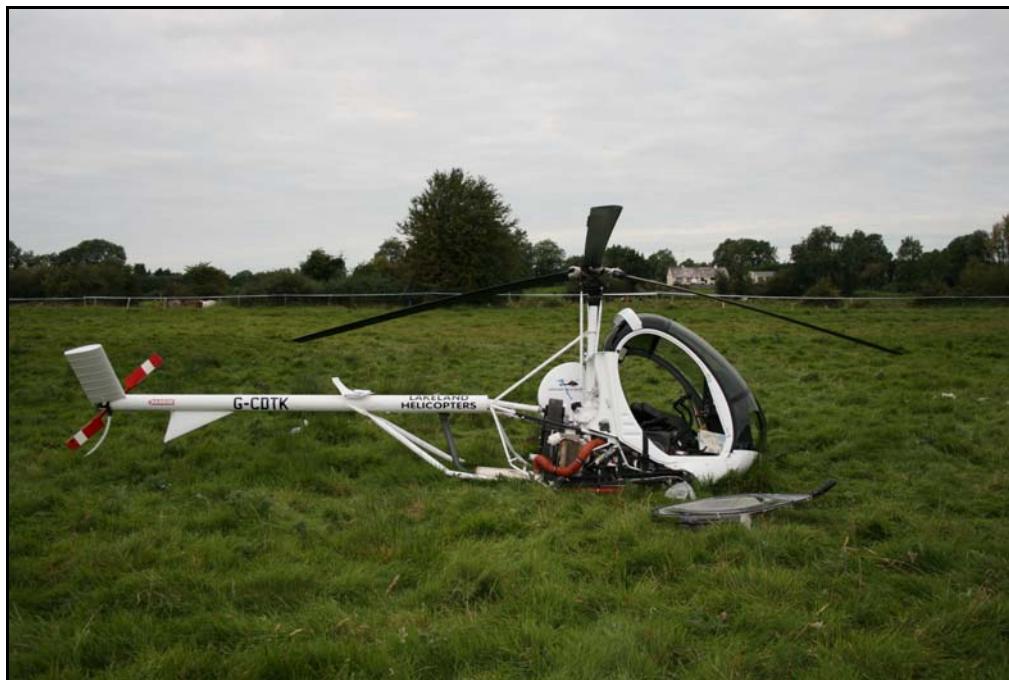
Photo No. 1

The helicopter suffered extensive damage, consistent with a heavy vertical impact. The skid undercarriage collapsed completely, the bottom of the fuselage suffered ground impact damage, the cabin floor and instrument panel were distorted, the main tail boom supports failed and the main blades suffered kinking damage. The extent of the damage to the helicopter probably rendered it beyond economic repair (**Photo No. 1**).

This photograph shows the helicopter at the accident site, prior to removal to the AAIU facility at Gormanston

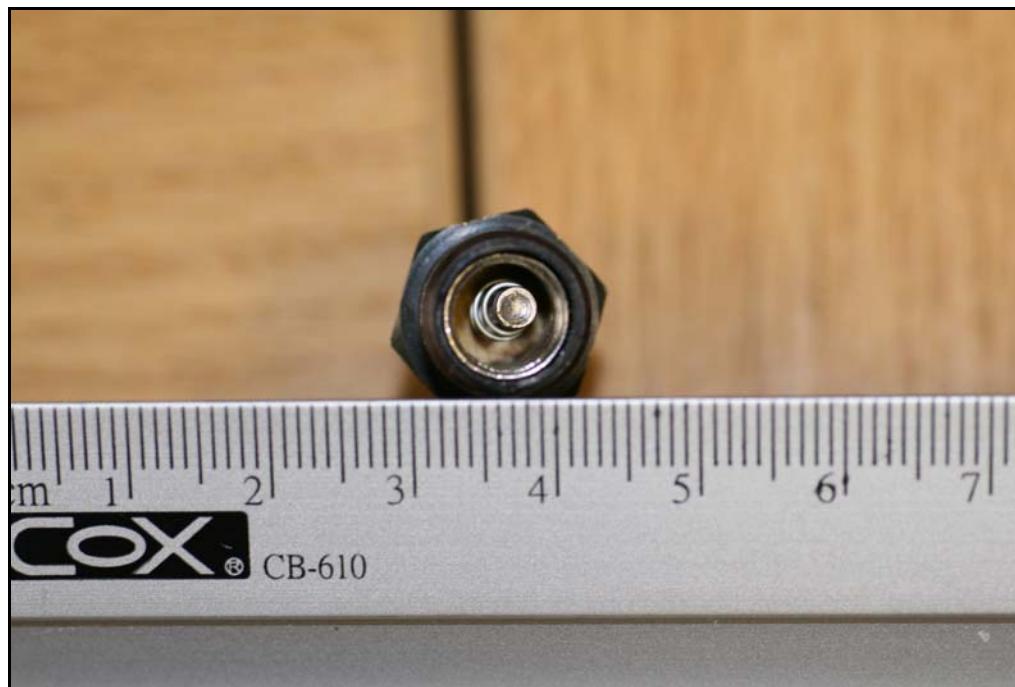
Photo No. 2

Due to the faulty bulb holder, the fuel low contents warning light probably did not illuminate as the helicopter was running low on fuel. This is consistent with the Pilot's recollection.

The Investigation was unable to determine when the central contact in the bulb holder of the fuel low contents warning system was damaged. This damage resulted in the warning system becoming defective, and the press-to-test feature being intermittent/inoperative. No record of such a problem was recorded prior to the departure of the helicopter from Enniskillen; nor did the Pilot report such a defect. The Investigation is aware that the spring contact in such bulb-holders is prone to damage by excessively robust use of the press-to-test facility.

3. The helicopter's low fuel contents warning light failed to illuminate as the fuel contents reached a critical level.
4. The failure of the low fuel contents warning light was caused by a damaged contact in the bulb-holder. This contact was probably damaged due to excessively robust use of the press-to-test facility.

This photograph shows the bent central contact of the fuel contents low warning light bulb holder. The contact can be seen to be significantly off-centre
