FINAL REPORT

AAIU Synoptic Report No: 2006-026

Aircraft Type and Registration:	Bell 206B, EI-BYJ
No. and Type of Engines:	1 x Allison 250
Aircraft Serial Number:	1897
Year of Manufacture:	1976
Date and Time (UTC):	13 June 2004 @ 18.15 hrs (19.15 hrs Local)
Location:	Inniskeen, Co. Monaghan
Type of Flight:	Public Transport
Persons on Board:	Crew - 1 Passengers – 4
Injuries:	Crew - None Passengers - None
Nature of Damage:	Tail boom damage following autorotation.
Commander's Licence:	Airline Transport Pilot's Licence (Aeroplanes) & Commercial Pilot's Licence (Helicopters)
Commander's Details:	Male, aged 45 years
Commander's Flying Experience:	8,830 hours, of which 263 were on type
Information Source:	Station Manager, ATC Dublin. AAIU Field Investigation

SYNOPSIS

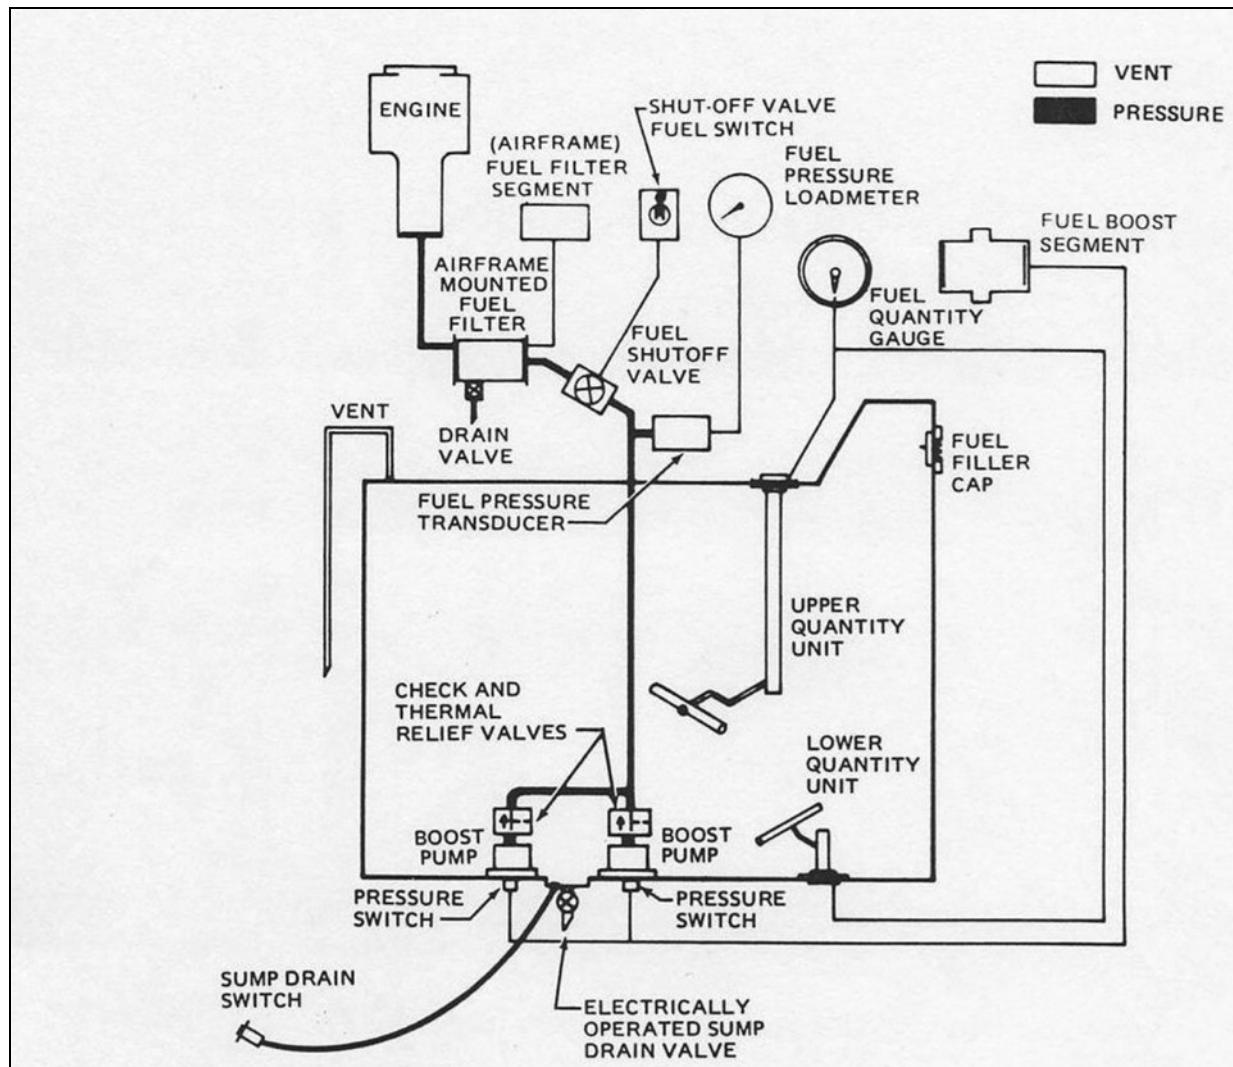
Fuel System Schematic

A schematic for the Bell 206 fuel system is shown in **APPENDIX A**. The helicopter is fitted with a single fuel tank, as shown on **APPENDIX B**. The tank is in the shape of an L, with the foot of the L facing forward. The fuel contents are measured by two float sensor units, which are wired in series. The upper section float sensor measures the contents in the vertical section of the L while the lower section float sensor measures the fuel in the bottom section of the tank. The fuel contents gauge registers the sum of these two sensors. As the tank contents reduce, the sensor from the upper section hits a bottom stop at a point where the fuel quantity is level with the top of the lower section. At this point the fuel quantity in the tank is approximately 15 US gallons. As the fuel is further exhausted, the contents are measured solely by the sensor in the lower section.

Fuel is pumped to the engines by two electric pumps fitted in the bottom of the tanks. These pumps are connected in parallel, and pump fuel from the tank up to the engine. If either pump fails, or if the intake is uncovered (so that the pump draws in air), the loss of fuel pressure is detected by a pressure sensor on the pump outlet which turns on a warning light on the caution panel of the cockpit instrument panel. The sensor on either pump feeds into the single warning light. This warning light is red and contains yellow script “FUEL PUMP”.

Each pump is fitted with a non-return valve (NRV), so that in the event of pump failure, or the pump inlet uncovering, the fuel provided by the remaining serviceable pump is not lost by escaping back into the tank through the unserviceable pump.

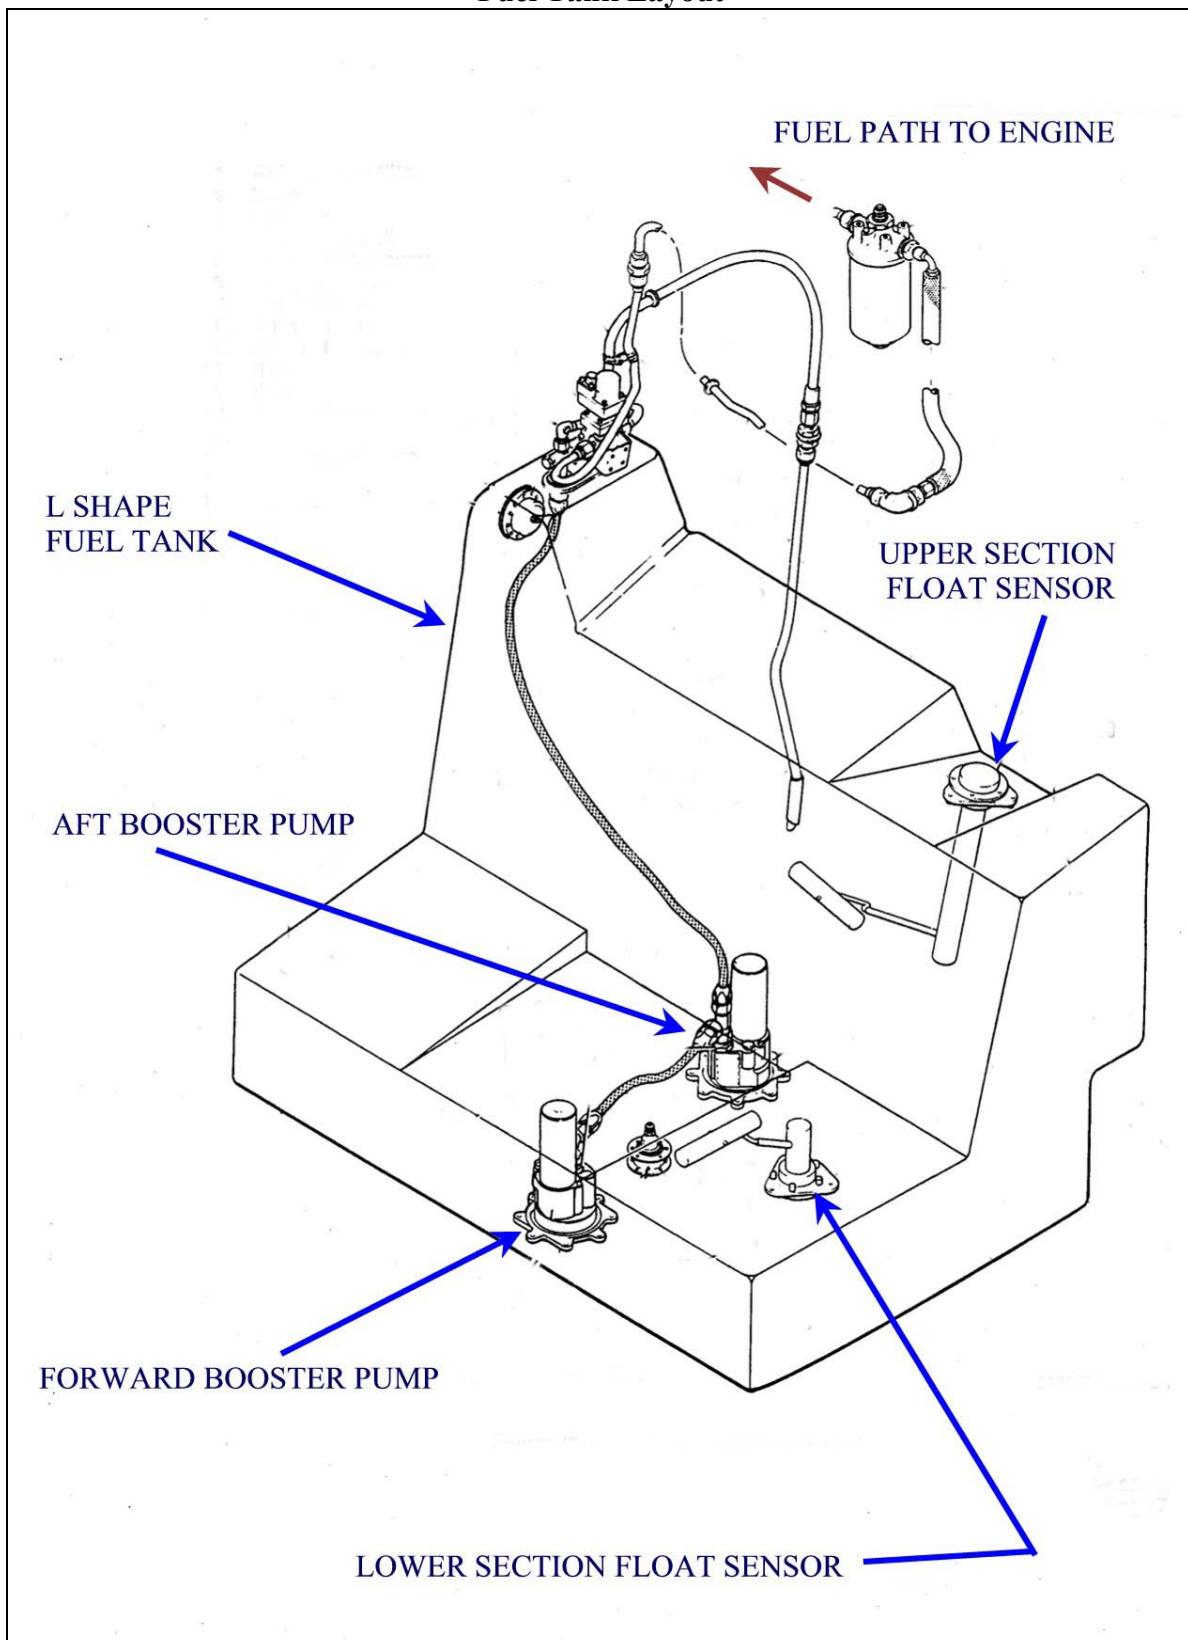
Fuel Tank Layout

Because the two sensors are longitudinally displaced, the fuel quantity reading when the upper sensor hits the bottom stop can be slightly in error. This is caused by variation in the flight pitch angle of the helicopter. This means that in normal forward flight, with a nose pitch down angle, the fuel gauge indication remains at or about the 15 US gallon point for a short period.

The unusable fuel of the Bell 206 is approximately 2.4 US gallons. This relatively high figure is, in part, due to the relative large area of the tank bottom. The figure for the unusable fuel is somewhat approximate, due to the effects of longitudinal pitch changes. Because the two pumps are longitudinally displaced along the helicopters fore-aft axis, the rear pump will usually uncover first, as the fuel level reduces, when the helicopter is in the nose down altitude associated with forward flight. The fuel available from the time the first pump uncovers, and activates the warning light, until the engine stops due to the second pump inlet uncovering is not constant. It varies according to the nose down pitch angle, which changes considerably throughout the flight operating envelope.

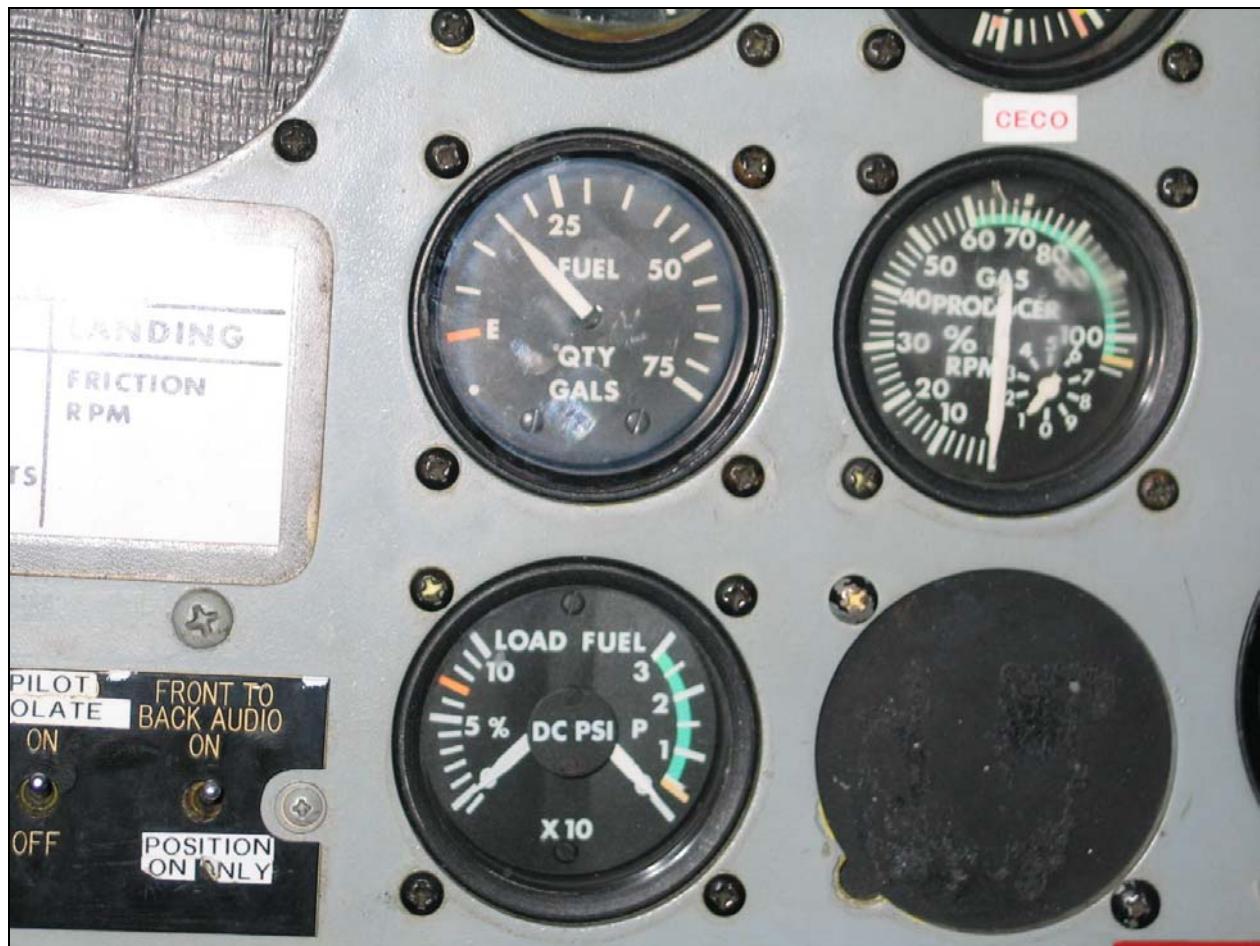
APPENDIX C

The fuel gauge is shown at approximately full size in **APPENDIX C**. It is noteworthy that the graduations are small and that there is relatively little needle movement between 10 Gallons and zero. As the pilot is not seated directly in front of the gauge, the effects of parallax can lead to reading errors.

2.12 It is possible that the pilot, at the end of a long and tiring day, misread a fuel gauge reading of 5 US gallons (or slightly above) for a perceived reading of 10 (or slightly above) US gallons. The Investigation concludes that there was probably 5 US gallons in the tank at the time of the final take-off.

While this possibility can not be proven, it is consistent with the facts. Examination of **APPENDIX C** indicates the possibility of such a misreading.

This photo shows a section on the instrument panel of EI-BYJ containing the fuel gauge, which is located at top centre. The photo is scaled at approximately full size. The gauge is located approximately 60 cm from the pilot's eye (an arm's length), below and to the left of his line of vision. The contents indication when this photo was taken was 15 US gallons. Empty is indicated by the orange line with the symbol E to the right of it. The graduation immediately above this zero mark is 5 US gallons and the next one up again is 10 US gallons.

3. The European Aviation Safety Agency (EASA) should review the certification for helicopters engaged in commercial operations, with the objective of requiring such helicopters to be fitted with an independent low fuel contents warning light.
[\(SR 17 of 2006\)](#)

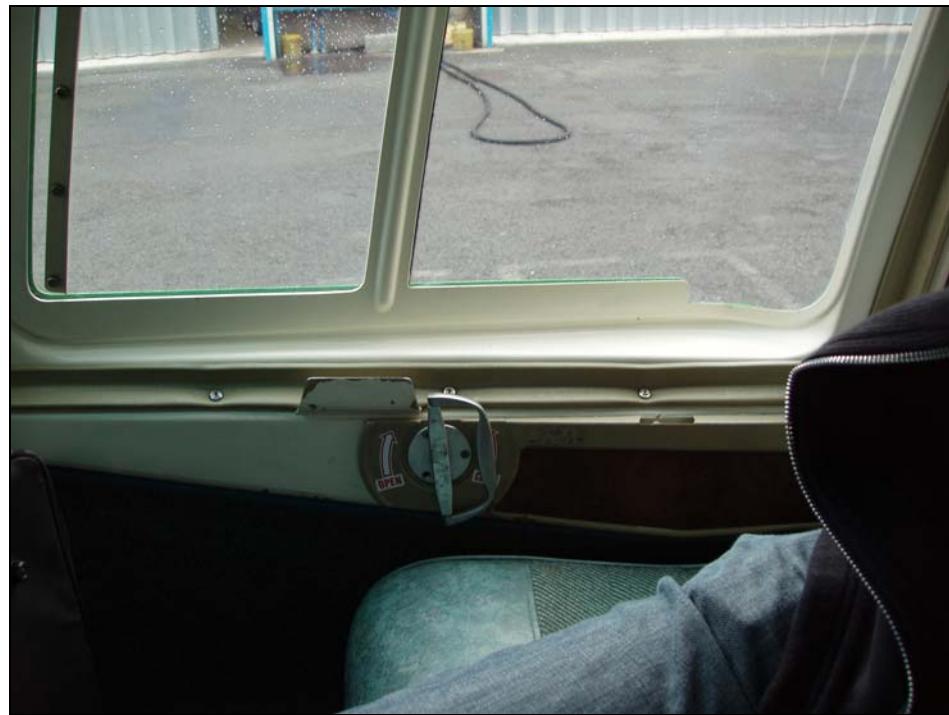
Photo 1

The cabin has a door on either side of the helicopter. These doors are hinged on their leading edges and open outwards. The door locking/opening mechanism consists of a rotating handle as shown in **APPENDIX D, Photo 1**. The handle is rotated clockwise to open the door and anticlockwise to lock it. The handle is located somewhat low and towards the rear on the door. The Investigation noted that a person seated beside either rear door does not have a clear view of the door operating handle, as it is obscured by their own leg, as shown in **APPENDIX D, Photo 2**. Furthermore their view of the operating handle on the opposite door would be obscured by the person sitting next to that door. The door can also be opened and locked from the outside by a corresponding rotating handle on the door’s external surface.

This photo shows an unobstructed view of the operating handle of the RH door on EI-BYJ

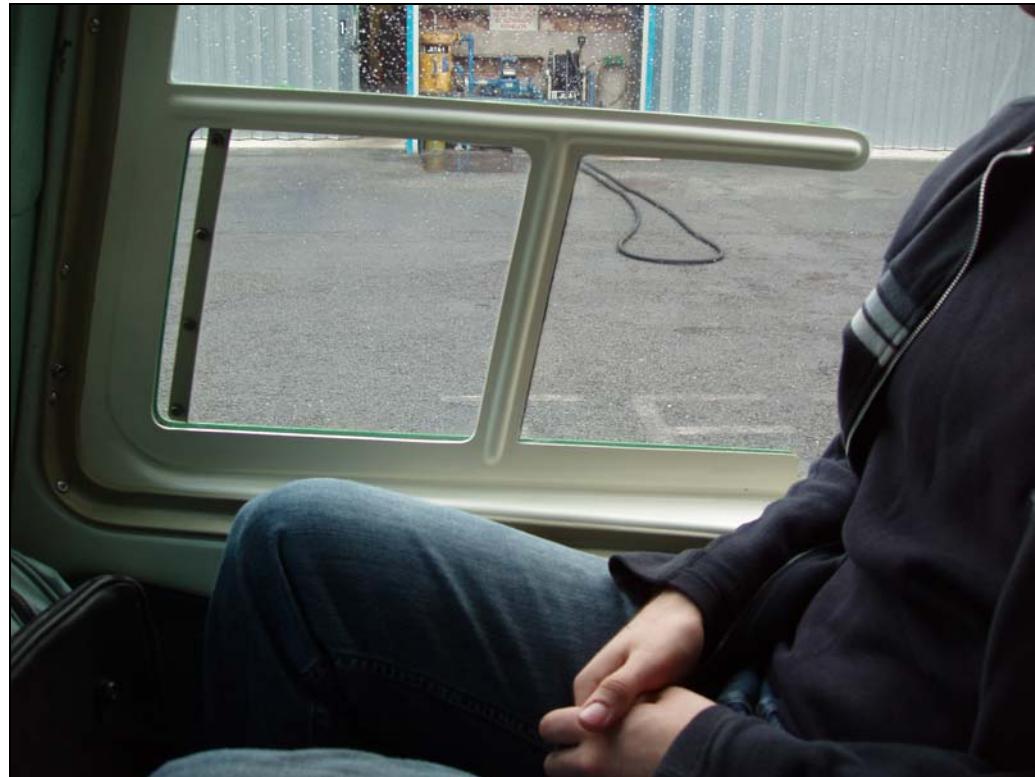
Photo 2

2.17 In the case of this particular accident, the father was seated by the left rear door. Hence his view of the door opening handle was obscured by his left leg and he was unable to locate it. His view of the operating handle on the right door was obscured by the two children. The Investigation noted that there were no instructions in the Safety Leaflet covering the location or operation of the handle, or on opening the door, particularly from inside the helicopter.

This photo shows how the view of the operating handle of the RH door on EI-BYJ is obstructed when a person sits beside the door.

1. The Operator should revise the Safety Card used on its helicopters to cover the opening of all types of seat harnesses fitted to its aircraft and to give instructions on how the doors should be opened from inside the helicopter. The Safety Cards should be always available, in the helicopter, particularly in the rear seat area. Consideration should be given to permanently fixing such Safety Cards to the rear of the bulkhead immediately in front of the rear seats. [\(SR 15 of 2006\)](#)

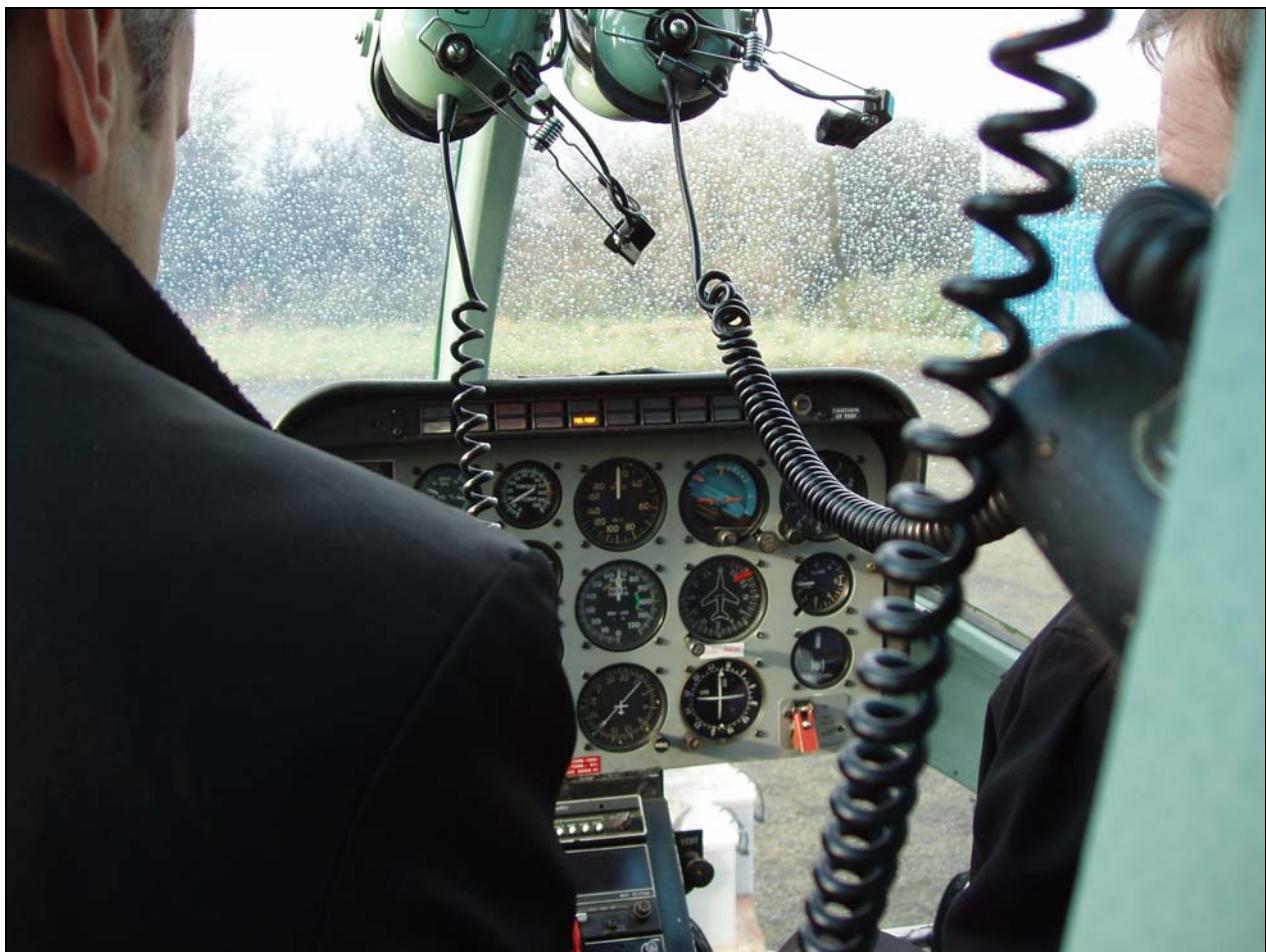
APPENDIX F

This photo shows the instrument panel as viewed from behind the head of a person seated in the front LH seat. This photograph was taken during the test runs noted in paragraph 1.12 of the main report. It represents what would have been seen by the pilot and front LH seat passenger when one booster pump was uncovered but before the second pump uncovered and the engine failed. The visible red light in the Warning Panel (upper centre) is the "FUEL PUMP" warning light. The main lighting of the warning light is red, while the logo "FUEL PUMP" is yellow. Because of the colour balance of the camera, the yellow is more visible in this digital photo, compared to the actual situation. In this test the low main rotor light was also on, as the rotor was running at idling speed. In this photograph, this warning light is hidden by the headphone cable to the right of centre. The fuel gauge is located on the left of the instrument panel. In this photograph it is hidden by the person seated in the LH seat.
