FINAL REPORT

AAIU Formal Report No: 2009-003

Manufacturer: Cessna Aircraft Company

Registration: N208EC

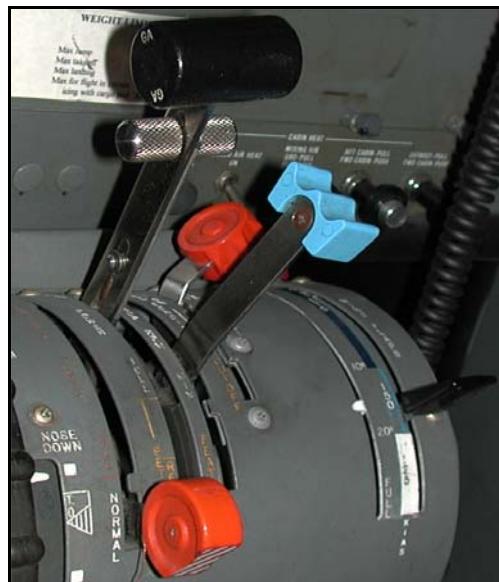
Photo No. 1: Powerplant and flap controls

The Power Lever was found at a high power setting, just short of maximum. The Propeller RPM Lever was found approximately 2.5 cm (1 inch) from maximum. The Fuel Condition Lever was noted in the "low idle" position. Since the controls to the fuel control unit had separated the pre-impact lever positions of these levers could not be determined with the exception of the Emergency Power Lever, which was wire locked in the "Normal" position. The Flap Lever position was approximately 10°.

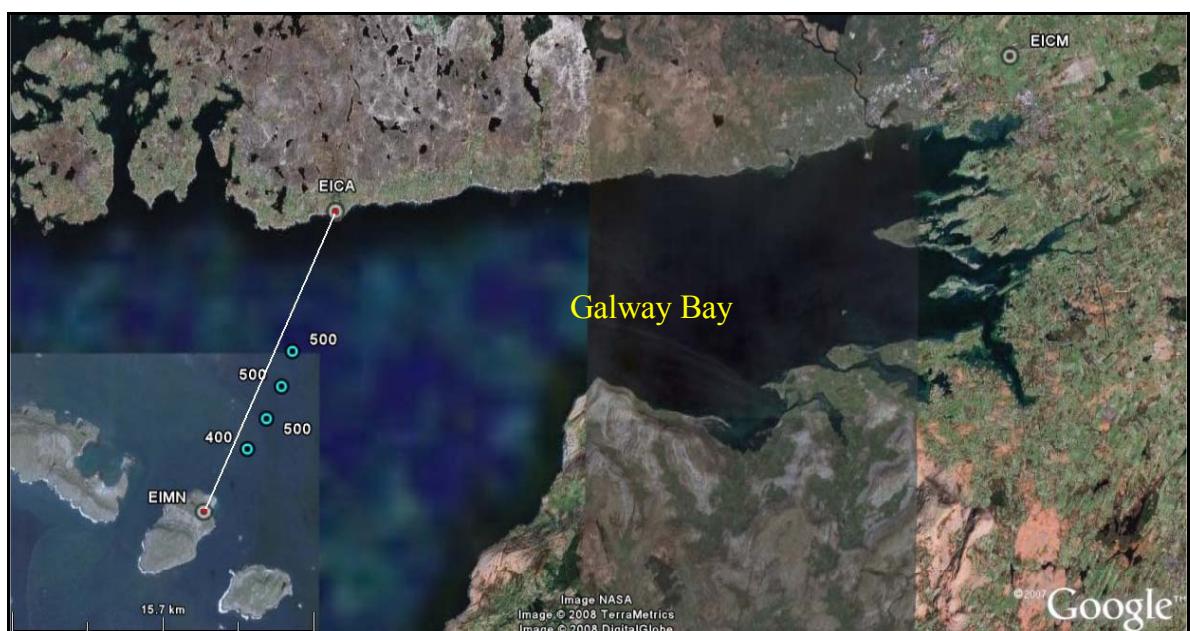
Graphic No. 1: Radar position and height plot of N208EC between 13.45:30 and 13:46:40 hrs.

Similarly, radar observed the aircraft for a limited part of the accident flight, appearing at 13.45:30 hrs but at a lower height of 500 ft. It disappeared off screen at 13.46:40 hrs. The complete ATC radar positions recorded for the accident flight are provided in **Appendix B. Graphic No. 1** was constructed from those readouts.

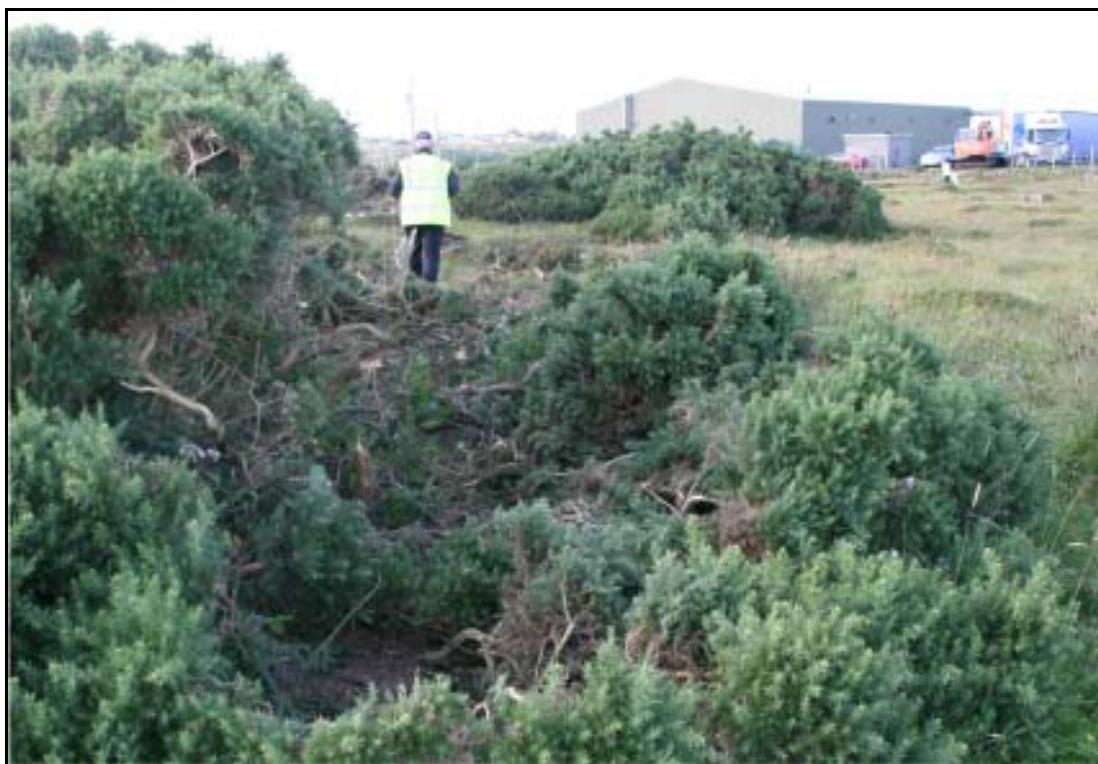
**Photo No. 2: Chopped path through the furze - heading 012°T
(Looking along the line of impact)**

A path some 19 metres in length and 012°T in direction, was chopped through these shrubs. The path widened as the ground rose in a northerly direction. On the left hand side of this path, where the furze ended, was a large boulder (**Photo No. 3**) on whose flat face were three vertical strike marks (see **Section 1.18**).

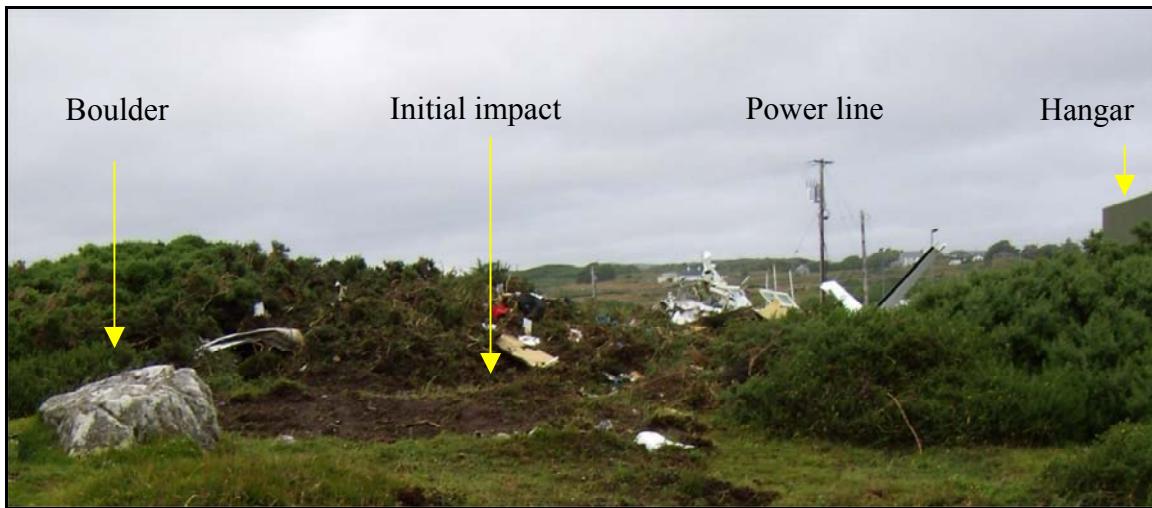
Photo No. 3: Showing boulder, initial impact position, wreckage and power line transformer.

The initial ground impact point was located 3 metres beyond this boulder and there the debris trail commenced. The ground at the initial impact point was soil-covered rock with bare rock to the left in the furze. The impact position was just under the right hand brow of the mound. The main wreckage was located 34 metres beyond this point with the fuselage pointing in the opposite direction to the debris trail. The final impact was in a shallow wet depression, partially filled with water.

The fuel tanks in both wings had ruptured and no fuel remained. However, there was physical evidence of a substantial fuel deposit at the impact site.

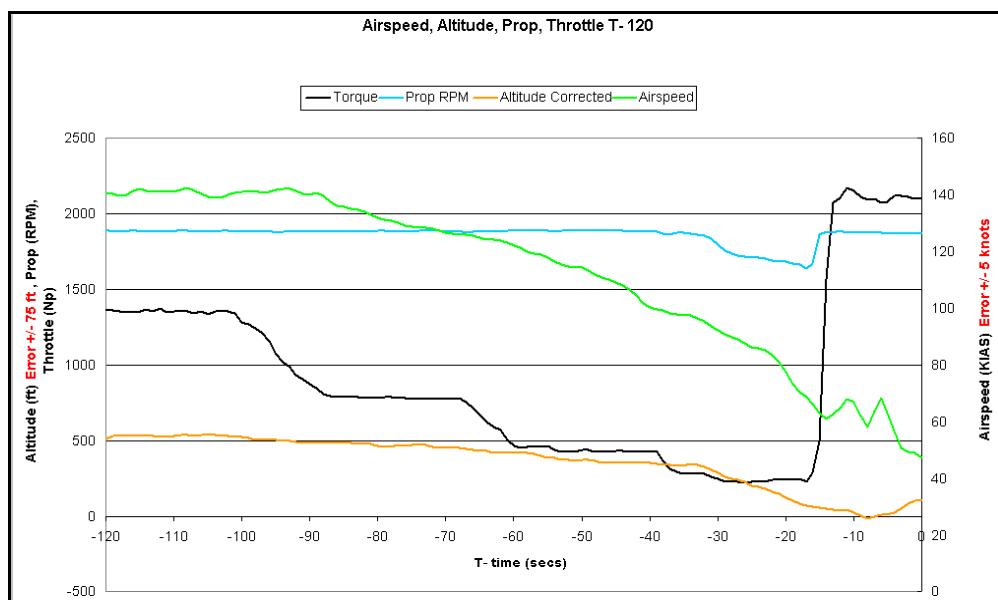
Graphic No. 3: Smoothed final 120 Seconds of ADAS recording

This low speed is corroborated by a final ADAS recording of 46 kts (accuracy ± 5 kts). The AMS on board the aircraft also commented that the aircraft was at an abnormally high nose up pitch attitude.

ADAS data confirmed that airspeed decay had by then become excessive and that the overshoot was commenced at an abnormally low airspeed. The consequent torque reaction to the application of maximum power and RPM, about the same time, probably resulted in the aircraft inadvertently turning left towards rising ground and the terminal buildings. Due to rising terrain, the heavy weight of the aircraft and increased apparent weight²¹ in the turn, the resulting drag and lack of altitude did not allow the aircraft to accelerate. This resulted in a semi-stalled condition with the stall warning sounding before impact, as the passengers reported. As the aircraft's speed was on the back of the drag curve and with no altitude available to descend and accelerate, ground impact became inevitable.

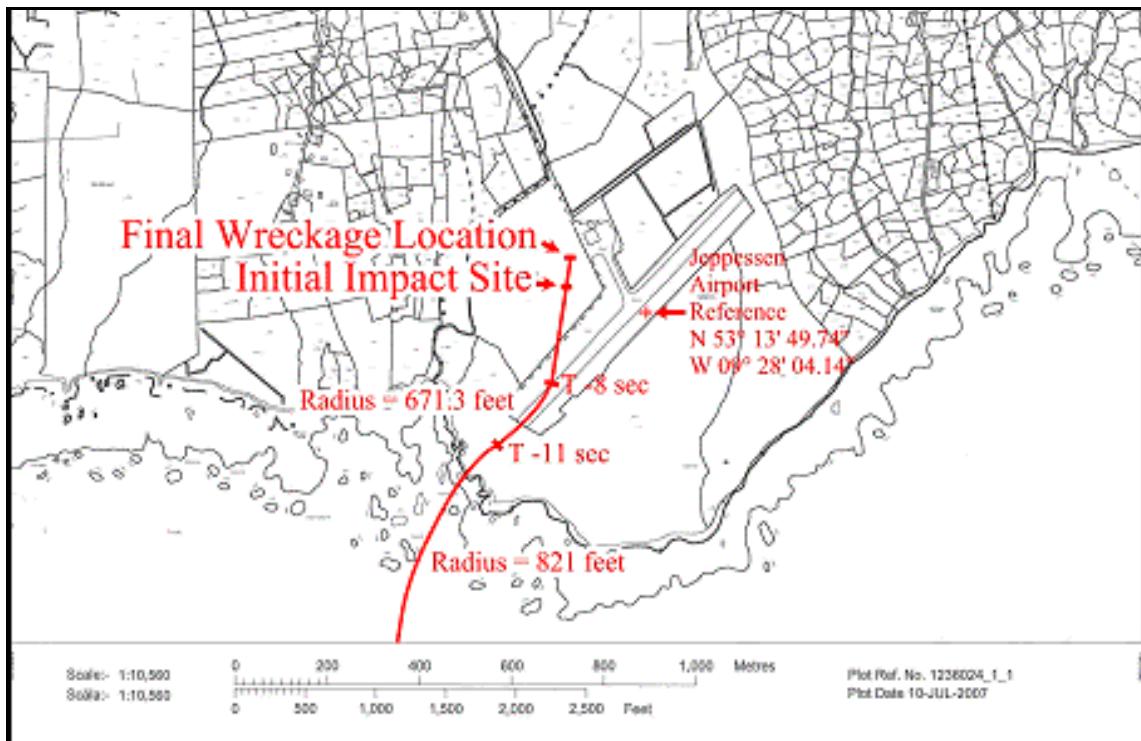
Graphic No. 4: Calculated plot of the final track of N28EC

The ADAS data was corrected for wind velocity and groundspeeds and drift angles were derived. Using ATC radar records during cruise, the observations of ground witnesses and the passengers, the probable final track of the aircraft was calculated yielding turn radii, bank angles, distances and G loading. This is shown in **Graphic No. 4**. The maximum bank angle was estimated at 35° with a g loading of 1.57g.

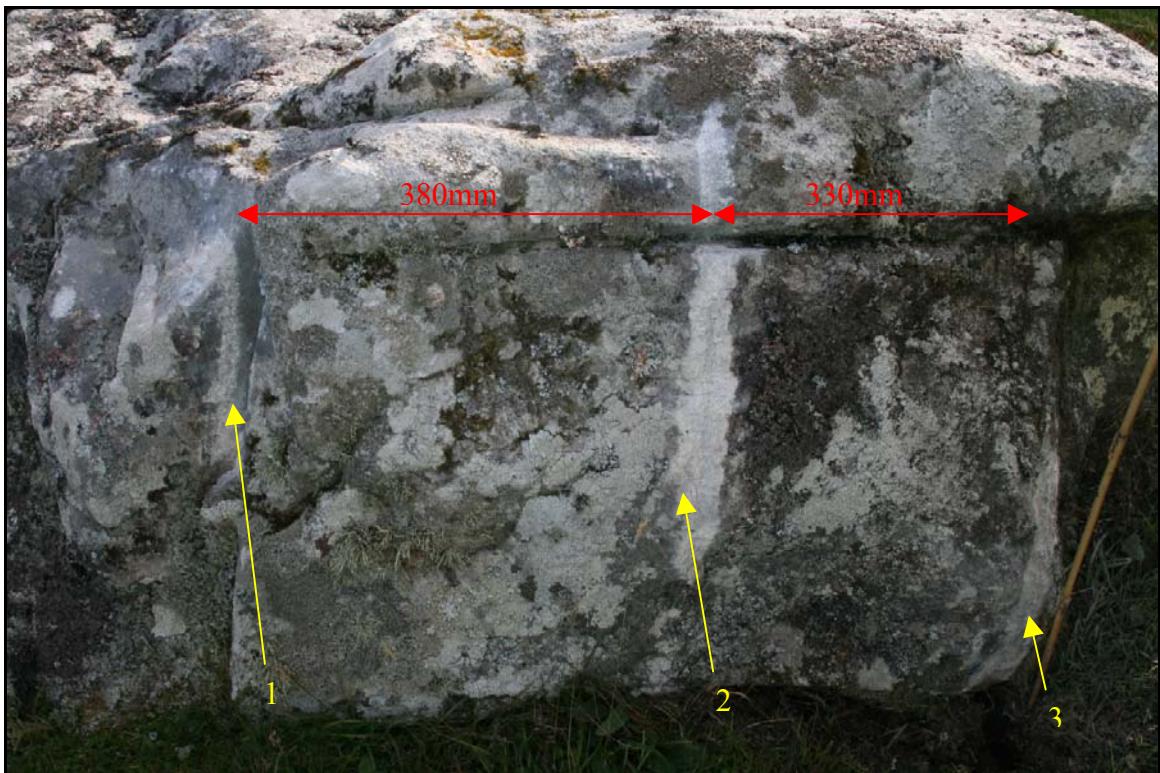
Photo No. 4: Rock with propeller strike marks

A large boulder or rock was situated on the outcrop slightly to the left of the flight path, approximately four metres before the initial impact. Three score marks were visible on the rock face as shown in **Photo No. 4**. The rock surface was an irregular plane whose alignment was not parallel to the direction of flight, but angled towards it. These score marks were regularly but not evenly spaced along the surface. The score marks shapes indicated that the propeller blades were not feathered. A small piece of propeller blade tip was found buried underneath the rock directly below the third score mark. The Investigation determined that the marks were caused by the rotating propeller striking the rock immediately before impact.

The Cessna Caravan has a three-bladed, constant speed, McCauley propeller. In one complete 360° revolution of the propeller would produce four strike marks (three spaces), as the first blade rotates to strike a second time on completion of the revolution. Therefore the three score marks (two spaces) indicate two thirds of a revolution of the propeller. Propeller RPM was 1,868 before impact, as recorded by the ADAS data (see **Section 1.18.2**). This RPM was then used in calculating the ground speed of the aircraft immediately prior to impact.

The Propeller strike marks on the boulder were analysed. If deceleration caused the variation in strike distance the force required would need to be of the order of $-5g$. There are, however, no witness marks at the location that would cause such a deceleration.
