FINAL REPORT

AAIU Synoptic Report No: 2010-012

Aircraft Type and Registration:	Gulfstream IV (GIV) SP, VT-MST	
No. and Type of Engines:	2 x Rolls Royce Tay 611-8	
Aircraft Serial Number:	1379	
Year of Manufacture:	1999	
Date and Time (UTC¹):	13 July 2009 @ 08.13 hrs	
Location:	Near Killarney, Co. Kerry, Ireland	
Type of Flight:	Private	
Persons on Board:	Crew - 2	Passengers - 1
Injuries:	Crew - Nil	Passengers - Nil
Nature of Damage:	Substantial damage to No. 1 engine Windshield fractured	
Commander's Licence:	Airline Transport Pilot Licence issued by the U.S. Federal Aviation Administration (FAA)	
Commander's Details:	Male, aged 45 years	
Commander's Flying Experience:	12,500 hours, of which 1,027 were on type	
Notification Source:	Shannon Air Traffic Services (ATS) and Kerry Airport ATS	
Information Source:	AAIU Field Investigation

SYNOPSIS

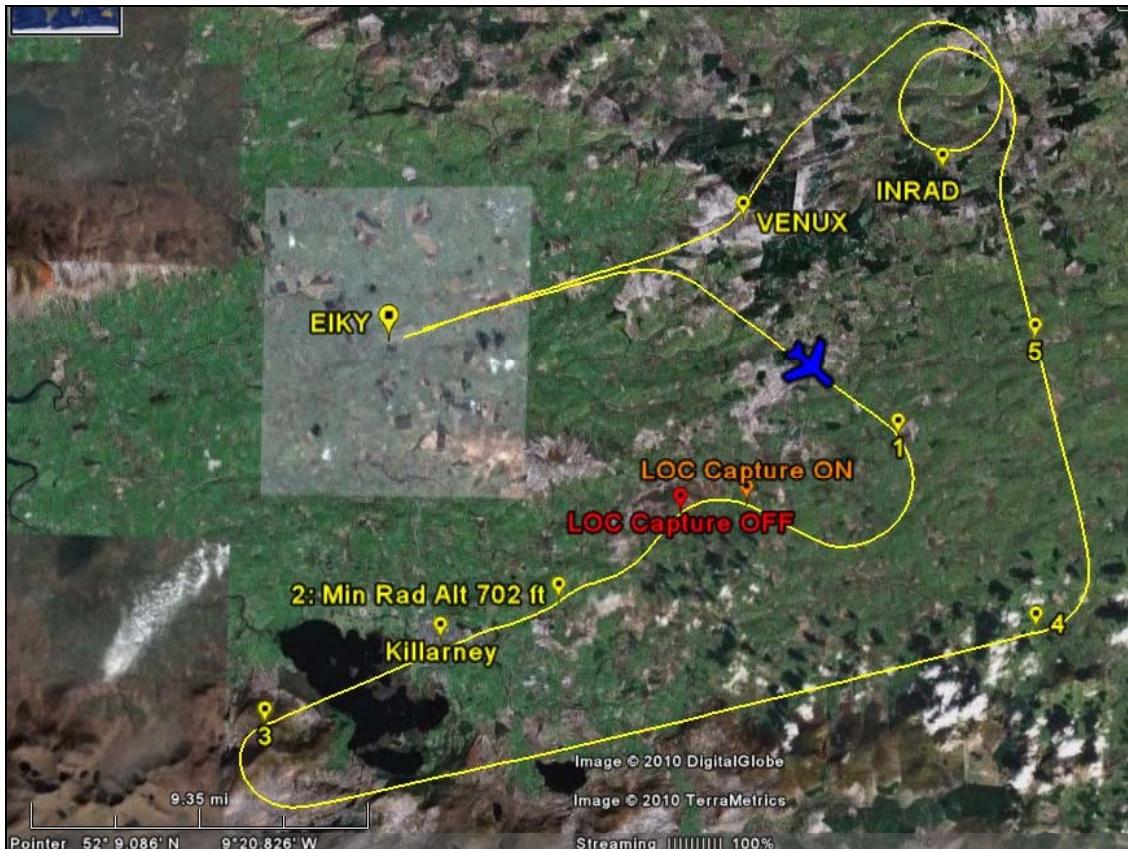
Figure No. 1: Flight Path of VT-MST

The aircraft, which had initially been following the CRK 1C departure procedure, levelled off at 3,000 ft and then commenced a 180° turn to the right at 08.09:20 hrs, (Point 1 on **Figure No. 1**). It rolled out onto an inbound heading towards EIKY.

Subsequently, at 08.15:45 hrs, (Point 3 on **Figure No. 1**) Shannon ATC vectored the aircraft initially on a heading of 090°M and at 08.21:34 hrs, (Point 4 on **Figure No. 1**) onto a heading of 350°M towards the localiser for RWY 26 at EIKY. At 08.23:42 hrs, (Point 5 on **Figure No. 1**), VT-MST confirmed that the aircraft was 4.7 nm from reporting point VENUX⁸. Shannon cleared VT-MST to turn left and route direct to VENUX to establish on the localiser RWY 26 at EIKY and, when ready, to descend to 3,300 ft. VT-MST acknowledged this instruction and stated that they would report when established on the localiser.
