AAIU Report No.2002-014
AAIU File No.: 2001/0043
Published:15/11/2002

Operator:	Aerial Advertising Ltd
Design	YAKOLAV, Russia
Manufacturer:	AEROSTAR, Romania
Model:	YAK 52 (Romanian IAK 52)
Nationality	Lithuania
Registration	LY-AHF
Location	Weston Airfield
Date/Time (UTC)	24 July '01, 15.15 hours

SYNOPSIS.

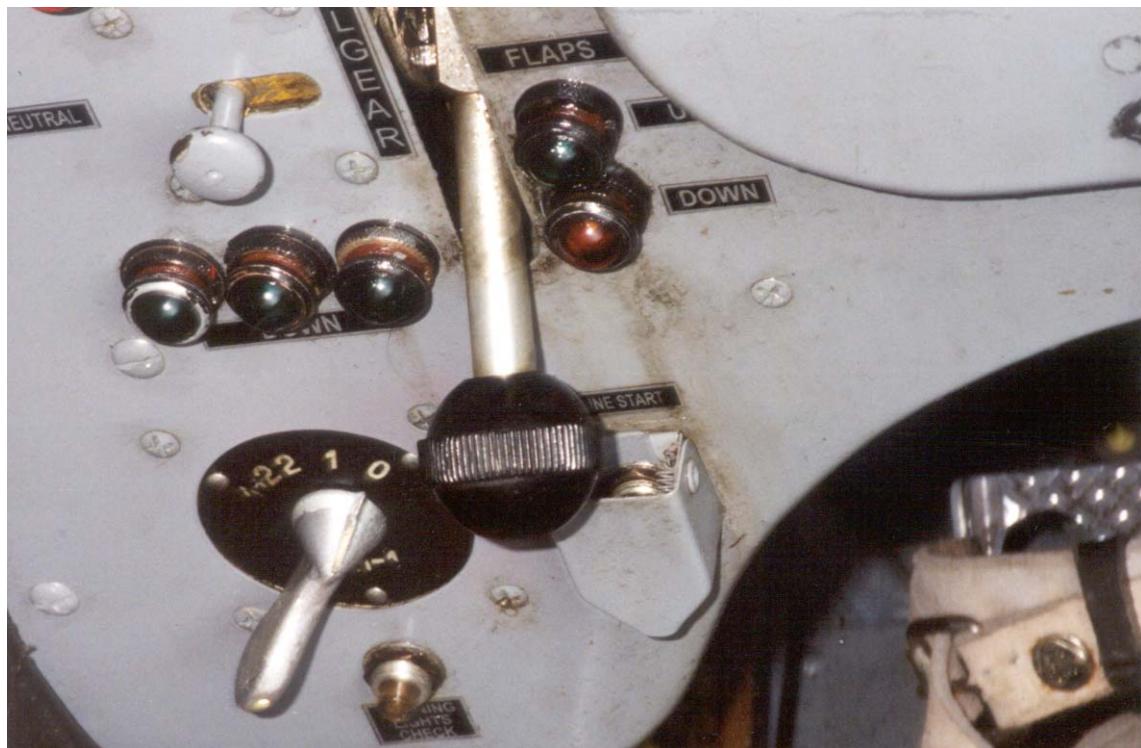
APPENDIX A

The investigators are also of the opinion that the two flap indicator lights adjacent to the undercarriage lever should be transferred to a more left position on the instrument panel and more in line with the flap lever, in order to avoid the possibility of the flaps “down” indication being confused with undercarriage “down” indication. It is considered that its present position may confuse the pilot during “finals checks”.

Photo of front instrument panel showing three green ("undercarriage down") lights to the left of the undercarriage lever with the flaps indicator lights to the right and adjacent to the undercarriage lever.

- 4.1** The manufacturers of this aircraft should review the position of the flap indicator lights in order to remove them from the vicinity of the undercarriage lever. [\(SR 29 of 2002\)](#)
- 4.2** The manufacturers of this aircraft should consider the installation of a “Wheels-Up” warning device on the Yak 52 aircraft. [\(SR 30 of 2002\)](#)
- 4.3** As the aircraft does not meet the requirements of ICAO Annex 8, the Lithuanian authorities should issue a CofA in the Experimental or Restricted Category. [\(SR 31 of 2002\)](#)
- 4.4** The Lithuanian CAA should advocate the training of pilots through a short introductory flying course on this aircraft. [\(SR 32 of 2002\)](#)
