FINAL REPORT

AAIU Report No:- 1999/008
AAIU File No:- 19980042

Aircraft Type and Registration: Sikorsky S61N, EI-MES

Location: Dublin Port

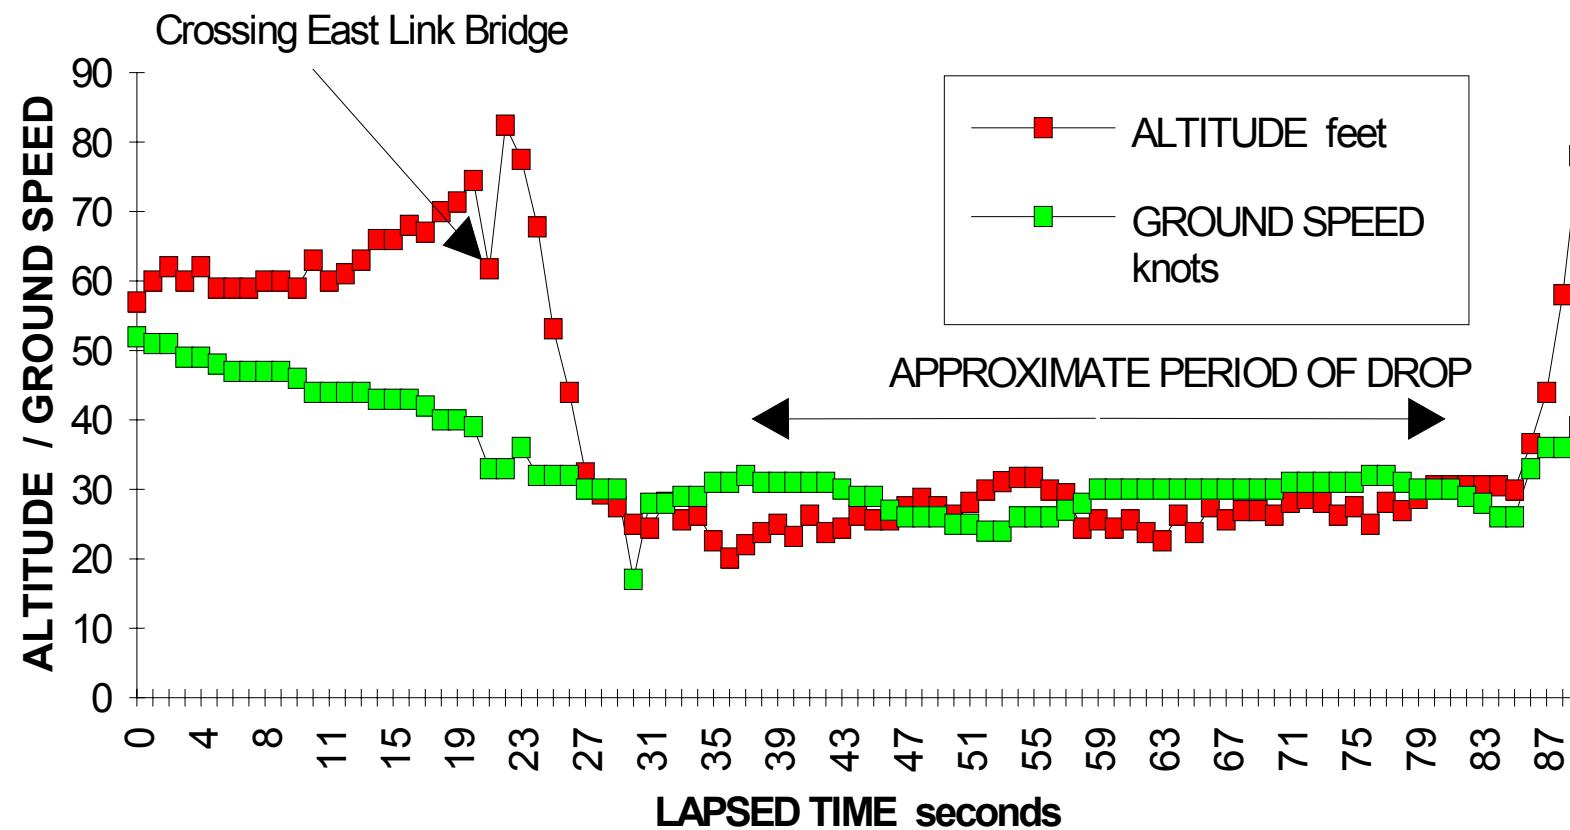
ANNEX A

Data obtained from the aircraft's flight recorder show that the swimmers jumped from the aircraft when it was travelling at a forward speed varying between 26 and 31 kts, at a height varying between 22 and 31 feet. This data is shown in Annex A. The FDR evidence is supported by photographs and video taken by members of the Garda

The injuries to the Diving Section members were consistent with high forward speed entry into the water, in that the injuries and bruising were concentrated on the left side of their bodies, which in turn is consistent with exiting the aircraft on the right hand side facing directly out of the doorway.
