Air Accident Investigation Unit Ireland

**INCIDENT REPORT
EADS Socata TBM 700N, M-SHEP
Dublin Airport (EIDW), Co. Dublin, Ireland
03 February 2011**

AAIU Report No: 2012-001

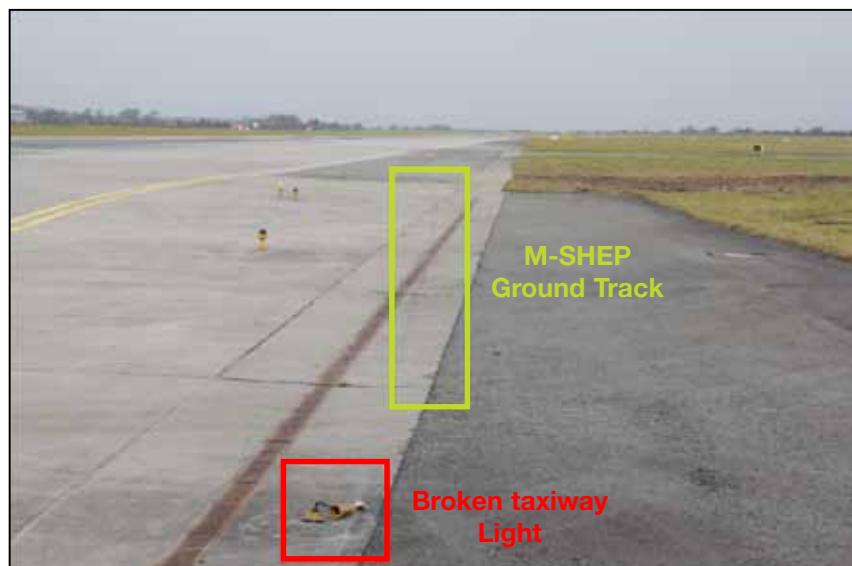
The aircraft landed back on the right hand edge of RWY 28 in the area where TWY E3 meets RWY 28. The propeller struck a blue TWY E3 light, destroying it. The Pilot then regained directional control and steered the aircraft through the area between the pavement edge and the taxiway/runway edge lighting and then back onto the central area of the runway, (**Photo No. 1**). Subsequently, the aircraft taxied slowly off RWY 28 via TWY E5 and the B taxiways to the light aircraft park.

Photo No. 1: Aircraft track between edge lighting and runway edge

It seems likely that a severe gust, as recorded on the anemometer trace, caught M-SHEP just after its initial touch-down and the aircraft became airborne again. The aircraft travelled diagonally above the runway surface before touching down again on the right hand side of the pavement within a few meters of the grass verge. While the Pilot at that stage regained directional control, he was unable to prevent the propeller from striking a taxiway light. Thereafter, he was able to steer the aircraft away from the runway edge while avoiding the other taxiway and runway edge lights in his vicinity.

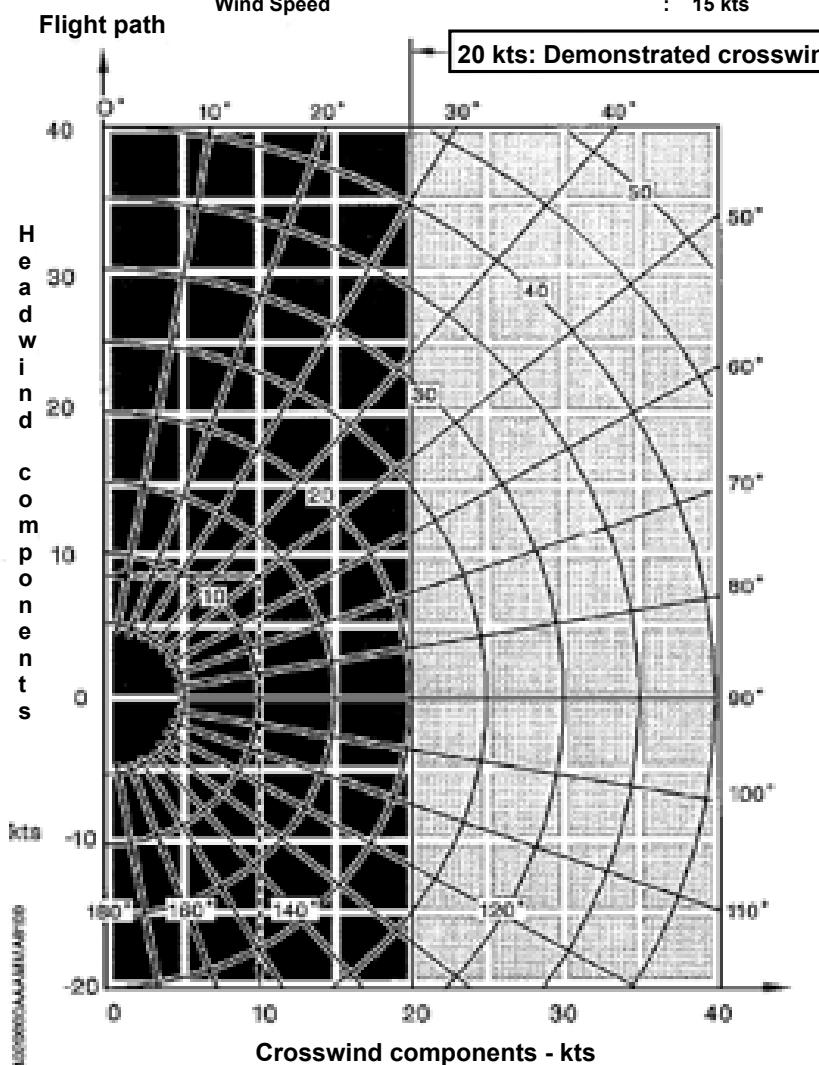
Figure 5.7.1 - WIND COMPONENTS

Figure 5.7.1 of the POH illustrates that a wind gust of 30 kts from a direction of 210°, i.e. an angle of 70° between the wind direction and the orientation of RWY 28, has a headwind component of 10 kts and a crosswind component of 28 kts.

The Pilot was attempting a landing in what were very challenging gusty crosswind conditions. Gusts of 30 kts and higher from directions between 200° and 220° contained crosswind components in excess of the demonstrated crosswind performance of 20 kts set out in the POH. Although the Pilot was reasonably experienced on type, the Incident serves to demonstrate that attempting to land in conditions that exceed manufacturer's guidance is unwise.
