FINAL REPORT

AAIU Report No.2002/004

Name of Owner:	McAuliffe Trucking Ltd
Name of Operator:	Eirecopter Helicopters
Aircraft Type and Registration:	R22 Beta, EI-MAC
No. and Type of Engines:	One Avco Lycoming 0-320-B2C
Aircraft Serial Number:	1433
Year of Manufacture:	1990
Date and Time, Coordinated Universal Time (UTC):	27 August 1999, 10:11 hours
Location:	Cornakelly, Ballinamuck, Co. Longford
Type of Flight:	Private
Persons on Board:	Crew-one Passenger - one
Injuries:	Crew- Fatal Passenger - Fatal
Nature of Damage:	Aircraft Destroyed
Commander's Licence:	Private Pilot's Licence (Rotorcraft)
Commander's Age:	42 Years
Commander's Flying Experience:	Total Fixed Wing - 271 hours Total Helicopter (R22) - 50 hours
Information Source	Air Traffic Control (ATC) Watch Manager, Dublin Airport. Air Accident Investigation Unit (AAIU) Field Investigation.

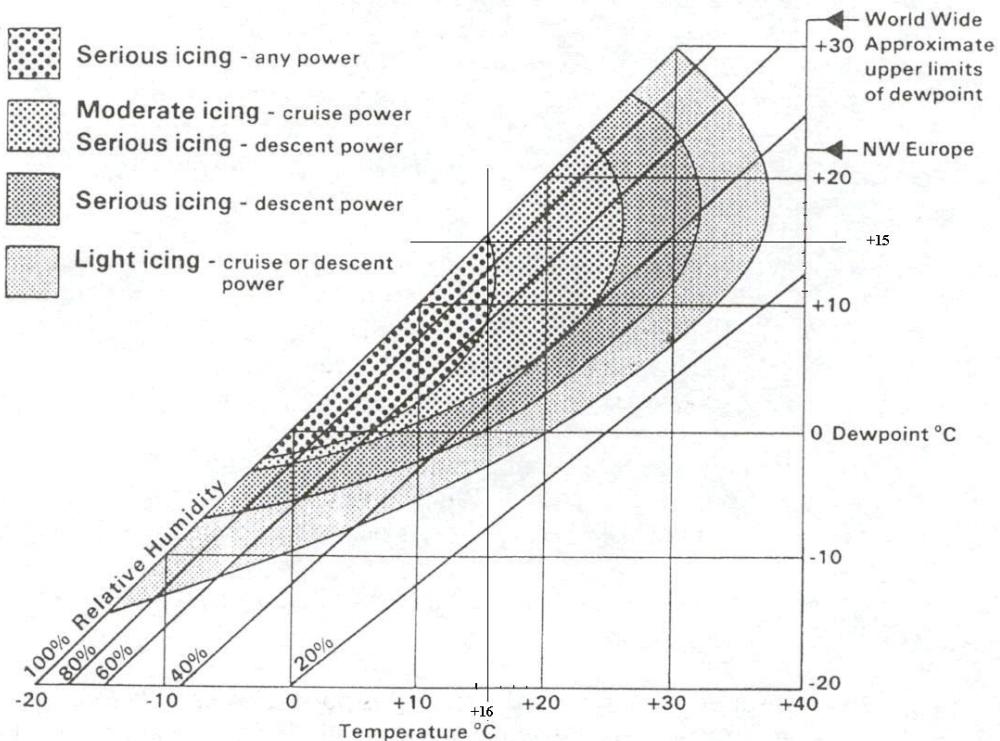
CARBURETTOR ICING IN AIR FREE OF CLOUD, FOG, OR PRECIPITATION

The graph shown above is reproduced from the Irish Aviation Authority (IAA) Aeronautical Information Circular (AIC) NR 11/97, titled "Induction system icing on piston engines as fitted to aeroplanes, helicopters and airships"

A Temp/Dew point of 16°/15°C (forecast for the area) corresponds to conditions where serious icing could occur at any power setting but particularly at a low power setting such as during descent. Cruise power could also produce moderate carburettor icing.
