# FINAL REPORT

**AAIU Synoptic Report No: 2004-008**

| <b>Aircraft Type and Registration:</b> | Rallye 100 ST, EI-BFP | |
| <b>Location:</b> | Clonlara, Co Clare | |

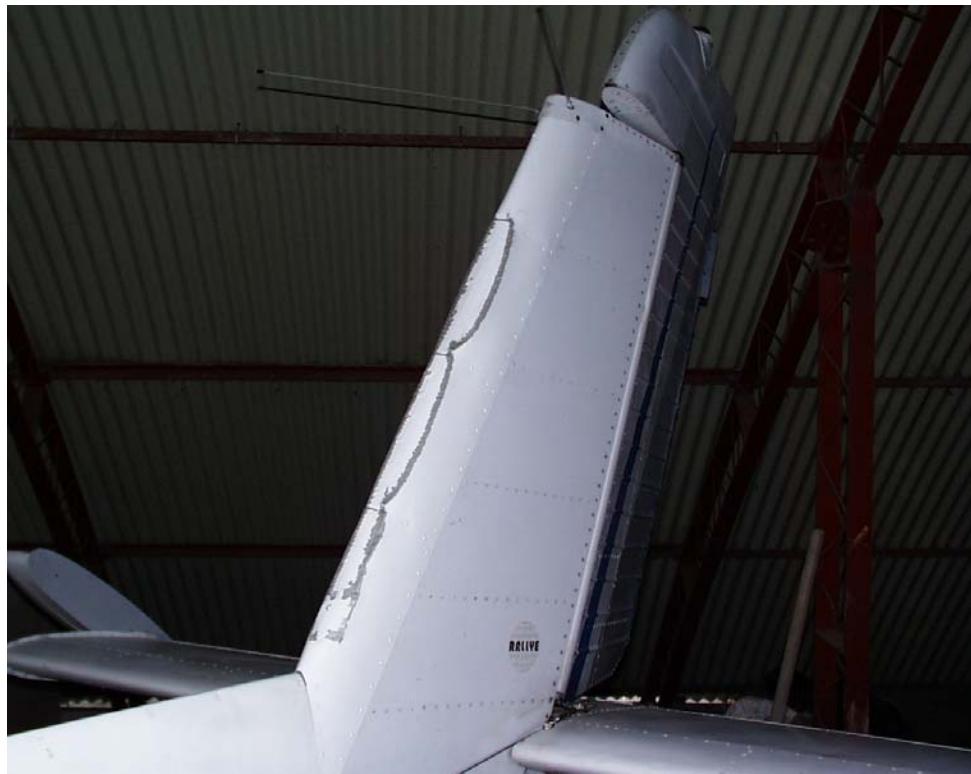
With the aircraft appearing to handle normally, the Pilot elected to return to EICN, where it landed without further incident at 15.30 hrs. An examination of the aircraft (**Appendix B**) determined that the leading edge cowling of the vertical tail fin suffered impact damage from wire cables, as did the port mass balance horn of the elevator, as a result of the cables running across its surface. In addition, the VHF antenna, which is located on top of the fuselage just forward of the vertical tail fin, was severed at its root. The Pilot reported the event to the AAIU Inspector-on-call at 15.45 hrs on the same day and also contacted the ESB advising them that he had struck cables in the Clonlara area. In a frank Incident Report Form submitted to the AAIU, the Pilot attributed the cable strike to:

**Photo No 1. Cable impact damage to leading edge cowling of vertical tail fin**

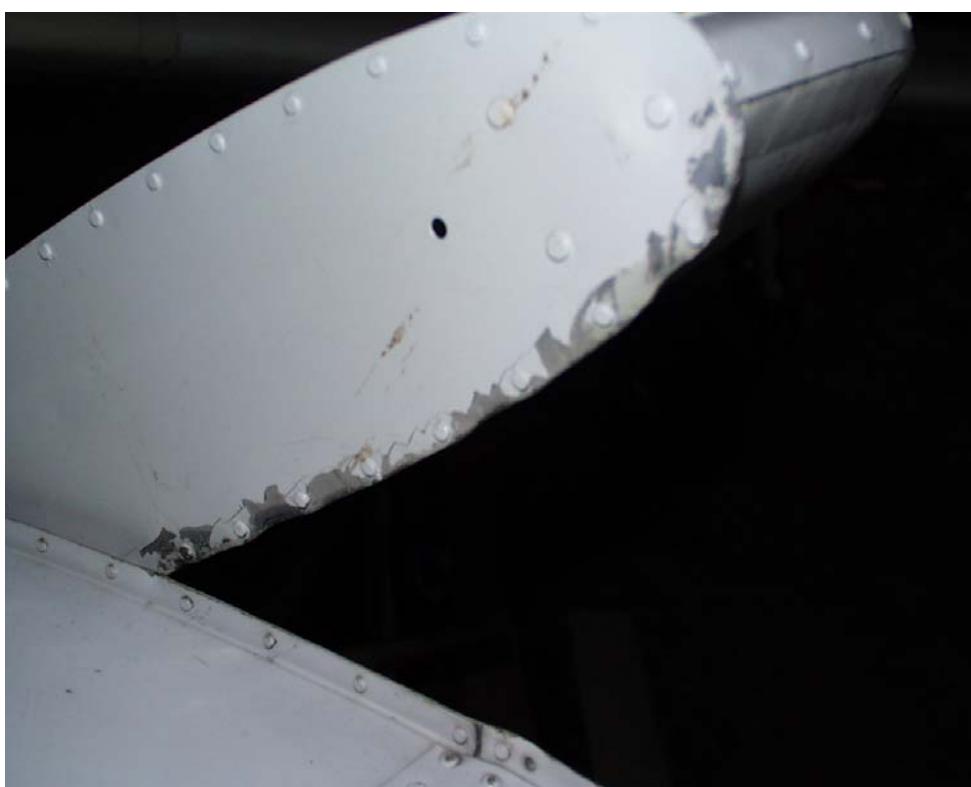
**Photo No 2. Damage resulting from cables running across the lower surface edge of the port mass balance horn of the elevator**
