FINAL REPORT

AAIU Synoptic Report No: 2009-018

Aircraft Type and Registration:	Agusta Westland A109E, EI-SBM
No. and Type of Engines:	2 x Pratt and Whitney PW 206 C
Aircraft Serial Number:	11174
Year of Manufacture:	2004
Date and Time (UTC):	20 March 2008 @ approximately 15.40 hrs
Location:	Lagore, Dunshaughlin, Co. Meath
Type of Flight:	Private Category
Persons on Board:	Pilot - 1
Injuries:	Pilot - Serious
Nature of Damage:	Substantially damaged
Commander's Licence:	Commercial Pilot Licence (H)
Commander's Details:	Male, aged 41 years
Commander's Flying Experience:	2,421 hours, of which 1,500 were on type
Notification:	ATC Station Manager, Dublin Airport
Information Source:	AAIU Field Investigation AAIU Accident Report Form submitted by Pilot

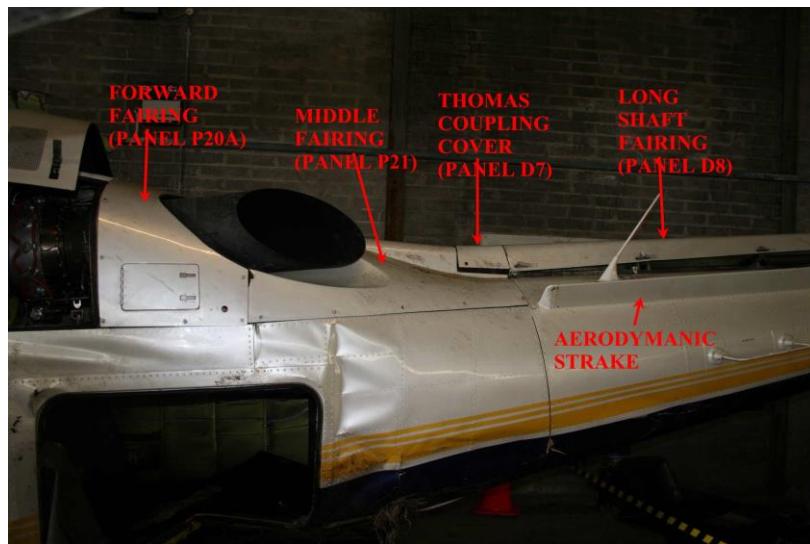
Photo No. 1

This shows the location of the various fairings and the Aerodynamic Strake. This photo was taken after the helicopter was recovered to the AAIU facility and the distortion of the helicopter prevented the Thomas Coupling Cover and the Long Shaft Cover from closing completely.

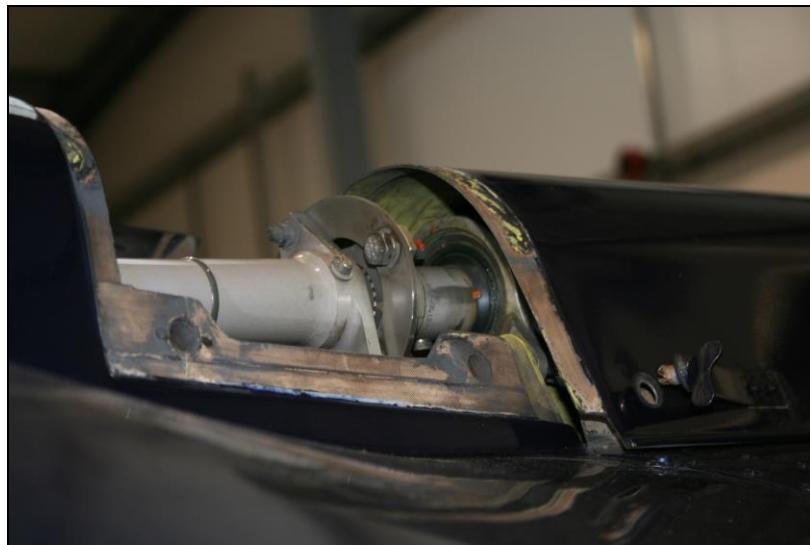
Photo No. 2

This photograph (taken on another A109) shows the Thomas Coupling at the forward end of the Long Tail Rotor drive-shaft when the small Inspection Panel of the Middle Section fairing is in the open position. The rear end of the Middle Tail Rotor drive-shaft assembly is seen to the left of the opening. On the right, the front end of the Long Tail Rotor drive-shaft, and the No. 1 Hanger Assembly of the Long are also visible. The nuts, bolts and protruding bolt threads on the Coupling can be seen. No trace of material was found on these fittings. Elements of material were found on the bolts that secure the No.1 Hanger Assembly to the top of the tail boom.

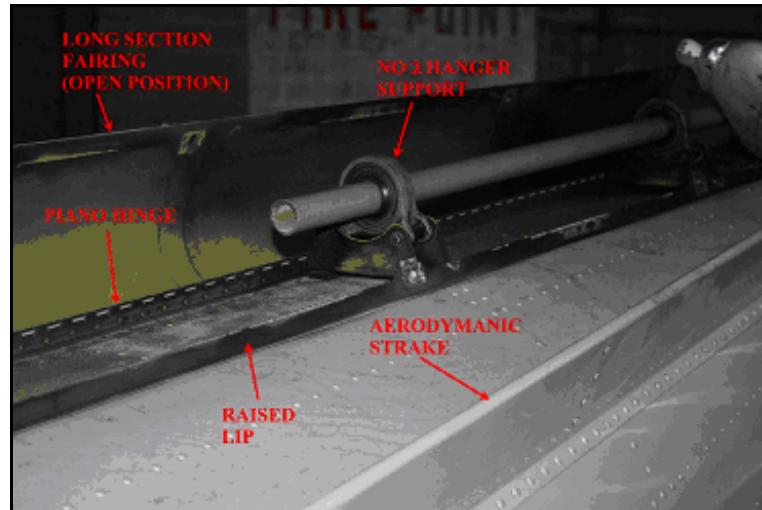
Photo No. 3

This shows the top of the tail-boom in the area of No. 2 Hanger Support showing the Long Section Fairing in the open position. The raised Lip and the Aerodynamic Strake can also be seen. It may be noted that in this picture the Long Shaft has been cut just forward of the No. 2 Hanger Support as part of the ongoing investigation.

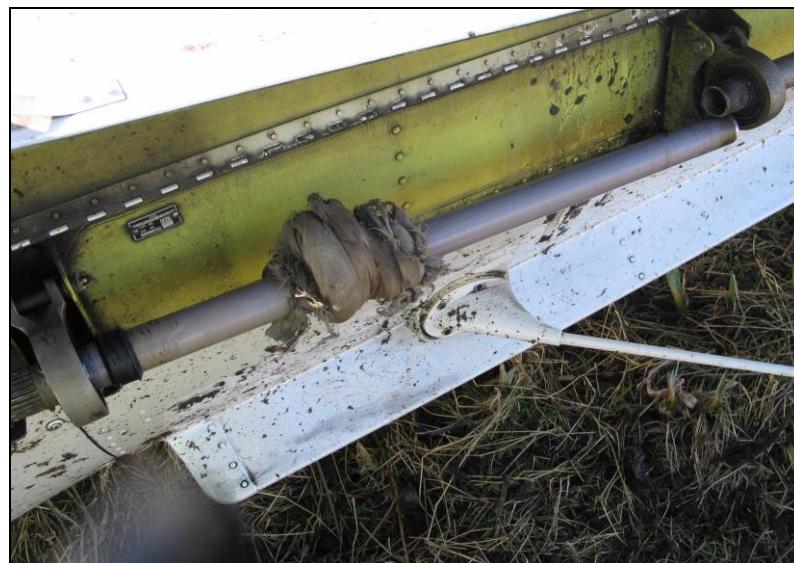
Photo No. 4

The cloth was very tightly wrapped around the long tail rotor drive-shaft. It was compressed and measured 10 cms along the shaft. In addition, it was sodden with moisture when found. The cloth was subsequently unwound from the shaft, and was found to measure approximately 56 cms by 42 cms, and frayed at the edges. It weighed 72 grams when dry, and up to 225 grams when wetted as part of the ongoing Investigation. The cloth is shown in **Appendix C, (Photo No. 5)** after it was removed from the shaft.

The Investigation has no doubt that the presence of the cloth, however and whenever it was introduced into the tail rotor drive shaft system, was the cause of the long tail rotor drive-shaft failure.

The accident was caused by fatigue and failure of the long tail rotor drive-shaft, which was induced by a cleaning cloth becoming wrapped around the shaft.

Photograph taken at the accident site, showing the cloth, as found, wrapped around forward end of the Long Tail Rotor drive-shaft, and point of fracture of the Long Section. The splines leading into the forward Thomas Coupling can be seen on the left, just to the left of the No. 1 Hanger Assembly. To the right, the No. 2 Hanger Assembly can be seen.

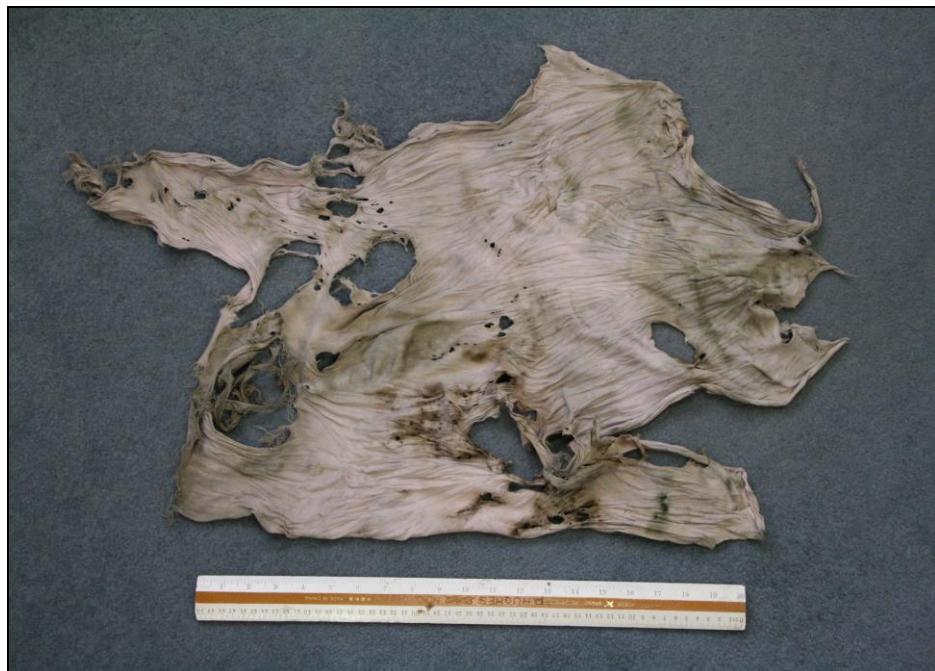
Photo No. 5

Photograph showing the cloth after it was removed from the Long Tail Rotor drive-shaft and unravelled by the Investigation. The ruler is 50 cm long.

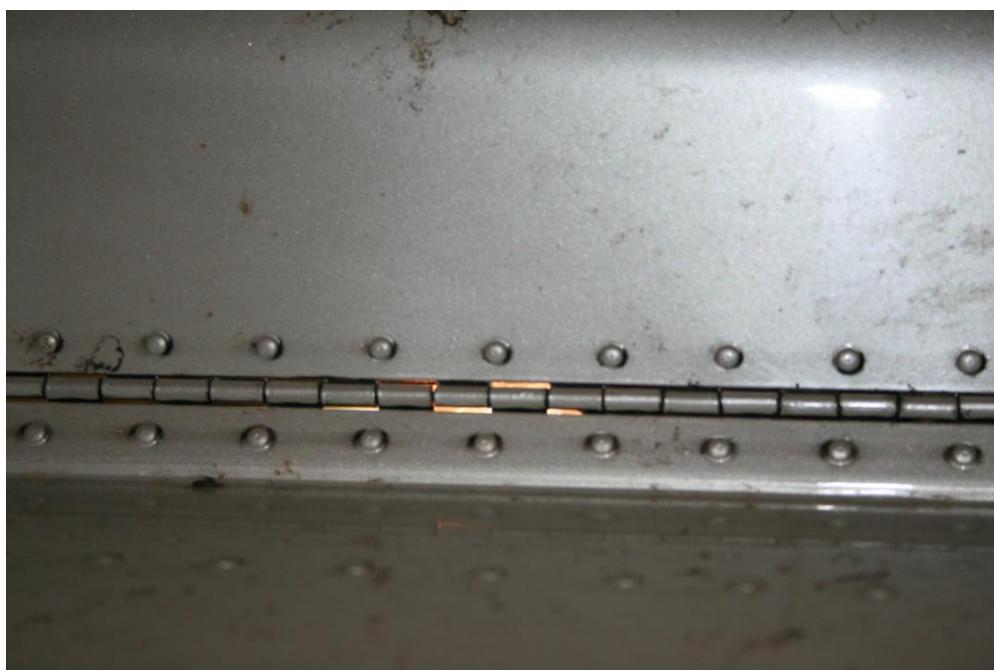
Photo No. 6

This photograph shows the Piano Hinge of the Long Section Fairing. The light of a torch is seen through the gaps along the hinge line.

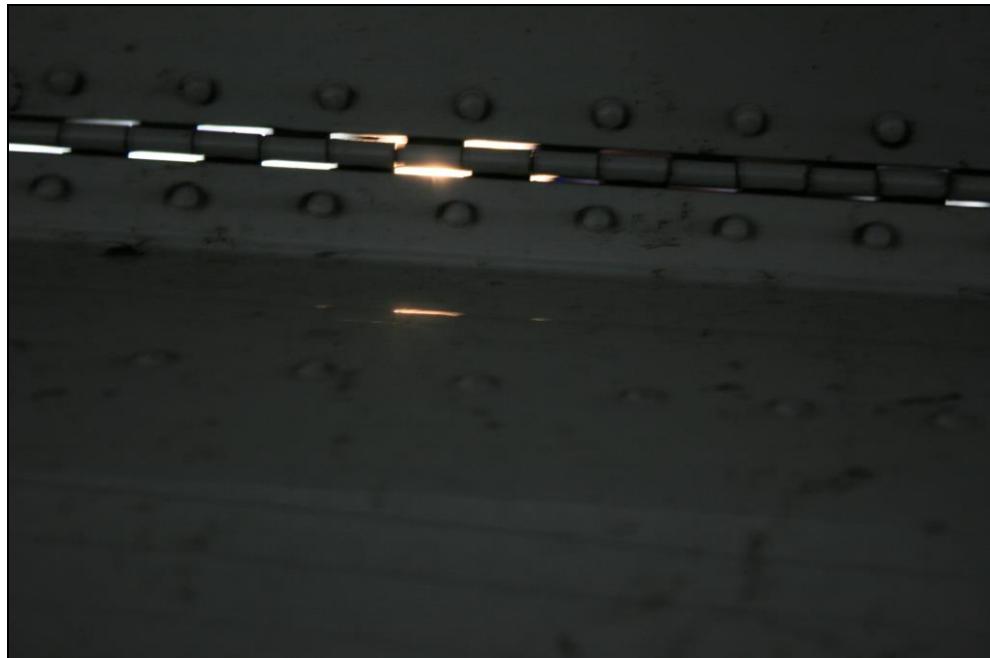
Photo No. 7

This shows a similar view to the previous photograph, but with an altered camera setting so that the gaps can be seen more clearly.

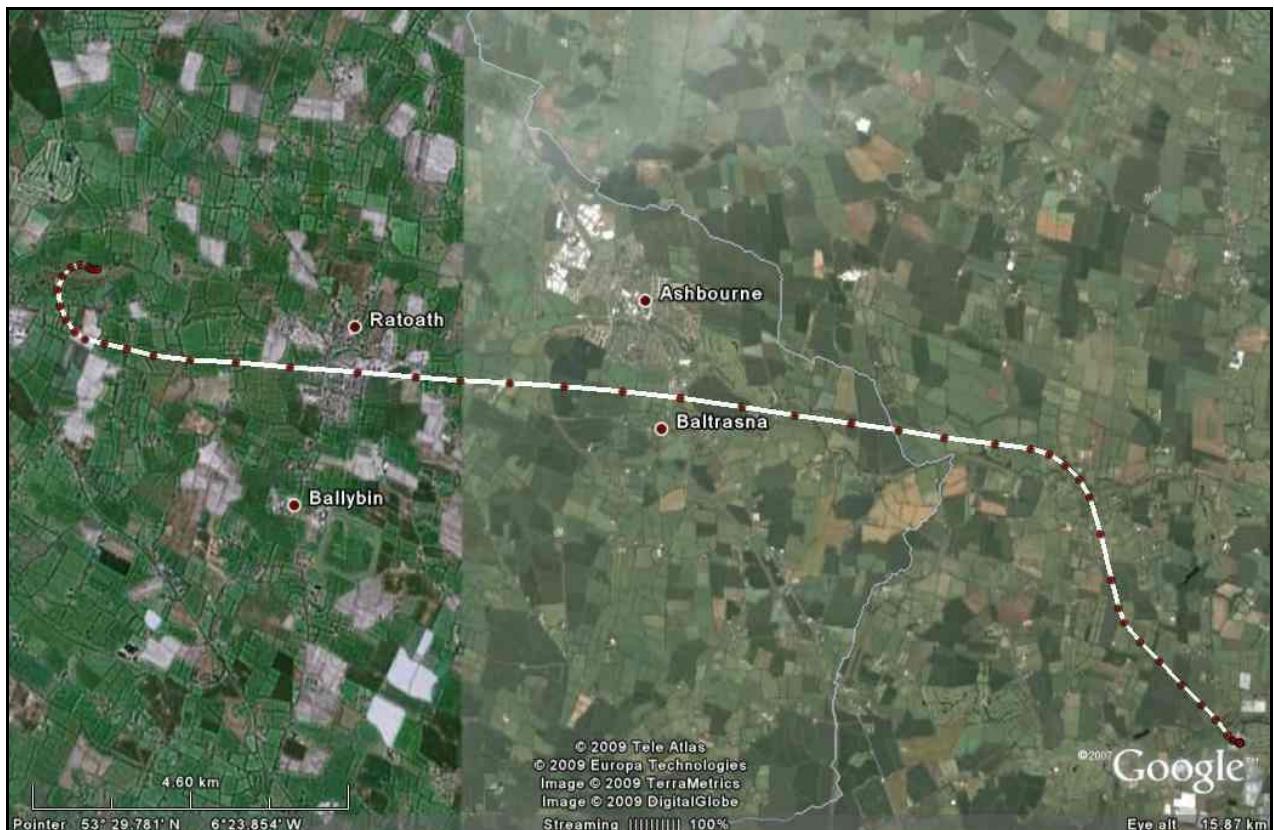
Figure D1

This shows the final flight of EI-SBM from Knocksedan to Dunshaughlin taken from the on-board GPS. The red dots are the recorded track points. The final turn to the right can be seen on the left of the figure. The right side of the figure is in a Google high-resolution area while the left side is low resolution. This is the reason for the tone difference.

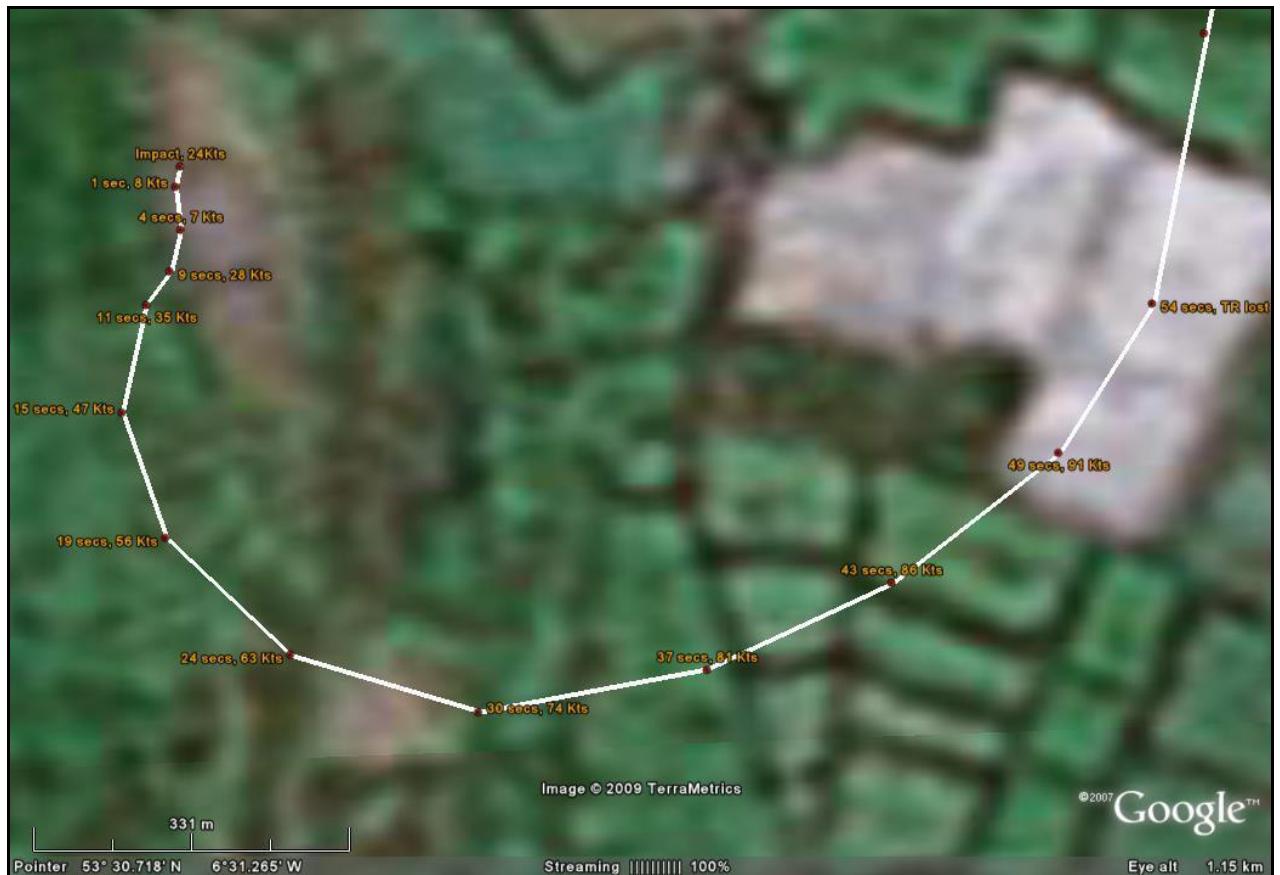
Figure D2

Reconstruction of last 54 seconds of flight. A constant wind of 270/22 was assumed. Aircraft ground speed and heading were resolved into component “airspeed” vectors parallel and perpendicular to 270. The components parallel to 270 were added, and the magnitude of the resultant of this addition and the perpendicular component was computed as an estimated airspeed experienced by the helicopter. Time calculations were performed to estimate the duration between TR loss and impact.
