AAIU Formal Report No.: 2002/013

Manufacturer: Socata

Model: Rallye Commodore MS 892A-150

Registration: EI-BCH

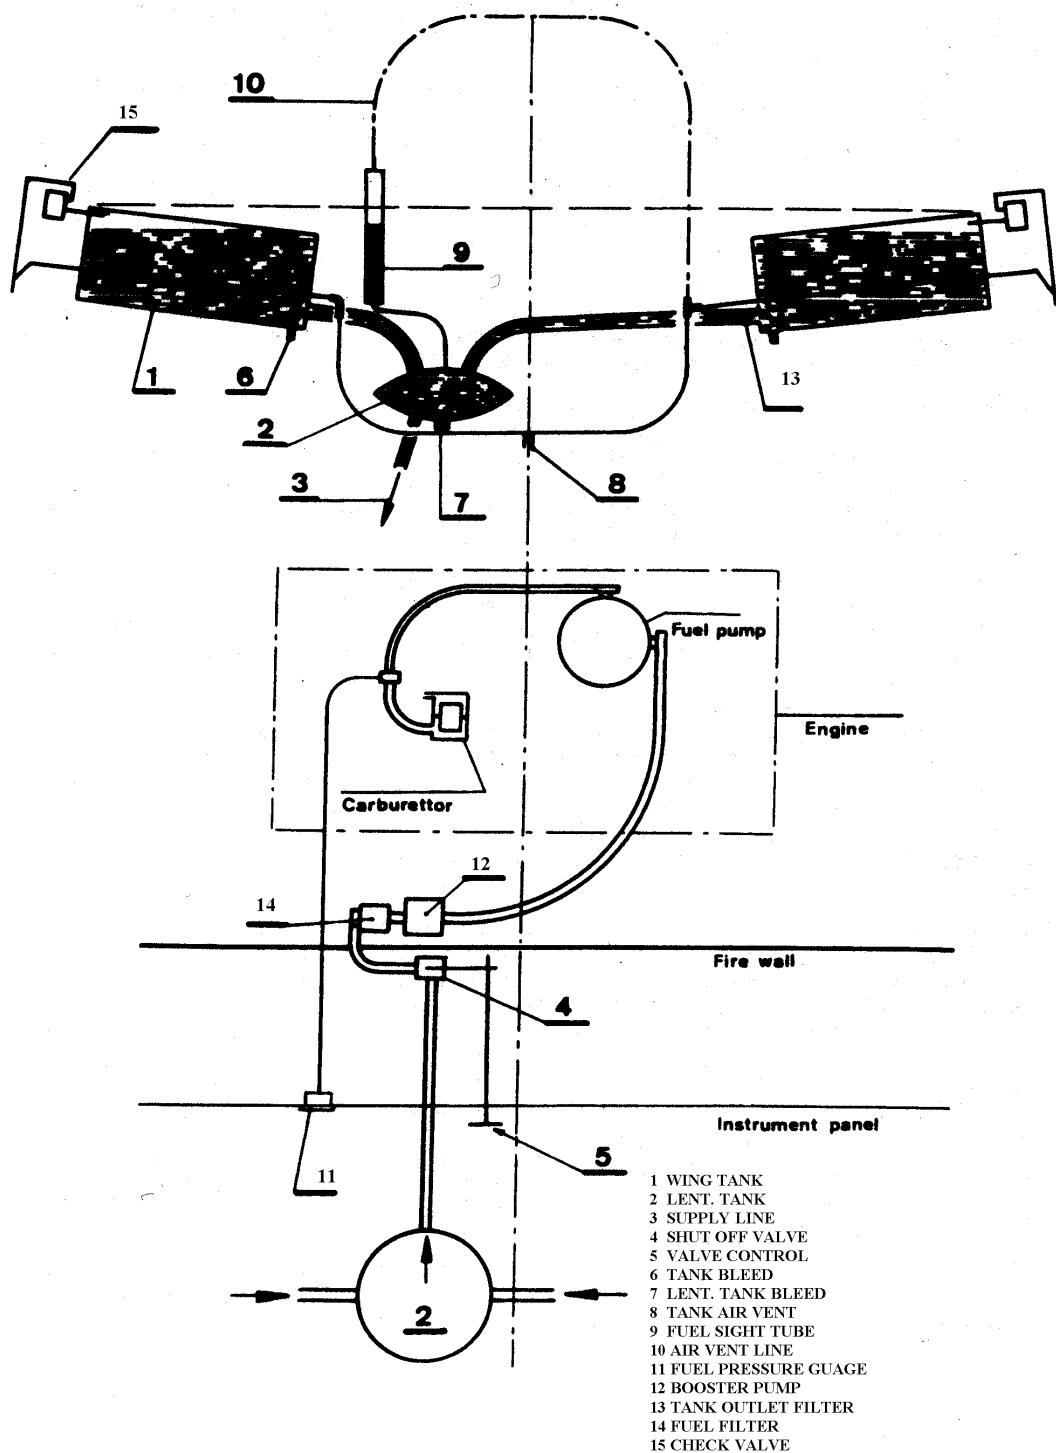
APPENDIX A

On the MS 892A-150 aircraft the fuel is contained in two metal tanks located in the wing compartment. The fuel is fed from these tanks into a lenticular tank fitted to the cabin floor. An illustration of the fuel system is shown at Appendix A.

A vent line connects the top of the fuel quantity sight tube with each tank vent. This line is then vented to atmosphere through the cabin floor. A check valve at each tank allows the tank to breathe.

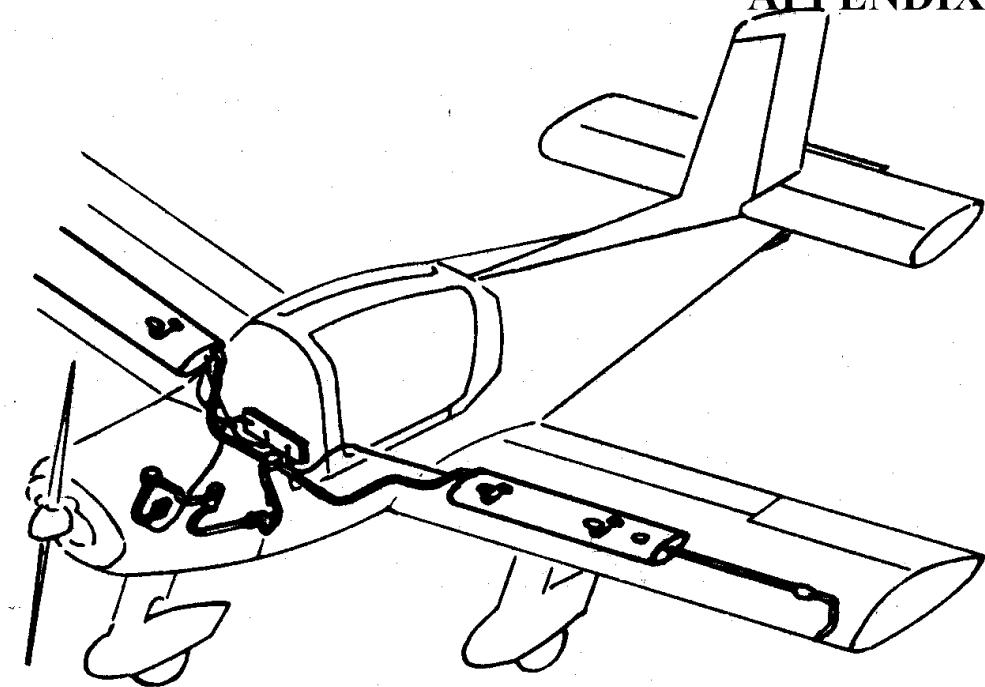
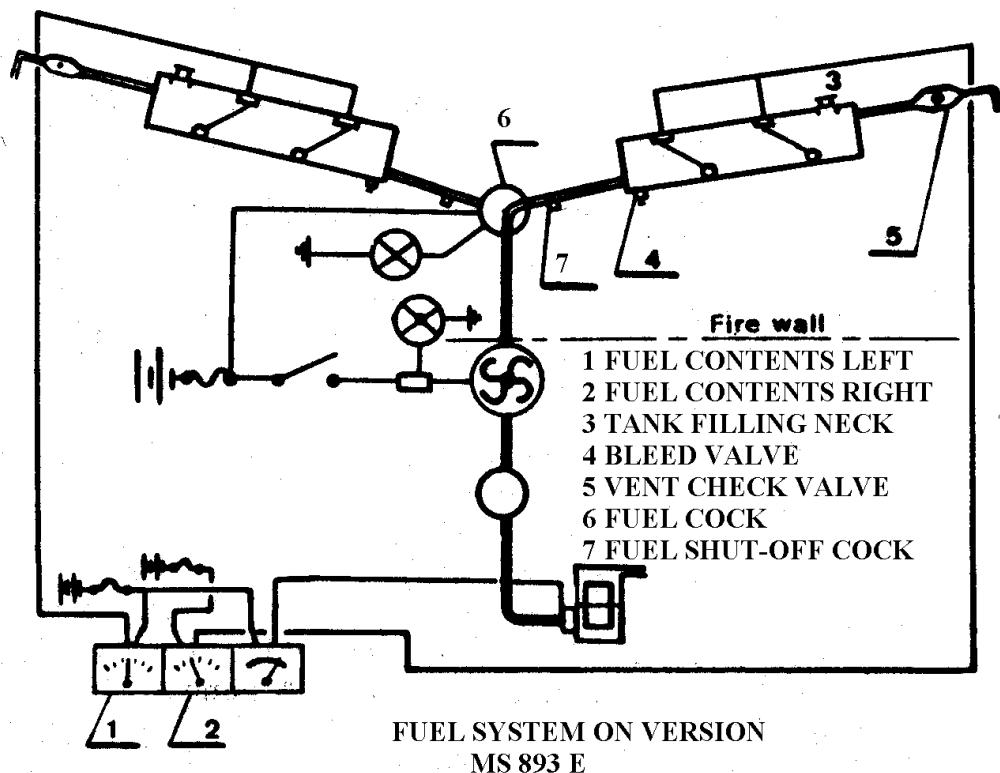
APPENDIX B

On the MS 893 E aircraft each tank is connected to a 3 way, 3-position (left-closed-right) cock. An illustration of its fuel system is shown at Appendix B. A pipe, passing through the firewall, feeds the fuel from the cock to the electrical booster pump and filter to the engine-driven pump. Each tank is fitted with 2 float-type transmitters, which allow the available fuel quantity to be known at all times. Fuel content indicators (1- 2) are located on the centre of the instrument panel strip. Each tank is provided with a filling neck (3), a bleed and drain cock (4) located on the wing lower surface, and a venting device consisting of a tube fitted with a check-valve (5) opening on the wing lower surface. A cock (6) located between each tank and the fuel shut-off cock (7) is accessible from under the fuselage.

The starboard wing of EI-BCH and EI-BFM are similar but not the same. They differ mainly in the fuel quantity measuring system used and fuel venting.

The installation of a starboard wing from EI-BFM on this aircraft changed the original design of the aircraft fuel venting system. However, this was not a contributory factor to this accident.

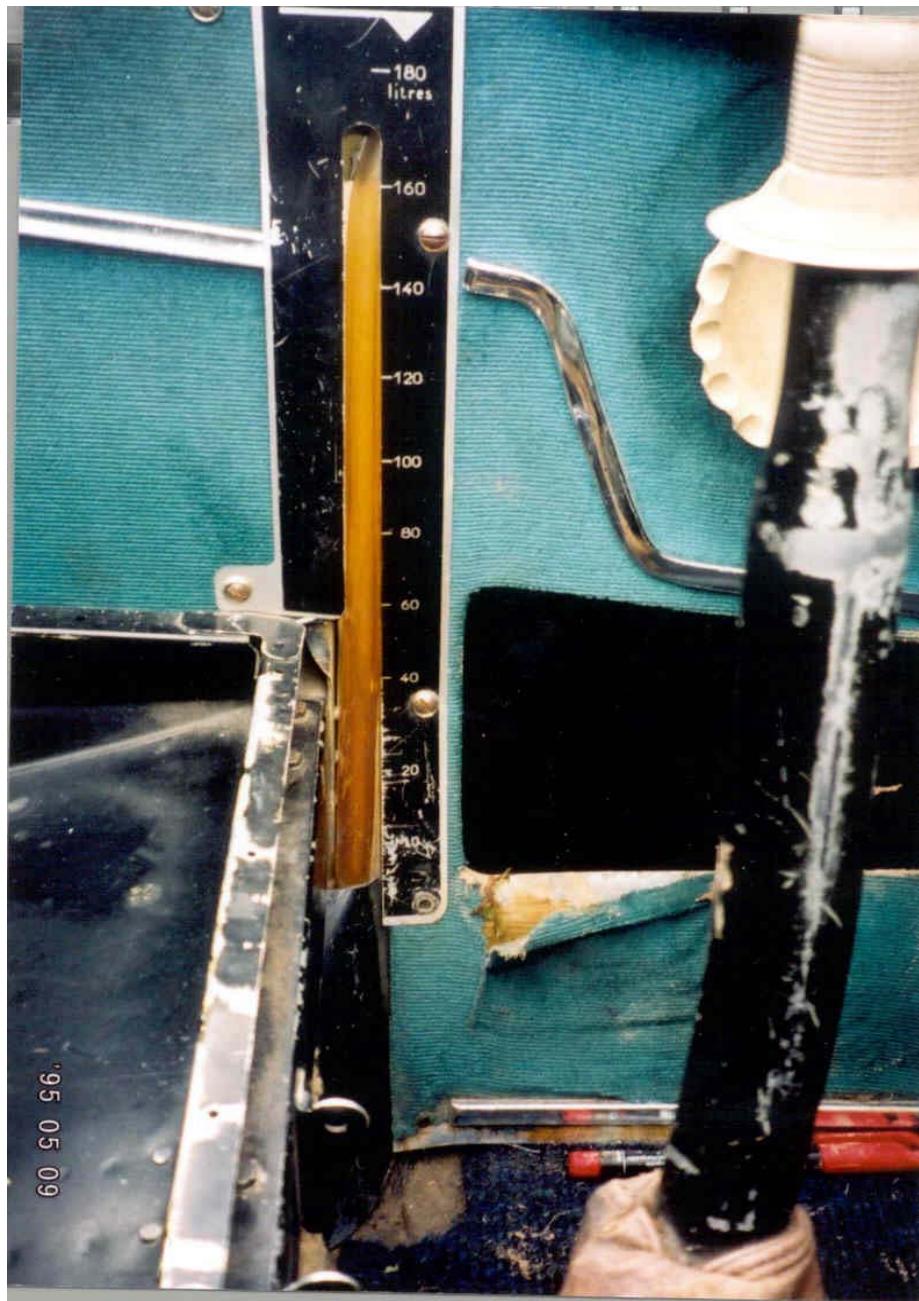
APPENDIX C

With the wings removed, the collector tank was filled with fuel and a variable head of fuel allowed to move the small sight ball of the fuel gauge up and down in the transparent tube. It was noticed that the ball would not at all times respond to the fuel level and that the fuel meniscus would drop away from the ball. This was particularly so between readings of 60 litres and 80 litres. As the sight gauge was discoloured with age, it was not always possible to observe the meniscus. Also the position of the gauge to the lower left of the pilot's seat would make it very difficult to continually observe this gauge in flight.

It is clear that the sight gauge was faulty particularly between the 60ltr and 80 ltr marks and from tests carried out, that this was due to the ball sticking in the gauge. It cannot be ascertained how the ball got from reading 40 ltr at the commencement of the penultimate flight to reading 84 ltr at the start of the accident flight without aircraft refuelling. It is possible that during the flight of the previous day fuel was forced up the sight gauge during a banked manoeuvre, aerobatics or heavy landing and that the ball stuck in the tube as the aircraft levelled. However this would not explain how the ball subsequently dropped from reading 84 to 80 to 60 litres just prior to the forced landing.

Empty fuel contents gauge, located on cockpit wall, pilot's side,
following the forced landing at Ballycorney.

- 4.1** The manufacturers of the aircraft should introduce an Instruction or Service Bulletin in order to replace the plastic tube of the fuel sight gauge with new tubes at regular calendar intervals. **(SR 27 of 2002)**
- 4.2** The Flying Club should review its fuelling policy in order to comply with the terms of LAMS/A/1999 Section7 (A5) for aircraft which do not have a visual method of verifying fuel indicator readings with actual fuel contents. **(SR 28 of 2002)**
