AAIU Report No. 2002-003
AAIU File No. 2001-036
Report Published: 11 March 2002

Name of Operator: Eirecopter Helicopters Ltd
Manufacturer: Robinson Helicopter Company
Model: R22 Beta
Registration: EI-CMI
Nationality: Irish
Location: Field adjacent to Birr Airfield
Date and Time (UTC): 12 June 2001 at 18:45 hours approx
Injuries: None

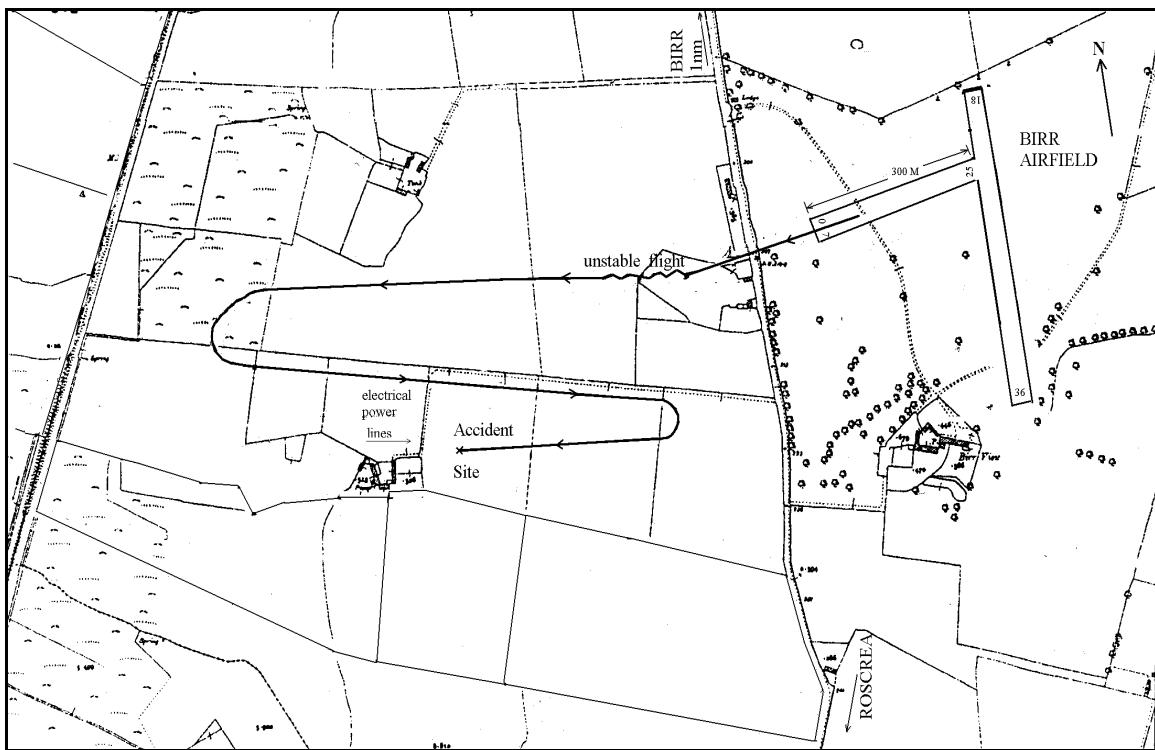
Fig 1.

In the belief that he may have been pulling too much collective, the pilot lowered the collective slightly to reduce power and applied forward cyclic to gain airspeed. After a short time the collective was again lowered slightly and forward cyclic was applied to gain airspeed. As these recovery actions had no effect on the climb performance of the helicopter and being confronted with an obstacle ahead of his position (most likely a tree positioned within a hedgerow at the western end of the field) the pilot wound the throttle fully open and turned left (east) through 180° back towards the airfield. As he crossed this field he flew over a set of electricity supply poles that were running at right angles (north/south) across his flight path. At the eastern end of this field the pilot was once again confronted with a number of obstructions ahead of his position (most likely electricity supply poles, trees and hedgerow along the main Roscrea to Birr road) so he turned the helicopter right (west) through 180°. On completion of this turn the pilot observed a farmhouse ahead of him so he elected to land-on immediately. The most likely “track made good” is presented as Fig (1) below.

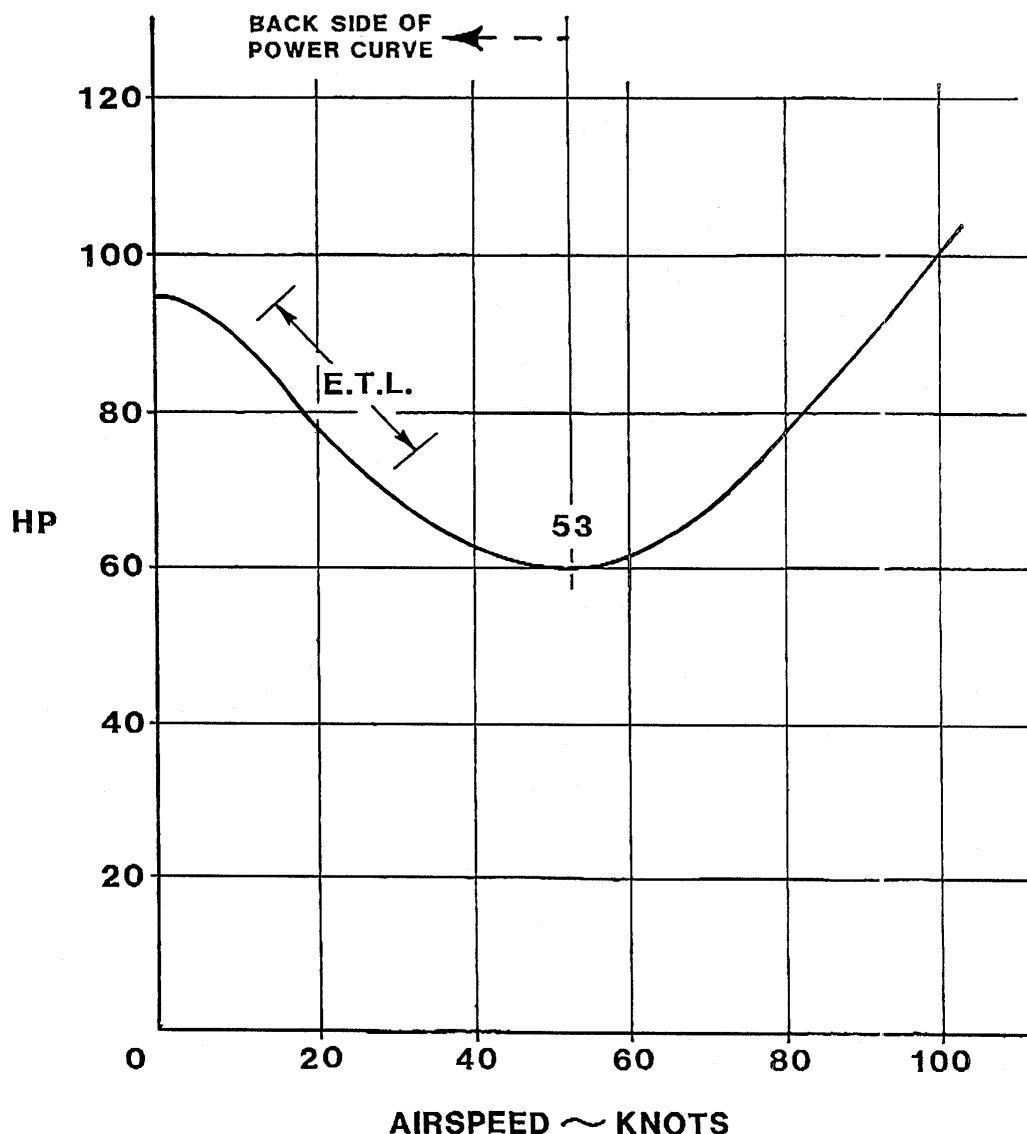
ROTOR POWER REQUIRED

The pulling of too much collective pitch during the transition and initial climb would compound any power reduction problem. Over-pitching of the collective would cause the RPM to drop, which would add to the power problem and thus reduce climb performance. In addition, the initiation of pitch attitude for climb at 40 KIAS was less than the recommended speed of 55 KIAS as prescribed in the R 22 Flight Training Guide Manual (Section 1.6.4.1 of this report) and less than the recommended climb speed of 60 KIAS as prescribed in the R 22 Pilot's Operating Handbook (Section 1.6.5.1 of this report). Any attempt to climb the helicopter at a speed less than that recommended for climb will require a greater demand of power to maintain that speed due to reduced ETL. If power available is insufficient to maintain the selected airspeed, the helicopter will decelerate, settle and descend. Any further demand on power at this point will result in rotor RPM decay and a decrease in lift. A graph describing power required versus airspeed during ETL is presented as **Appendix B** to this report.
