*AAIU Report No.2002-001
AAIU File No. 19990047
Published: 18/01/02*

Name of Operator	Garda Aviation Club Limited
Manufacturer	Reims Cessna
Aircraft Model	Reims Cessna FA 150K
Nationality	Irish
Registration	EI-AUC
Location:	Laraghcon, Lucan, Co. Dublin
Date and Time (UTC)	15 July 1999, 17.30 hours

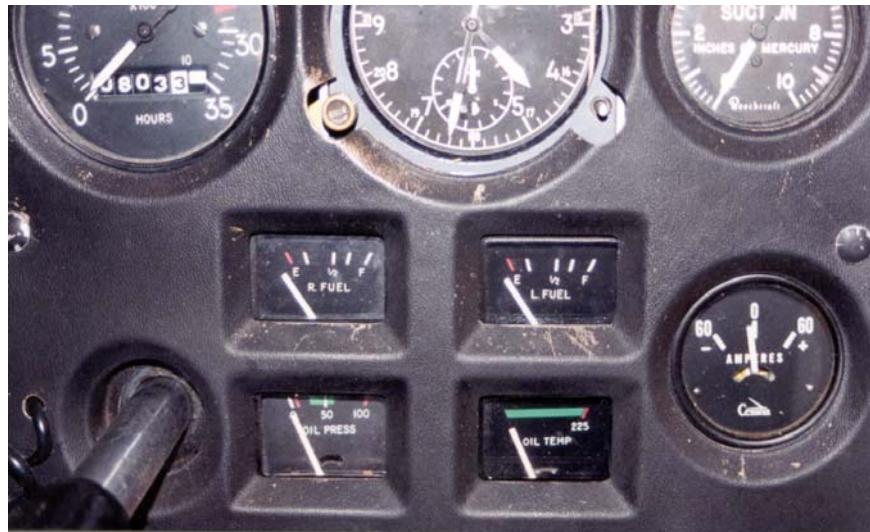
It was noted that, on this particular aircraft, the fuel gauge marked "L FUEL" was actually installed on the right and connected to the right tank. The gauge marked "R FUEL" was installed on the left and connected to the left tank. The right hand gauge (marked "L FUEL") read "FULL" irrespective of the right fuel tank contents. This faulty reading was attributed to a faulty cockpit indicator.

- 3.5 Although not always uniformly accurate, fuel gauges give an indication of the fuel tank contents. It is clear that on flights prior to the final flight, these indications were being ignored. The right hand fuel indicator was incorrectly installed on the left whilst the left hand indicator was placed on the right.

Misplaced fuel gauges of EI-AUC

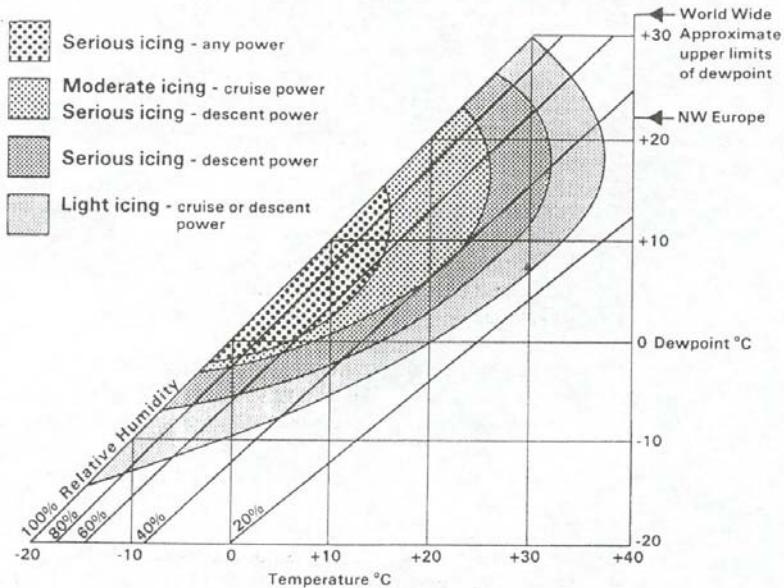
FIG.1

The chart at Fig.1 shows the wide range of ambient conditions conducive to the formation of induction system icing for a typical light aircraft piston engine. Flight tests have produced serious icing at descent power with the ambient temperature above 30° C even with a relative humidity as low as 30%. The forecast and aftercast figures for temperature and dew point at the time of the accident indicate that there was a risk of serious icing, particularly with descent power. Carburettor icing is prevented by heating the intake air in an exhaust heat exchanger.

- 3.3 Weather conditions at the time were conducive to carburettor icing. Even though the engine carburettor heat control was being cycled “on and off” during the downwind phase of landing and “on” at base leg, there is still a possibility that the engine could have been deprived of proper fuel/air mixture due to carburettor icing. This would have to have been coincident with the exact time when the engine speed was being reduced to 1700 RPM.

CARBURETTOR ICING IN AIR FREE OF CLOUD, FOG, OR PRECIPITATION
 -risk and rate of icing will be greater when operating in cloud, fog and precipitation.

A Temp/Dew point of 16°/10°C (forecast for Dublin Airport) or 18°/10°C (Met Eireann aftercast for the accident area) will correspond to conditions where serious icing may occur at a low power setting as during descent, whilst a figure of 14°/12°C (forecast for Casement Aerodrome) will correspond to conditions where serious icing can occur at any power setting.
