## **FINAL REPORT**

*AAIU Report No.: 2001/0019  
AAIU File No.: 2001/0034  
Published: 13 December 2001*

<b>Operator:</b>	Aer Arann
<b>Manufacturer:</b>	ATR
<b>Model:</b>	ATR42-300
<b>Nationality:</b>	Ireland
<b>Registration:</b>	EI-CBK
<b>Location:</b>	Approaching Cork Airport, Ireland
<b>Date/Time (UTC):</b>	29 May 2001, 1700 hrs.

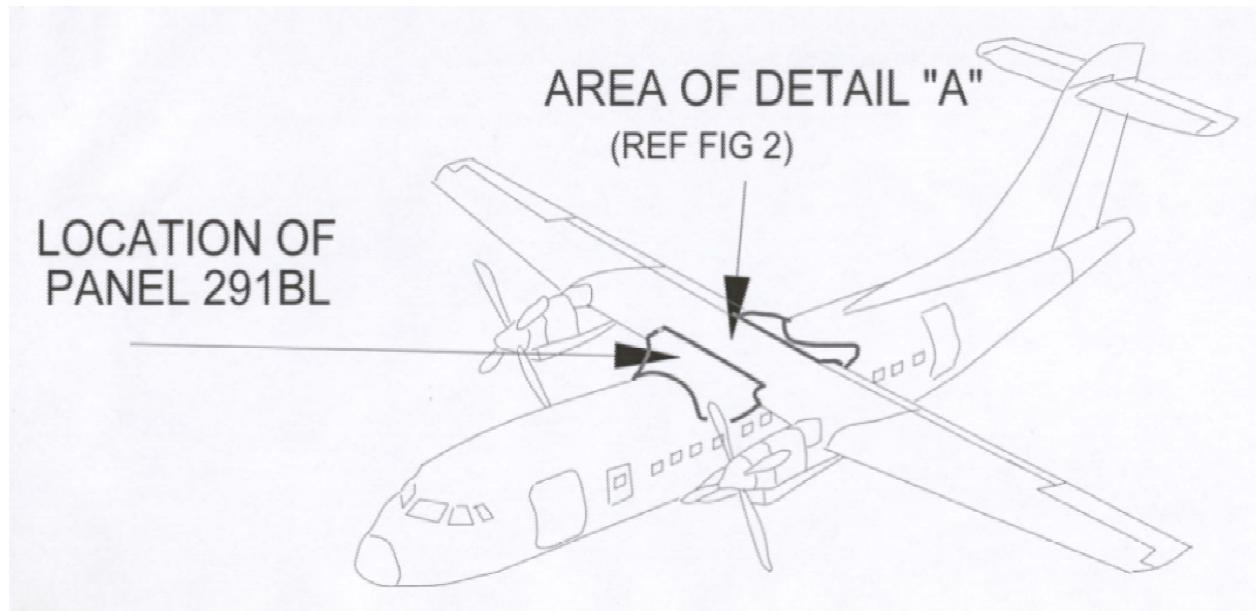
**FIG 1**

The only damage suffered by the aircraft was cracking in the trailing edge section of Panel 291BL. This panel is part of the wing-to-fuselage fairing and is located at the wing leading edge above the fuselage (see **Appendix A**).

Position of Panel 291BL on ATR-42

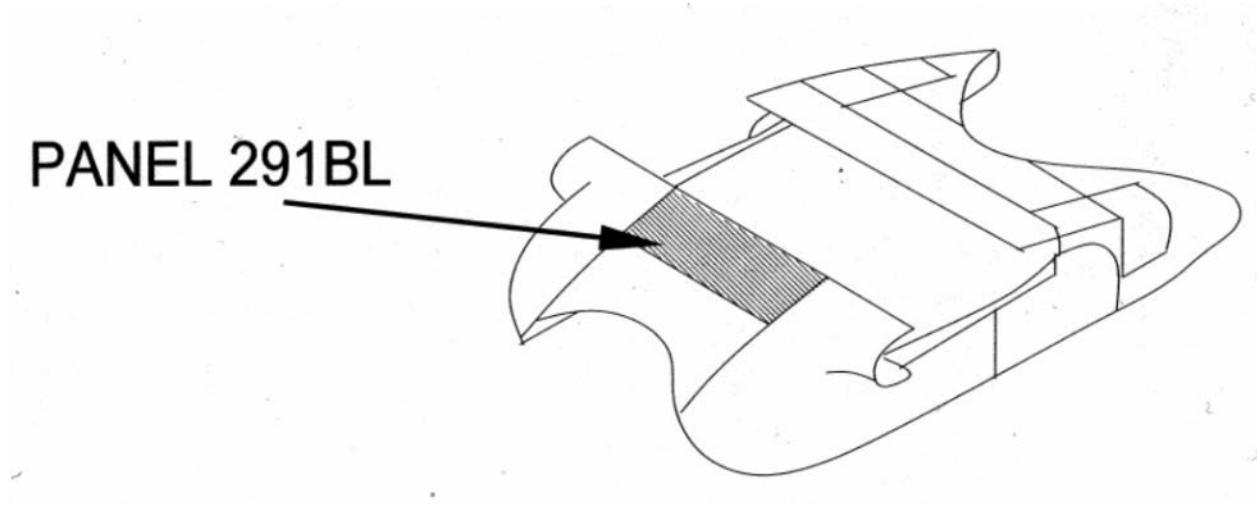
**FIG 2**

Detail "A" Showing location of Panel 291BL

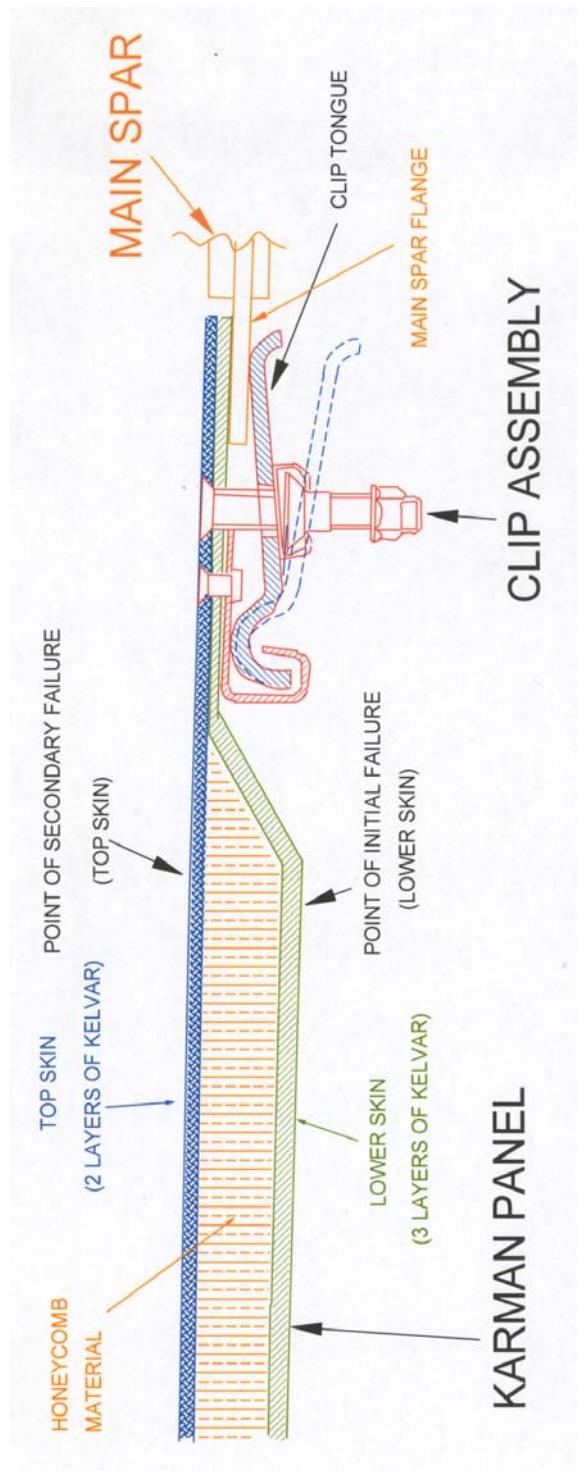
The Panel 291BL is constructed from composite material. The outer skin is constructed of 2 layers of Kevlar and the inner skin from 3 layers of Kevlar. The centre of the panel is made from honeycomb. The honeycomb does not extend to the edges of the panel, but stops about 75 mm from the edge. The direct bonding of the outer skin to the inner skin makes up the trailing edge lip of the panel. **Appendix B** shows this construction.

Section of Clip Assembly and Panel 291BL

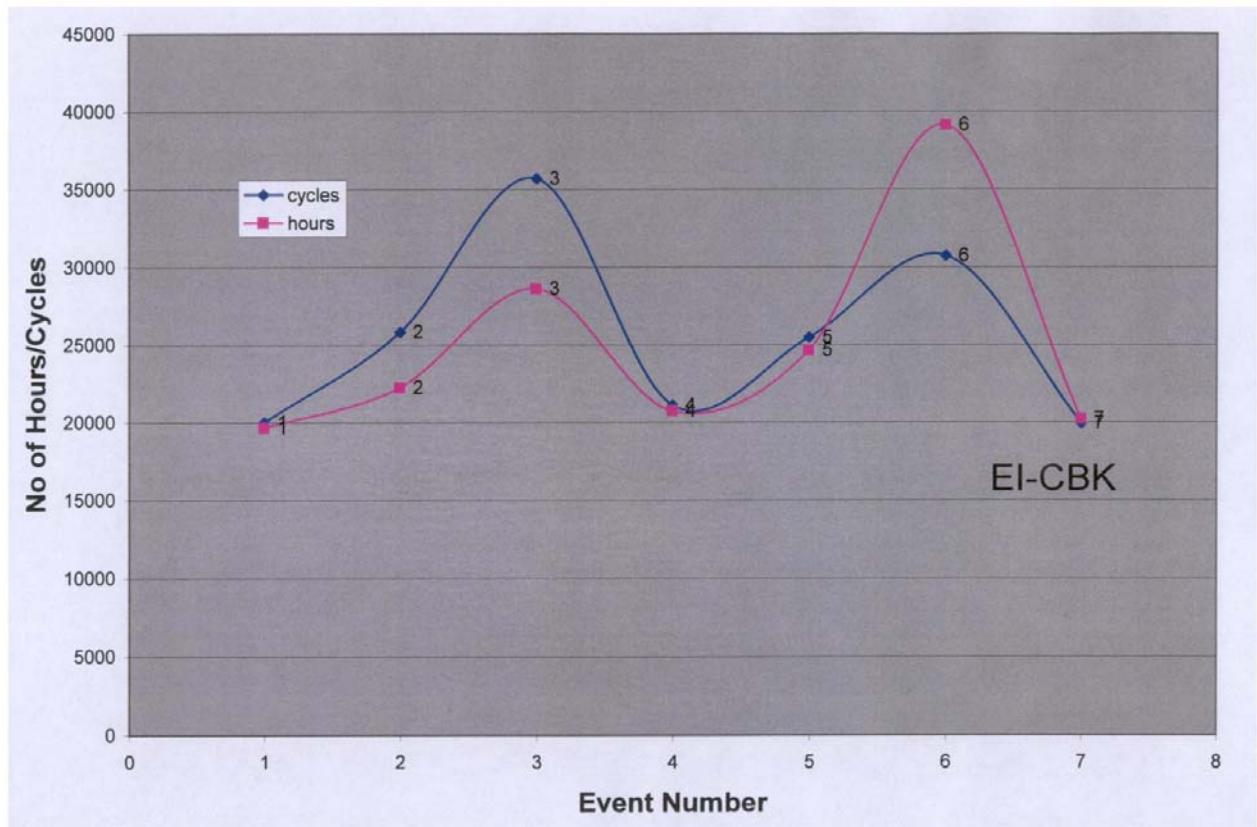
**2.10** **Appendix C** shows the historical data for the seven Panel 291BL events (as given in Para 1.6.6 above) in graphical form. This shows that the hours to failure and the cycles to failure show significant consistency.

Furthermore, it shows that the panel which failed on EI-CBK (event no 7) had almost identical hours flown (approx 20,000) and cycles flown (approx 20,000) compared with 2 others of the 7 events (Events 1 and 4). The graph clearly indicates that there is an utilisation ageing factor in the failure of this panel.

**Plot of Flying Hours and Cycles for Panel 291BL Events  
That Occurred to ATR 42 Aircraft**

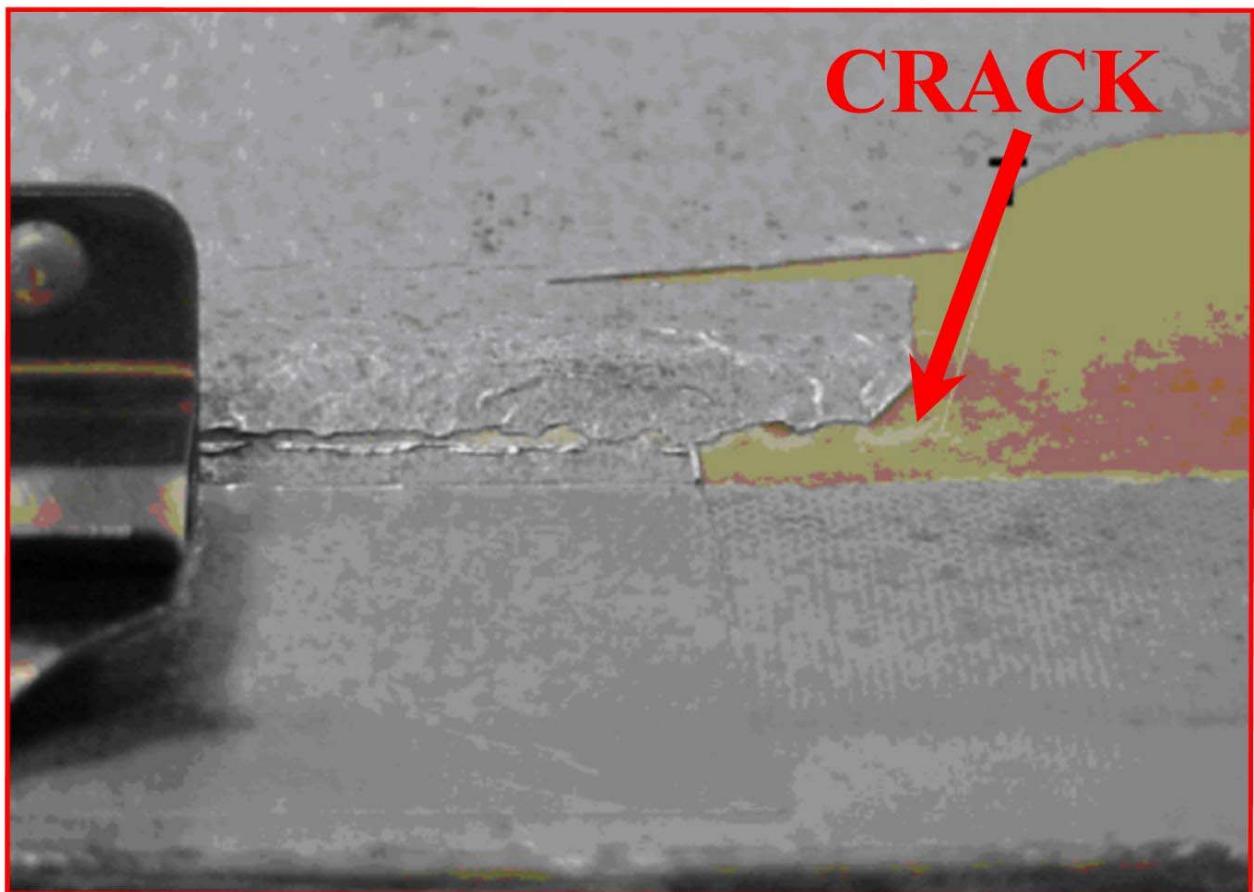
Following the test flight, it was agreed to subject the panel to further testing, including cutting it open. Initially the foil lining in the inner face was removed. This revealed the failure in the inner skin (See **Appendix D**). The panel was then subjected to C-Scan inspection, which revealed that the inner Kevlar skin had lost structural integrity along the entire length of the panel. This is shown by the yellow area in **Appendix E**.

**Inner face of Panel 291BL showing Failure  
(Foil Removed)**

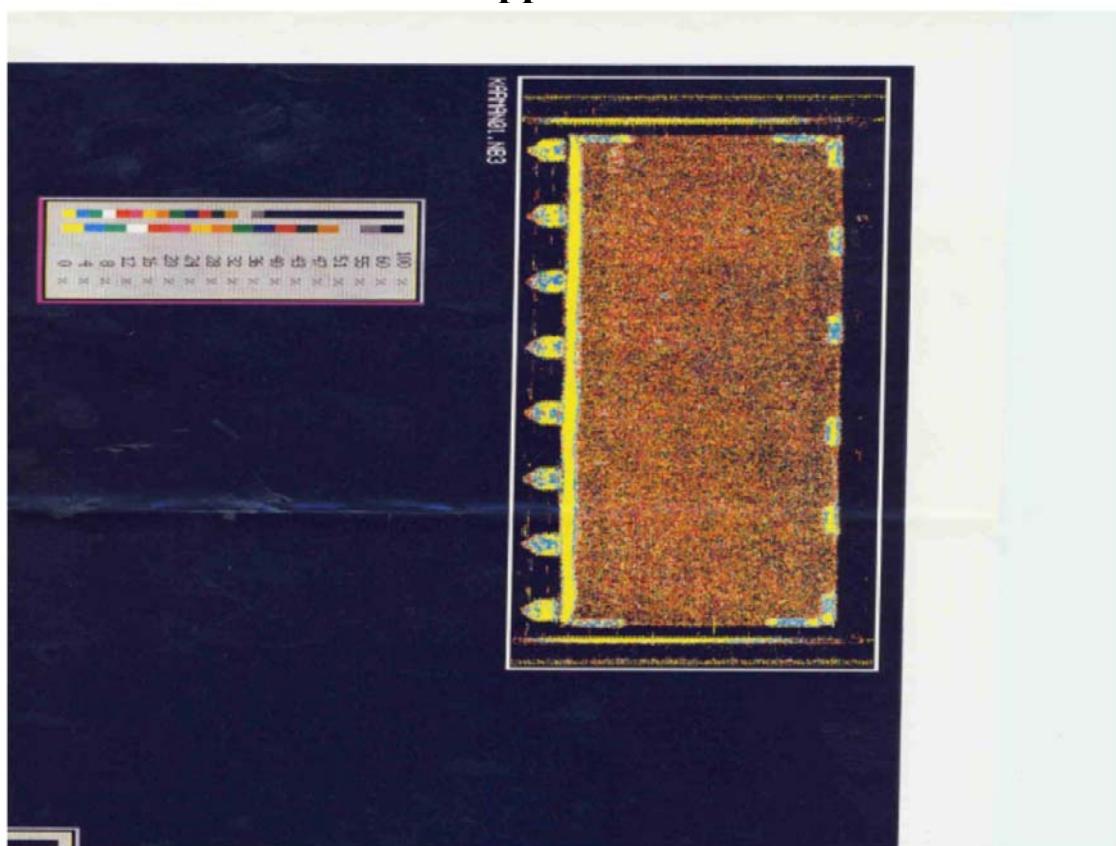
This in turn produced compressive loads in the inner skin and tensile loads in the outer skin. Due to the effects of telegraphing, the inner skin's ability to resist repeated applications of compressive loads was reduced. This ultimately led to failure of the inner skin along the line parallel to the trailing edge. This is shown by the C-Scan test.

**C Scan Result of Panel 291BL Inner Face**  
Failure is Indicated by Heavy Yellow Line

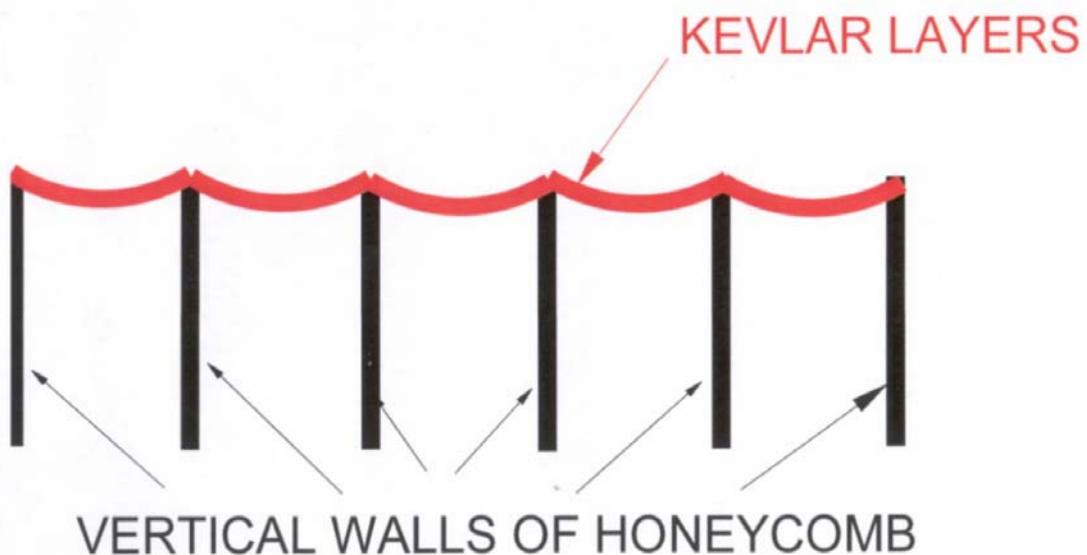
**Figure 1**  
Showing the sagging between vertical supports (exaggerated)

It has been found that when a small number of Kevlar and resin layers are applied over a honeycomb structure, the Kevlar layers sags slightly between the uprights of the honeycomb hexagonals. This has the appearance similar to that of telephone wires sagging between telephone poles and hence the origin of the name of the phenomenon: - “Telegraphing”. The effect is shown diagrammatically, in figure 1.

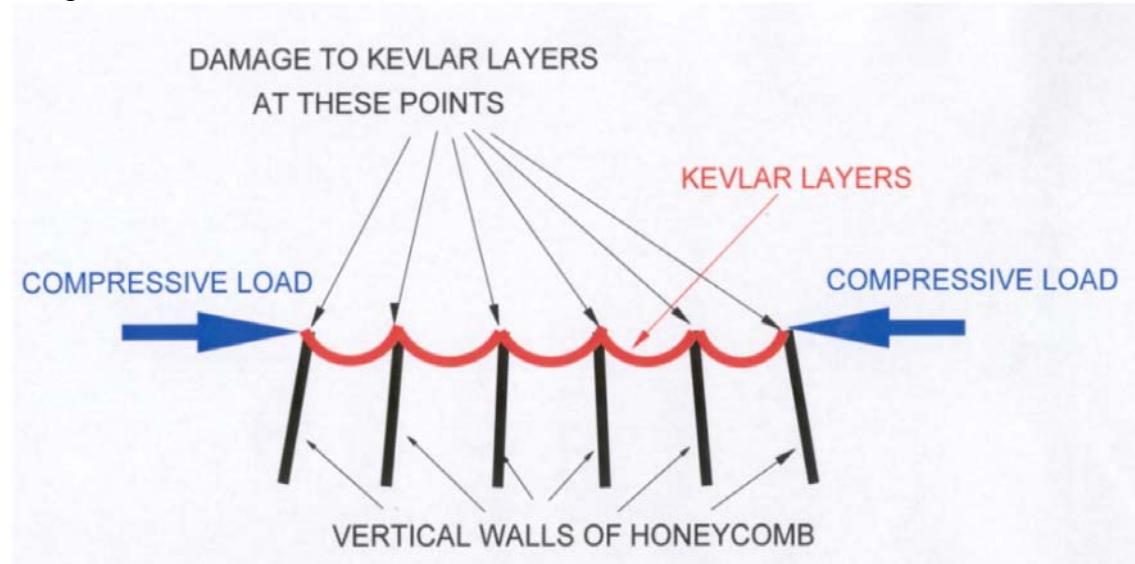
**Figure 2**  
Showing the effect of compressive loads (exaggerated)

The effect of telegraphing is to reduce the resistance of the Kevlar skin to compressive loads. Because the surface is already somewhat buckled by telegraphing, the effect of the compressive load is to increase the buckling effect, thereby further reducing the ability of the skin to resist the compressive load. When the compressive loads are cyclic, such as experiences by the Panel 291BL, the increased buckling, due to these varying loadings, causes working (movement) of the joint at the honeycomb-Kevlar interface. In time, this produces fatigue in the Kevlar fibres and separation between the Kevlar and the resin. This caused deterioration in the strength properties of the skin and, ultimately resulting in failure of the skin. The effect is shown, diagrammatically, in figure 2.
