**AAIU Report No. 2001/0018**  
**AAIU File No. 2000/0061**  
**Date Published: 30 November 2001**

<b>Aircraft Type and Registration:</b>	Boeing 737-800, EI-CSC	
<b>No. and Type of Engines:</b>	2 x CFM 56 – 7B	
<b>Aircraft Serial Number:</b>	29918	
<b>Year of Manufacture:</b>	1999	
<b>Date and Time (UTC):</b>	7 October 2000, at 1300 hours approx	
<b>Location:</b>	During climb-out from Stansted Airport, UK	
<b>Type of Flight:</b>	Public Transport, (Scheduled)	
<b>Persons on Board:</b>	Crew - 2 Pilots, 4 - CCM's    Passengers - 177	
<b>Injuries:</b>	Crew - Nil	Passengers - Nil
<b>Nature of Damage:</b>	None	
<b>Commanders Licence:</b>	Airline Transport Pilot's Licence (UK)	
<b>Commanders Age:</b>	44 Years	
<b>Commanders Flying Experience:</b>	6392 hours	
<b>Information Source:</b>	Report submitted by Operator AAIU Investigation

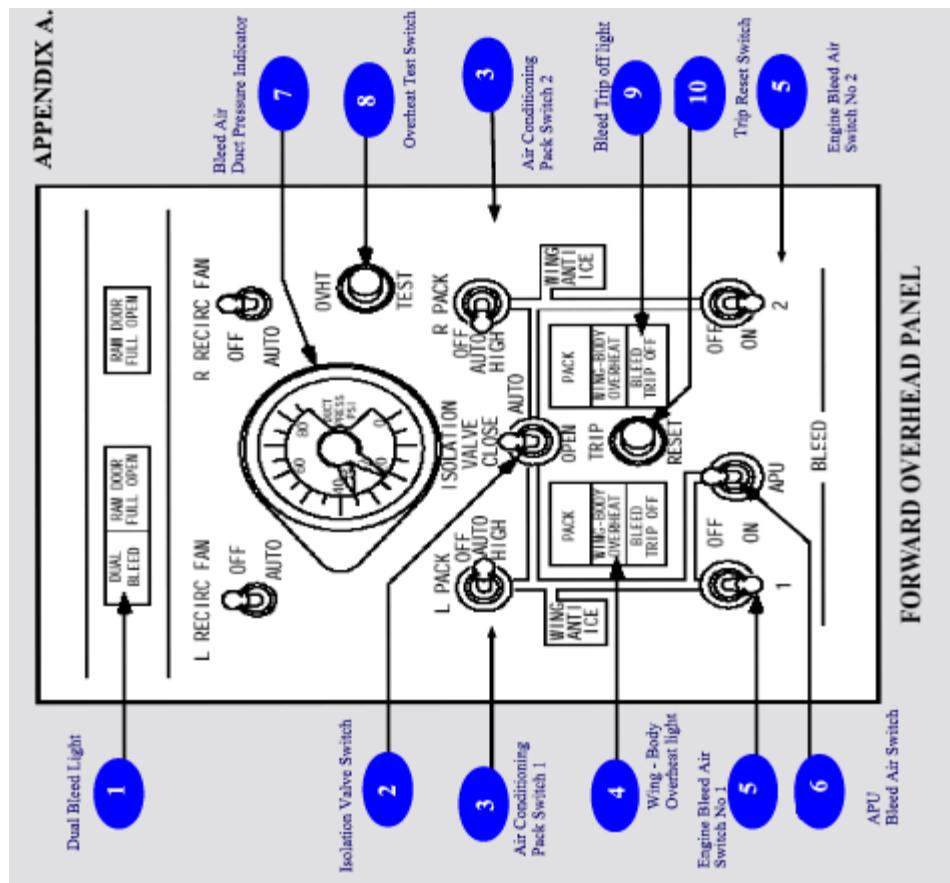
**APPENDIX A.**

**FORWARD OVERHEAD PANEL**

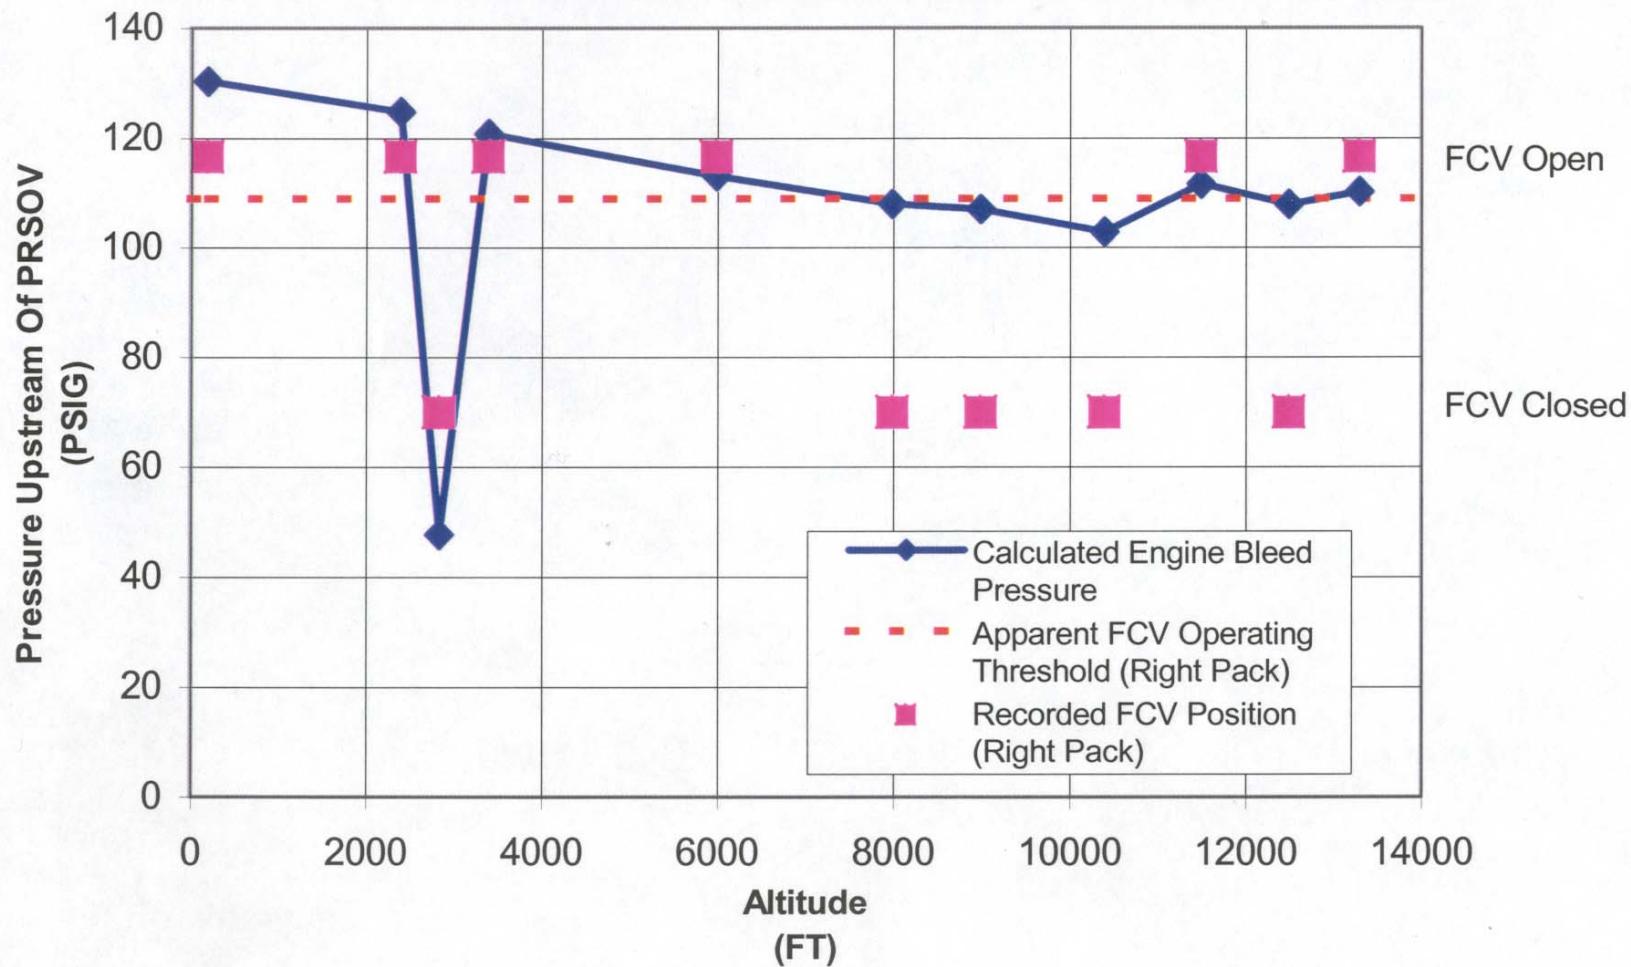
**737-800 EI-CSC**  
**Engine Bleed Pressure and Right Pack FCV Indications**

In order to determine the actual leakage rate past the closed PRSOV the engine bleed pressure upstream of the PRSOV was calculated. A graph presented as **Appendix C** to this report shows engine bleed pressure and recorded FCV position at several discrete altitudes selected from the DFDR data. The graph shows that when the engine bleed pressure is above approximately 109 psig, the FCV was recorded as open. Below that pressure, the FCV was recorded as closed. Therefore, the recorded positions of the FCV are very likely the result of expected system operation with the PRSOV commanded closed and the FCV commanded open.

The above scenario presumes that the right pack switch was selected “On” throughout the climb. The close correlation between the engine bleed pressure and FCV position suggest that this assumption is correct. It is possible that the left pack switch was also selected “On”, but that the left FCV didn’t open due to variability in operating characteristics of the left and right FCV.
