*AAIU Report No.2001/017
AAIU File No.2000/0045
Report Published 21 November 2001*

Aircraft Type and Registration: Jabiru UL Ultralight G-BXNU

SYNOPSIS

Following a 20 minute flight the aircraft stalled in a left base turn to land at Minnistown private airfield. The aircraft landed heavily in a small field and inverted.

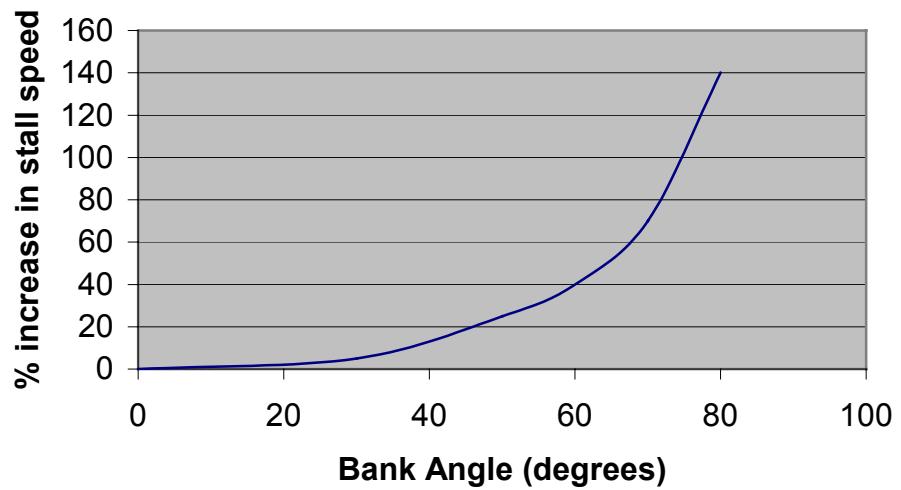
Typical Graph of % increase in stall speed versus Bank Angle

The increase of stalling speed with bank angle follows the general law demonstrated by the graph on page 10. On G-BXNU, the percentage increase in stalling speed increases further as flaps are extended. With engine power on, the stalling speed decreases slightly. However, the left wing had already stalled before engine power was increased. The estimated stalling speed for a $\frac{1}{2}$ stage (15°) flap in accordance with the flight test results would be in the region of 45 kt at 30° left bank. At a 60° to 70° left bank, the stalling speed could have been in the region of 60 kt. The pilot indicated that when he set the flaps the speed was less than 70 kt. (i.a.w. the AFM). It is likely therefore that a condition for a stall in the turn existed and that insufficient height was available for recovery. Also, the input of right rudder at this time could have induced the onset of an initial spin. The fact that the aircraft failed to respond to aileron indicates that at least the inner wing outer section had stalled. For a short field landing as intended, the flaps should have been set at full flap.

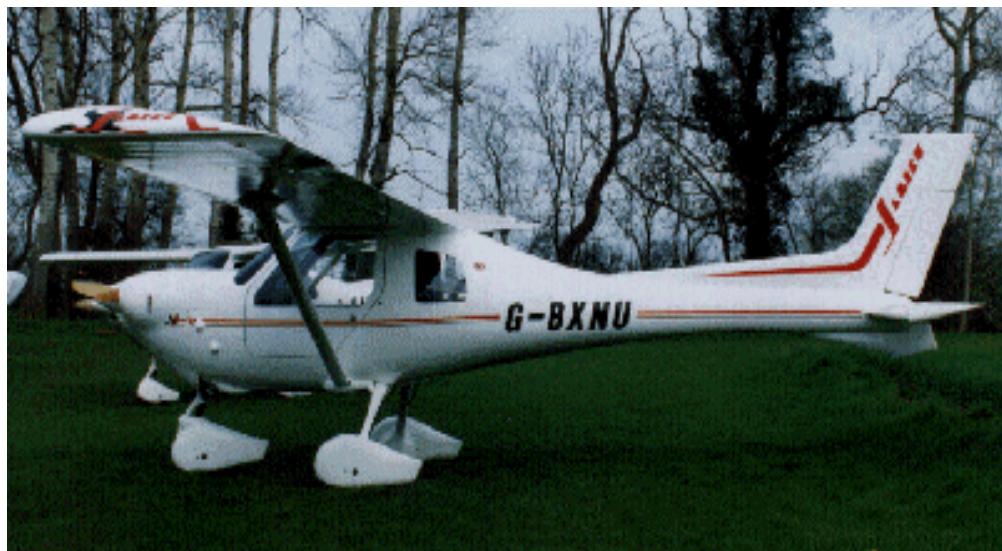
Photo of G-BXNU with two bladed propeller installed.
