FINAL REPORT

AAIU Report No. 2001-013
AAIU File No. 1998-006
Report Published: 20 Sept 2001

Aircraft Type and Registration: Boeing 767-300 (3Z9), OE-LAU

Location: Shannon Airport, Co. Clare, Ireland

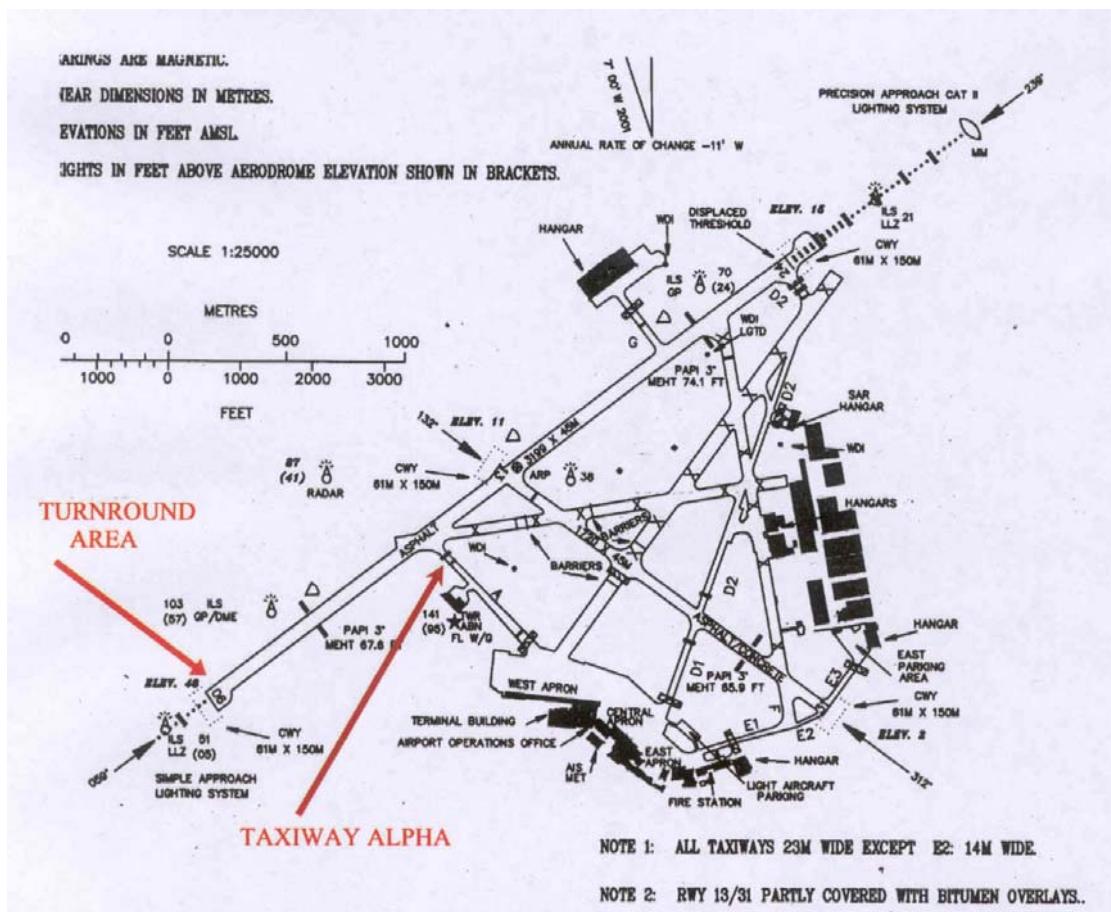
APPENDIX A

The aircraft landed normally on Runway 24 at Shannon Airport. It did not slow sufficiently to turn off at Taxiway Alpha (Appendix A) and it was therefore necessary to taxi to the end of Runway 24, where the turnaround is located in order to turn, prior to backtracking down the runway and clearing by Taxiway Alpha. As the aircraft taxied towards the turnaround, ATC requested that it expedite clearance of the runway, in order to clear the runway for following aircraft approaching this runway. Approaching the turning area, the pilot steered the aircraft slightly to the right of the centre-line, (Appendix B), in order to make more room for the 180° turn to the left. The pilot then attempted to turn the aircraft to the left, but the aircraft did not respond. The pilot subsequently stated that he could hear the nose wheel skidding at this time. Just before the aircraft reached the end of the runway, the nose suddenly swung to the left, but the aircraft continued to travel in the general direction of the runway centreline. The aircraft continued off the end of the runway and came to rest on a heading of 198° after the nose wheel had traversed 18 metres of the grass area. The right main wheels were 4 metres into the grass and the left main wheels remained on the strip of pavement where the threshold lights are located, which immediately adjoins the end of the runway.

It is also noted that Taxiway Alpha requires an aircraft landing on Runway 24 to turn by 100° to clear the runway. This means that the aircraft must be slowed to a virtual stop before attempting to turn off Runway 24 onto Taxiway Alpha. In order to permit aircraft to turn off at higher speeds, a large radius turn-off, with a maximum angle of 45°, but preferably 30°, is recommended in ICAO Annex 14.

LAYOUT OF SHANNON AIRPORT
SHOWING THE TURNROUND AREA
AND TAXIWAY ALPHA

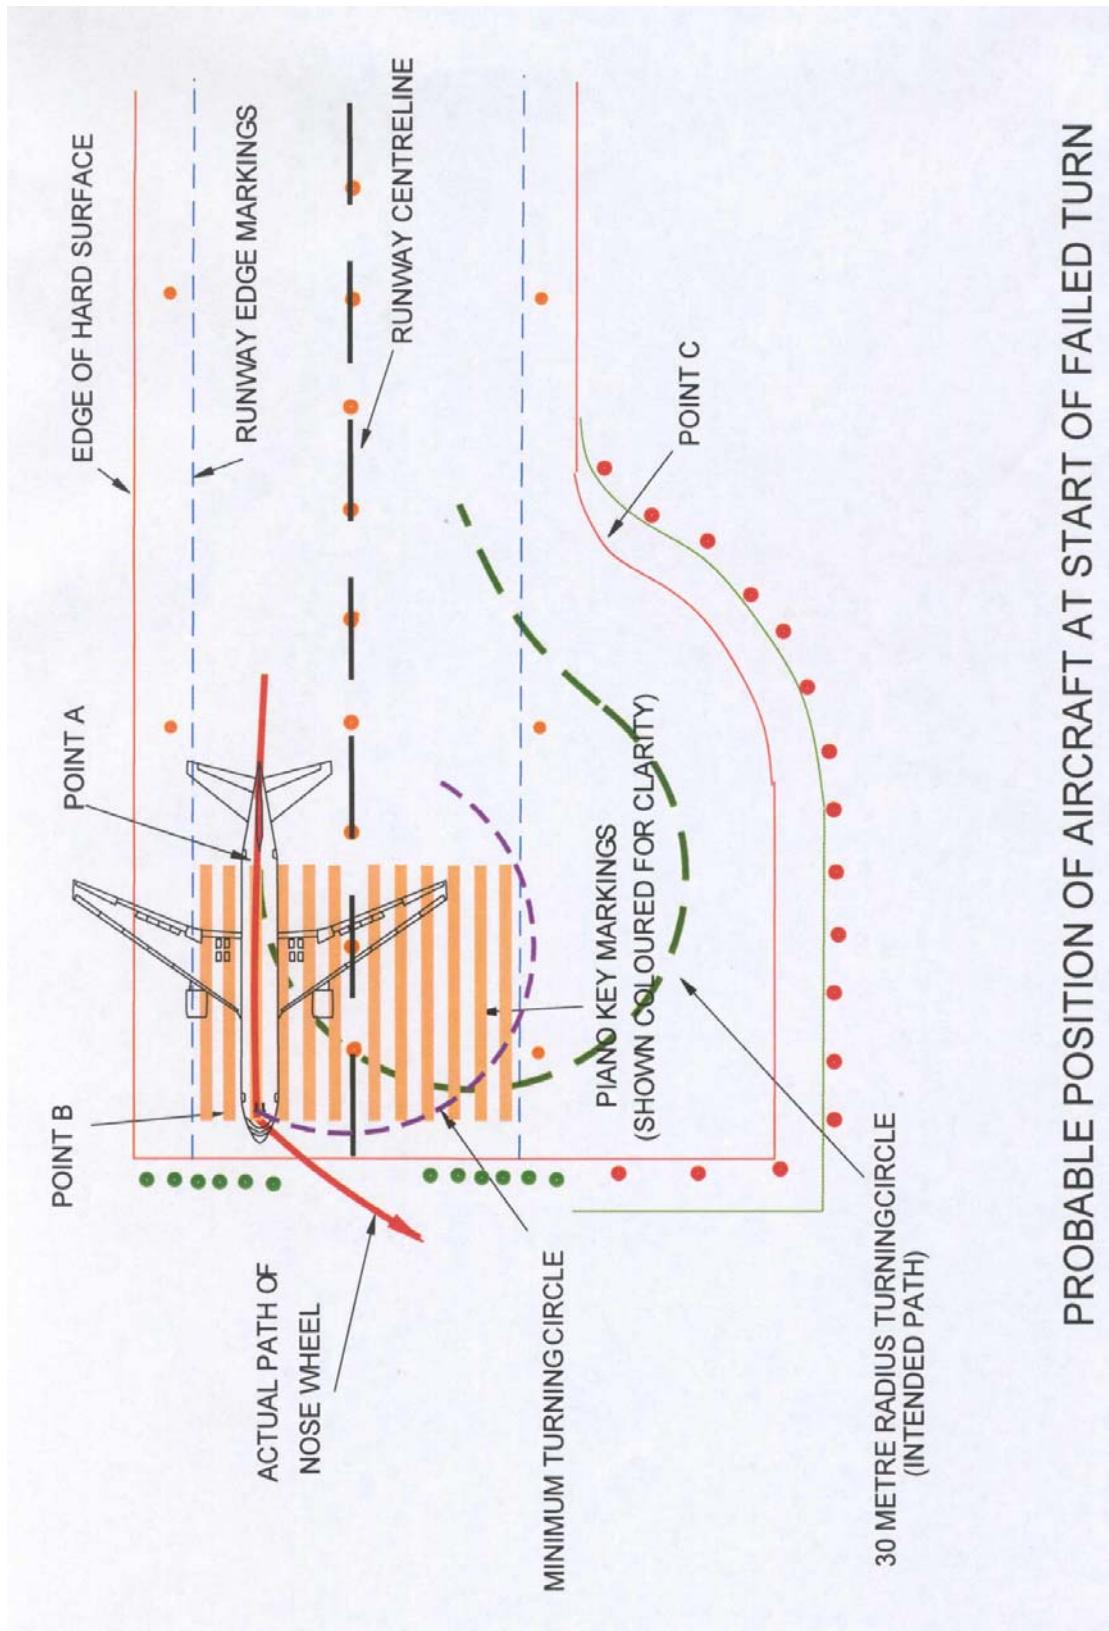
APPENDIX B

Appendix B shows the minimum and 30 metre radius turning requirements of the B767-300 superimposed on the turnaround area.

2.14 The intention of the pilot was to execute a 30 metre radius turn rather than to use the minimum radius of 22.3 metres. This would allow a slightly faster turn and would also reduce the possibility of loss of the momentum required to complete the turn. In order to execute the 30 metre radius turn he would have initiated the left turn of the nose wheel just as it entered the area containing the piano key markings, Point A in Appendix B. At this point the nose wheel started to hydroplane and the nose wheel skidded and the aircraft failed to turn. The aircraft continued in a straight line and the main wheels entered the low friction markings and probably aquaplaned, thereby destroying braking action. The nose wheels, orientated for the left turn, then entered the unmarked final 5 metres of the runway (Point B) and regained a grip on the runway and turned the aircraft by 42° to the left. As the right main wheels entered the unmarked area they also regained a grip on the surface and caused the aircraft to travel along the 198° heading. However it was impossible to avoid exiting off the runway in this limited distance.
