**AAIU Report No. 2000/013**  
**AAIU File No. 1999/0058**

**Aircraft Type and Registration:** MD83, HB-INV

**Date and Time (UTC):** 3 Sept '99 13.10 hrs

**Location:** Stand 32 Dublin Airport

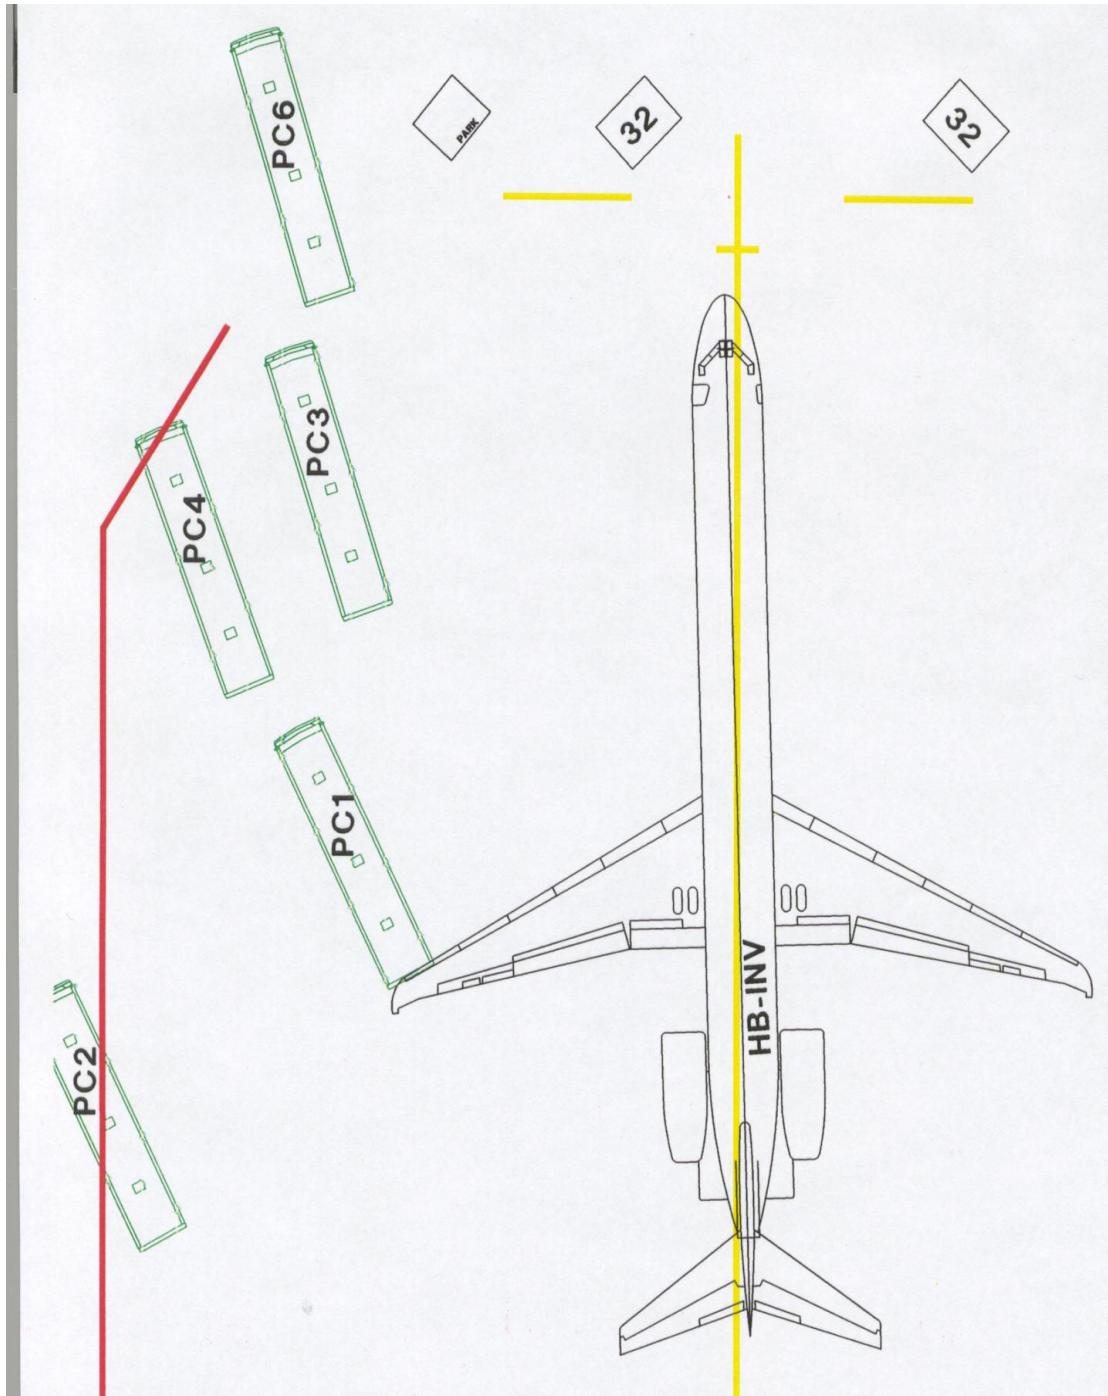
The Captain of the aircraft, the Marshaller and the Wingman were all aware of the proximity of the buses to the yellow taxiline along which the aircraft was about to be manoeuvred. The left wing impacted the rear of the bus from the wing tip to a point approx. 2 metres inboard from the tip.

Position of HB-INV and adjacent passenger vehicles at the time of the incident.
