AAIU Report No. 2000/0006

Aircraft Type and Registration:	Airbus 321-200 G-MIDH
No. and Type of Engines:	Two V2527-A5 Turbofans
Aircraft Serial Number:	968
Year of Manufacture:	1999
Date and Time (UTC):	15 January 2000, 07.55
Location:	Stand 40 Dublin Airport
Type of Flight:	Scheduled Public Transport
Persons on Board:	36
Injuries:	Nil
Nature of Damage:	Damage to Aircraft Radome
Commanders Licence:	ATPL
Commanders Age:	33 yrs
Commanders Flying Experience:	4300 hours total 400 hours on type
Information Source	Aer Rianta Duty Officer, Dublin Airport, AAIU Field Investigation

SYNOPSIS

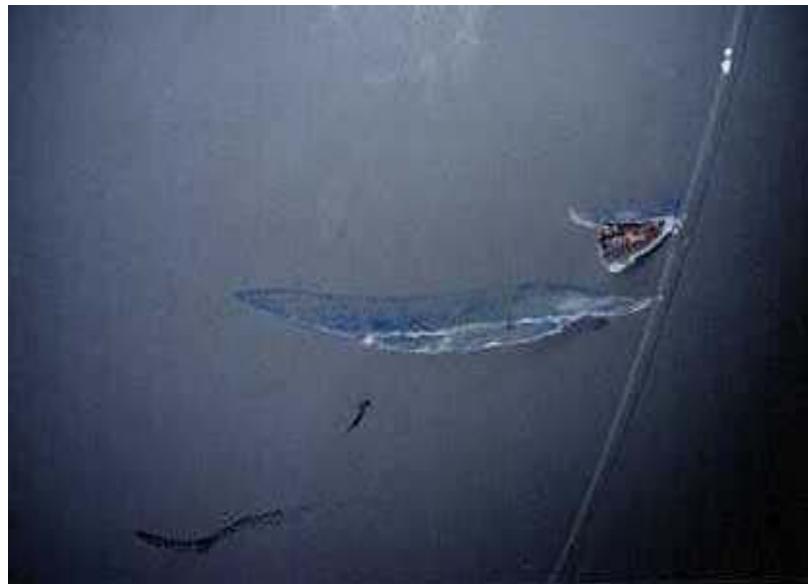
The radome was scratched on the underneath starboard side approximately 30 cm from the base of the radome. The LH corner at the top of the cab penetrated the radome leaving an indent of approximately 6 cm to expose the honeycomb interior.(Fig.1)

An incorrect towbar, of insufficient length, was used for the pushback. This was the cause of the incident.

Fig. 1 Damage to Radome of G-MIDH 6cm I---I

The towbar authorised for use with this aircraft type should have a longitudinal separation of at least 1 metre between the nose of the aircraft and the front face of the cab. **(SR 6 of 2000)**
