AAIU Report No. 1999/016
AAIU File No. 19980061
Published 11/06/1999

Aircraft Type and Registration: (i) Lockheed L 1011, CS-TEB
(Civil)
(ii) Learjet LJ35, 40085 (Military)

Name of Operators: (i) Airluxor
(ii) USAFE

Date and Time (UTC): 7th November 1998, 11.15 hours

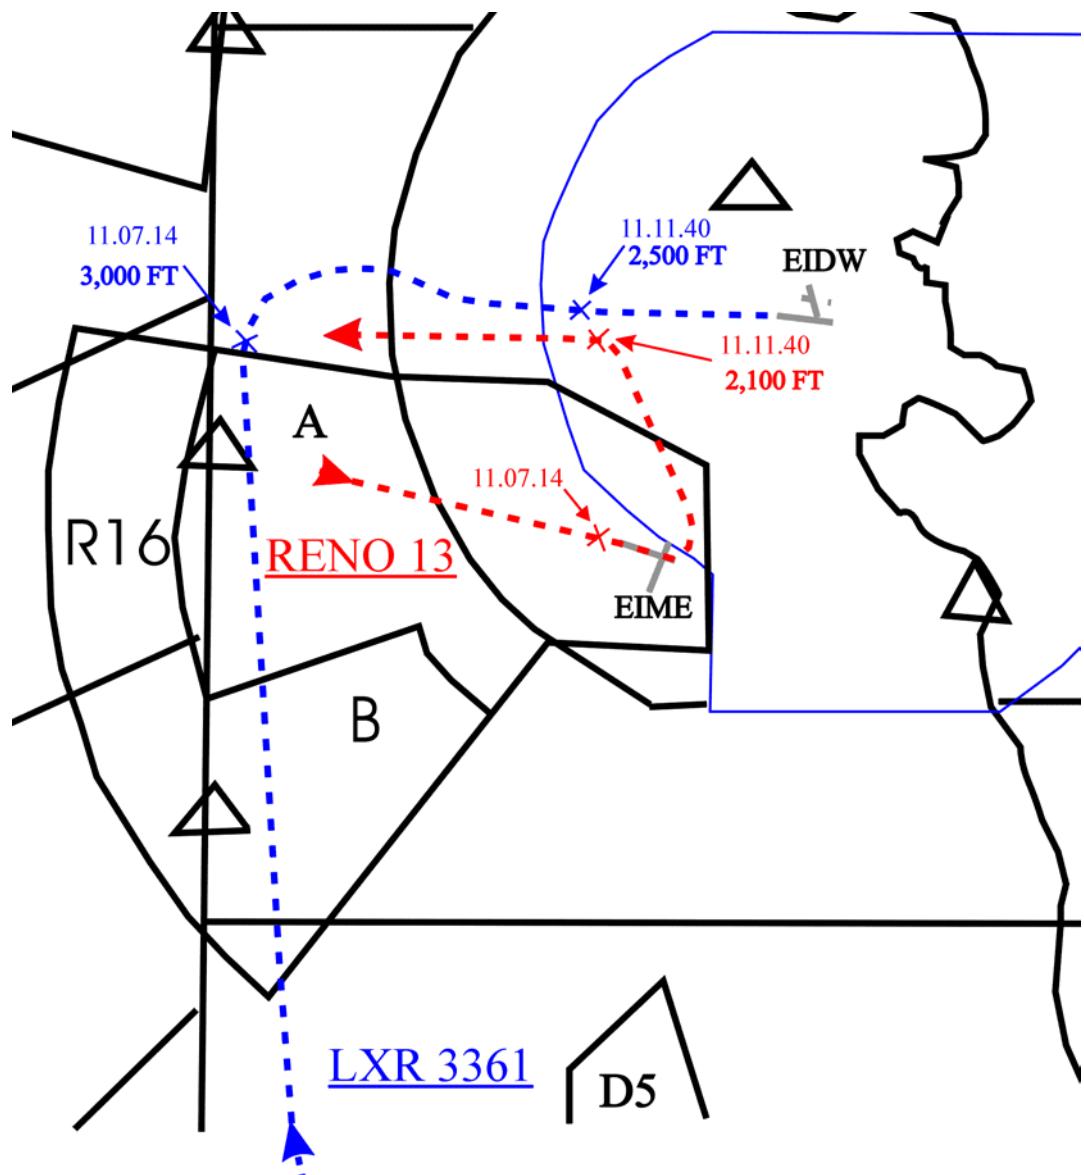
ANNEX A

The military aircraft, having passed the missed approach point, turned left as appropriate and climbed to 2,000 ft. The radar trace of the aircraft's track (see Annex A), indicates that the aircraft did not continue the turn on to a heading of 270° as required, but stopped turning on a heading of 345° with the mistaken intention of intercepting the 292° Radial to Baldonnel VOR. He continued on this heading of 345° and passed through the Dublin Control Zone boundary at about four miles from the Baldonnel VOR. The Dublin Approach controller then contacted military ATC who instructed the military aircraft to turn on to a westerly heading. By the time the military aircraft turned it was within 1.5 nm of the Luxor 3361 flight and approximately 400 ft below that aircraft.

Considering the closing speed of 360kts between the military aircraft whilst on a heading of 345° and the civilian aircraft on the ILS approach, with its vertical profile set, the risk must be considered to be in the "Risk of Collision" category.

**SKETCH SHOWING FLIGHT PATHS OF
RENO 13 AND LXR 3361**
