## REPORT

*AAIU Report No.: 2003/003*

<b>Aircraft Type and Registration:</b>	Augusta A 109E, EI-SQG	
<b>No. and Type of Engines:</b>	Two, Pratt and Whitney 206C	
<b>Aircraft Serial Number:</b>	11084	
<b>Year of Manufacture:</b>	2000	
<b>Operator:</b>	Premier Helicopters Ltd	
<b>Date and Time (UTC):</b>	25 September 2002, 0930 hours	
<b>Location:</b>	Spawell Leisure Centre, Dublin 6	
<b>Type of Flight:</b>	Public Transport	
<b>Persons on Board:</b>	Pilot – One	Passenger – Three
<b>Injuries:</b>	Pilot – None	Passenger – None
<b>Nature of Damage:</b>	Serious damage to main rotor blades	
<b>Commanders Licence:</b>	ATPL	
<b>Commanders Age:</b>	44 years	
<b>Commanders Flying Experience:</b>	5308 hours (of which 45 were on type)	
<b>Information Source:</b>	Aircraft Accident Report Form submitted by the pilot and further AAIU enquiries

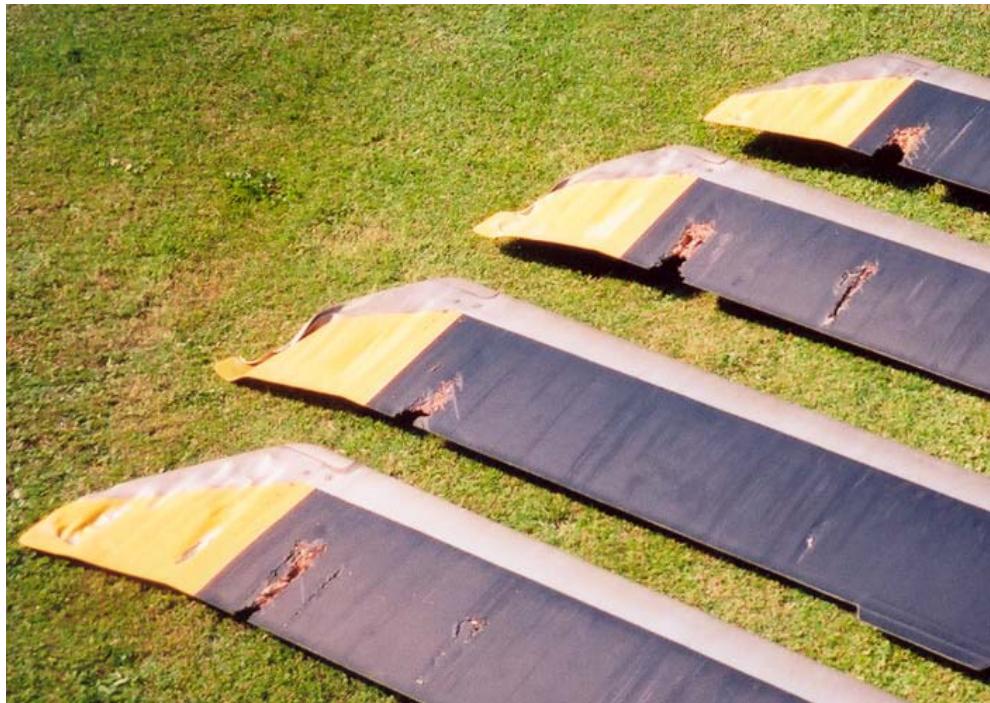
With the passengers on board, the pilot took off to a hover and air taxied his aircraft backwards in order to maximise the length of his take off run. During this manoeuvre the four main rotors struck near the top of a large conifer tree, approximately 15 feet high, a number of which are planted about this golf course. The tail rotor was undamaged as it went abeam the tree and did not touch it.

The four main rotor blades were extensively damaged (see photo). The helicopter's dynamic components also required an inspection as a result of the MR blade impact.

**DISMANTLED MAIN ROTOR BLADES**

The Operator should examine the general suitability of landing locations used by its helicopters for public transport operations. (**SR 4 of 2003**)
