FINAL REPORT

AAIU Report No: 2003-005
AAIU File No: 2001/0039
Published: 11 April 2003

Operator: Private
Manufacturer: Reims Aviation
Model: FA-150 L
Nationality: U.K.
Registration: G-BAOP
Location: Near Athboy, Co Meath.
Date/Time (UTC): 22 June, 2001 at 15:50 hrs

SYNOPSIS.

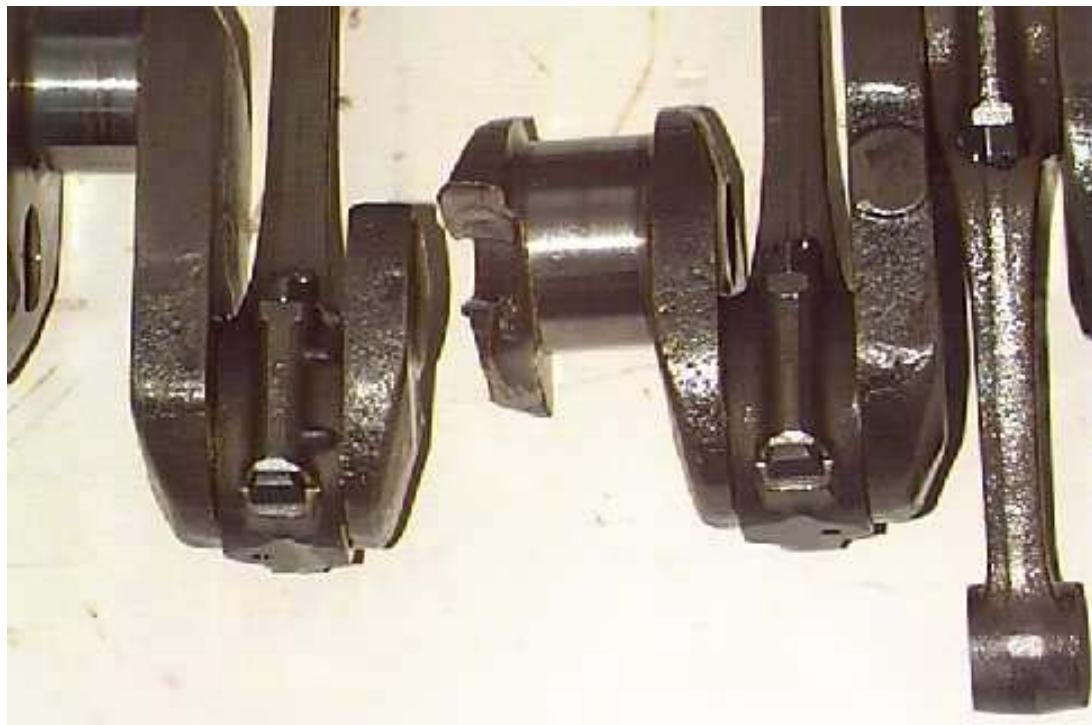
1.16.1 The engine was removed from the aircraft and dismantled. It was established that the crankshaft had failed on the crank between No. 2 cylinder big-end bearing and the central main bearing, at a point where the main bearing section meets the crank. Due to the orientation of the fracture, significant disruption of the innards of the engine occurred when the rear section stopped, and the forward section continued to briefly rotate under the fly-wheel effect of the propeller. The crankshaft failure is shown in Fig 1 of Appendix A.

1.16.2 The crankshaft was removed and subjected to metallurgical examination. This showed that the failure crack had initiated at the junction of the No 2 crank and the central main bearing. Examination also showed that the centre main bearing diameter had been reduced by machining and was then built up by applying flame spray. Flame spray (sometimes known as "Plasma Spray") is a process used to add metal to the surface of a component. The donor metal is fed through a spray gun, often in wire form. A mixture of compressed combustible gas, often oxygen and acetylene, is used to melt this material and it is then blown on to the surface of the component, in atomised form, by the compressed gas. The material is thus deposited on the component. During this process the temperature of the surface of the component can reach 6,500° C to 16,000° C, depending on the precise process used. In the case of a worn crankshaft bearing, this process would be used to build up the crankshaft to the required diameter.

1.16.4 Examination of the applied metal on the centre main bearing also showed that it extended about 40% of the way up the blend-in radius between the main bearing surface and the crank. The applied surface material was found to be flaking off at this junction. It was also noted that applied material was made up of 2 layers. This is normal where flame sprayed material is applied in order to build up a wear resisting surface. The inner layer is a 'key' coat for attachment of the outer layer to the base material. It was also noted that the 'key' coat had not been applied far enough up the radius and that this was the reason for the flaking noted above. It is important to note that the coating ended in a critical region on the surface of the blend-in radius, i.e. where the maximum cyclic stresses occur in service.

1.16.7 Examination of the crankshaft fracture surface showed approximately 150 markers. Each of these markers, which show up as wider bands on the fracture surface, indicates a power cycle, i.e. an increase of engine power from normal to a high setting.

2.6 The absence of a nitrided surface significantly reduced the fatigue resistance of the crankshaft in the critical area of the centre main bearing.

- 3.2.1 The in-flight engine stoppage was caused by the failure of the crankshaft.
- 3.2.2 The failure of the crankshaft was due to the use of unapproved repair procedures, i.e. the use of inappropriate surface preparation, and the application of metal build-up on the main bearing by flame spray. Additionally, the fatigue resistance was compromised due to the absence of a nitriding coating. The crankshaft ultimately failed in fatigue.

**Failed Crankshaft
Fig. 1**

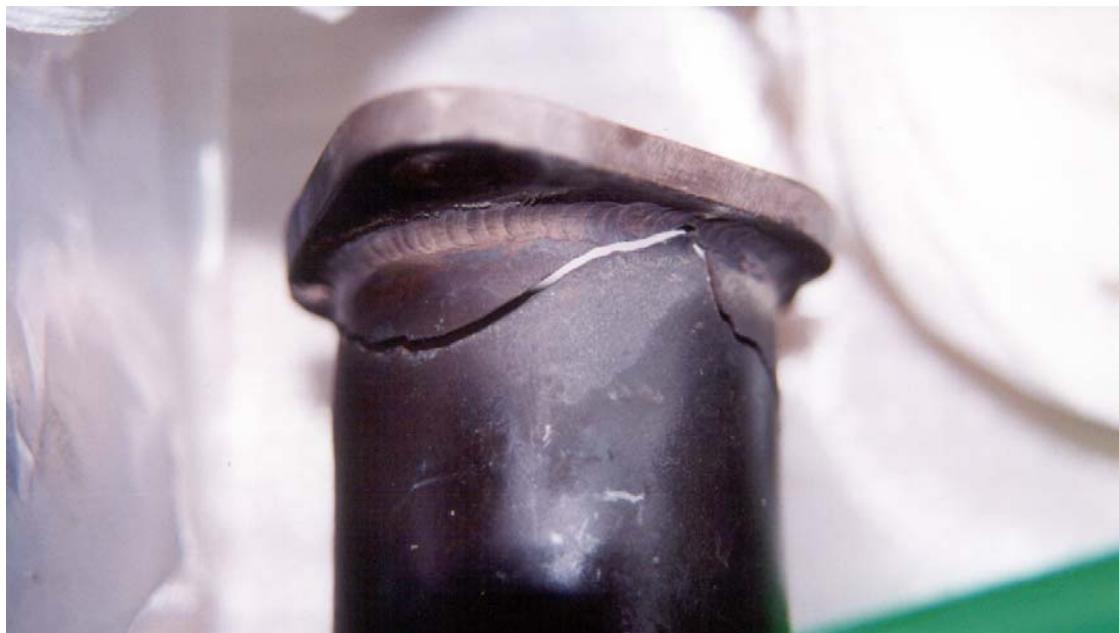
1.16.9 The exhaust stub of No.1 cylinder was found to be badly cracked, and the crack had opened up considerably. This crack displayed the characteristics of high cycle fatigue. There was noticeable exhaust gas staining of the exterior of the stub and the securing studs and nuts. The cracked stub is shown in Fig. 2 and Fig. 3 of Appendix A.

2.14 The high cycle nature of the fatigue crack of the exhaust stub of No.1 cylinder, and the extent of external staining, indicated that the stub had been cracked for a considerable time. The exhaust noise emanating from this crack would have rendered the engine considerably noisier than normal.

**Cracked Exhaust Stub
Fig. 2**

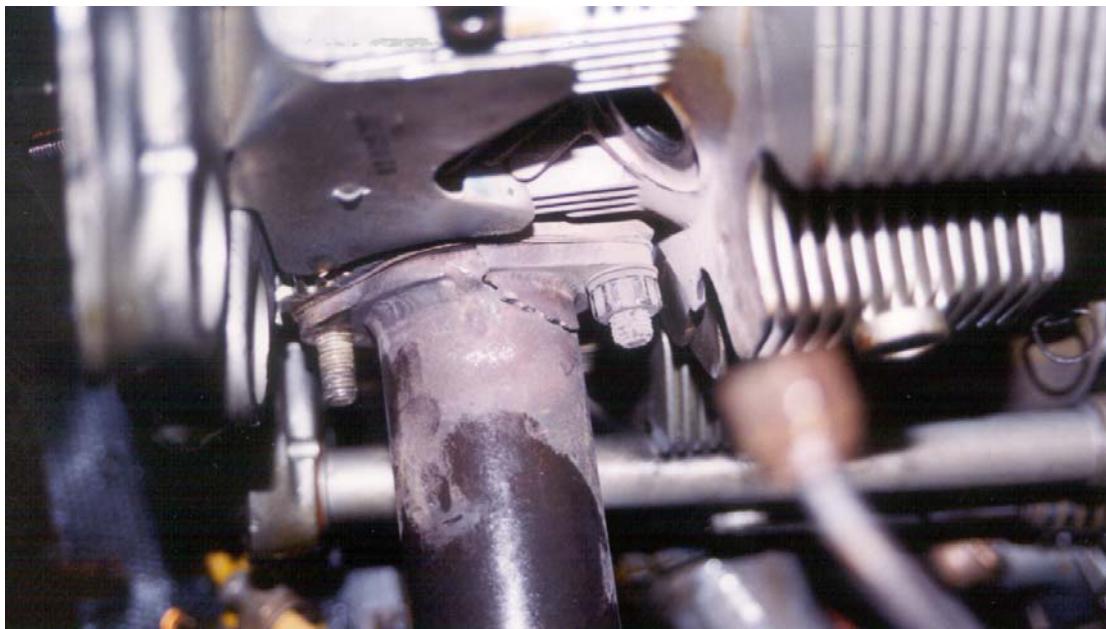
- 2.15** The crack in the exhaust stub could have been detected by careful examination of the engine. This can be seen in Fig 3 of Appendix A.
- 2.16** The damaged propeller blade was bent in excess of 4 times the maximum cold-rolling repair limit, as a result of this accident. It is a concern that an individual in the aviation maintenance business perceived no difficulty in having the propeller straightened and returned to service. This would indicate that the inappropriate repair of the crankshaft is not an isolated event.

Cracked Exhaust Stub
(as found on the engine – the missing nut was removed during the investigation)
Fig. 3

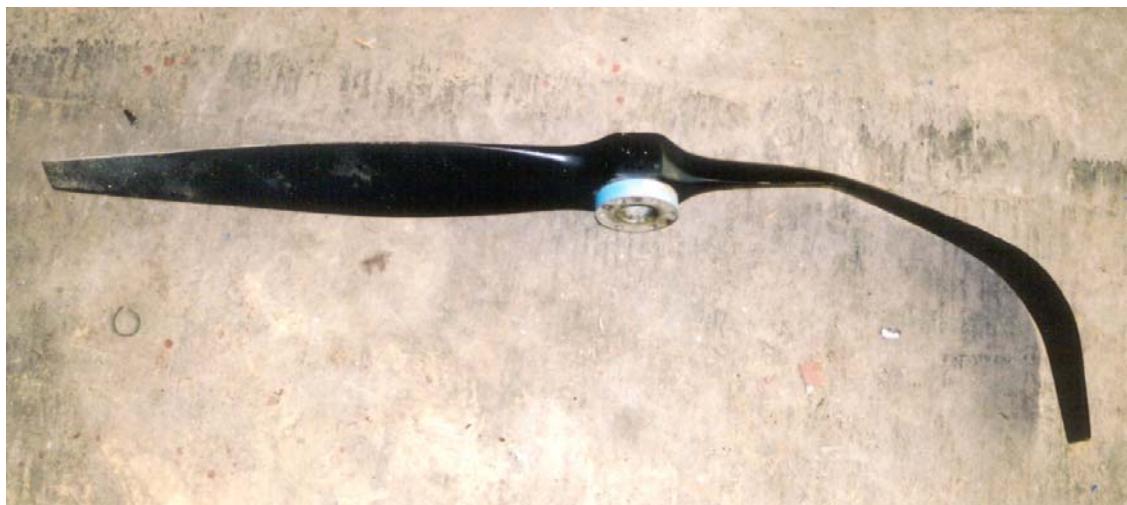
1.18.10 The following is not related to the causes of this accident, but is noteworthy. A prospective buyer of the salvage of G-BAOP, who works in the aviation business in the UK, viewed the aircraft after the accident. He stated to the investigation that he believed the propeller was repairable and saw no problem in straightening it and returning it to service. A photo of the damaged propeller is in Fig 4 of Appendix A. The propeller is bent back approx 85° at the tip. The maximum permissible cold rolling repair limit is 20°. This is laid down by the propeller manufacturer, McCauley, in Figure 4-2 of their overhaul manual, document 730720.

Bent Propeller
Fig. 4
