FINAL REPORT

AAIU Report No.: 2002/008

Operator:	Private
Manufacturer:	New Piper Aircraft Company
Model:	PA 28 – Cherokee 180
Nationality	British
Registration	G-AYPJ
Location	Weston Aerodrome
Date/Time UTC	26 April 2002 at 0730 hrs

SYNOPSIS.

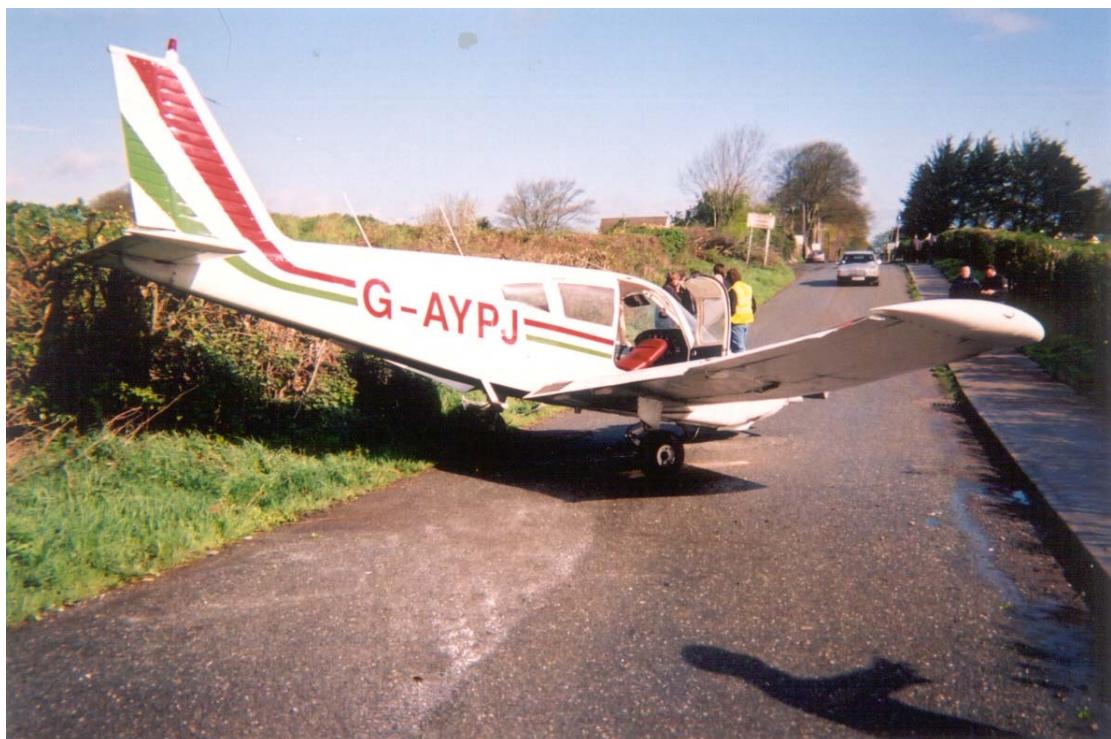
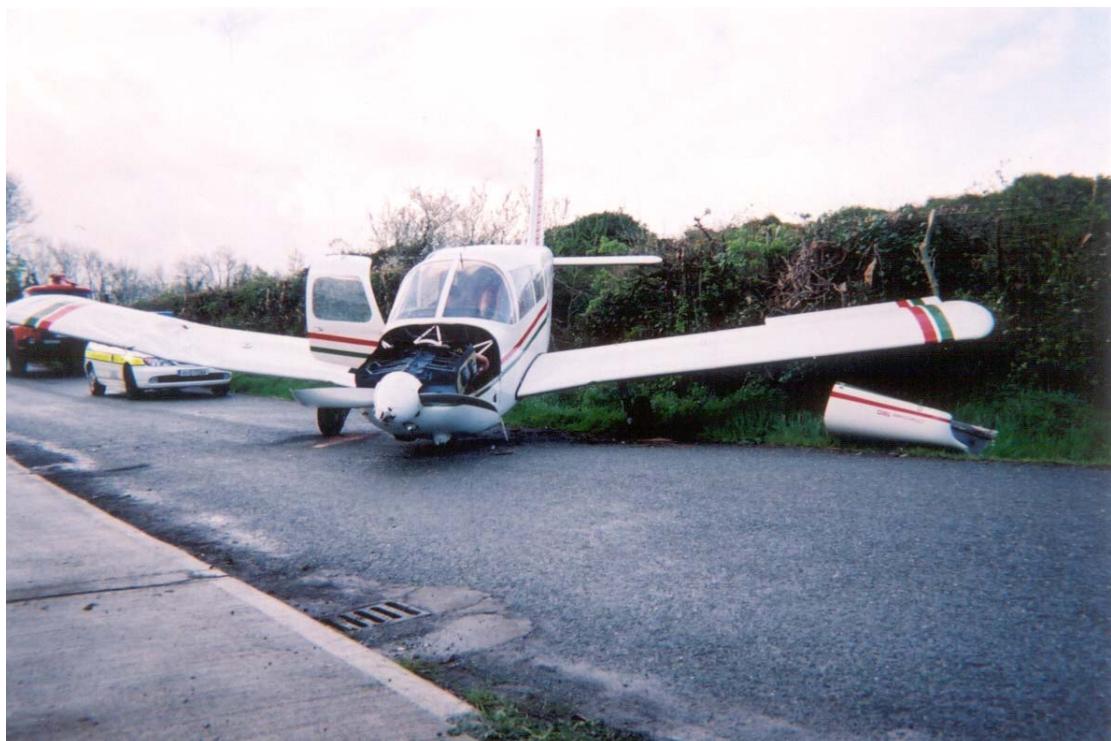
The nose wheel was sheared off on impact with an earth bank and was contained within the hedgerow. Leading edge damage, skin puncture and distortion to the starboard wing was caused during the aircraft's transition through the hedgerow and on to the road below. The propeller was bent as a result of the aircraft's transition through the hedgerow and the subsequent impact with the road. The aircraft was subsequently written-off by the insurers.

The aircraft suffered extensive damage as a result of its impact and transition through the hedgerow/bank and the impact with the road below.

Final resting position of G-AYPJ on Cooldrinagh Lane
