AAIU Report No. 2000-007

| Aircraft Type and Registration: | Piper PA18-150, EI-CIG |

SYNOPSIS

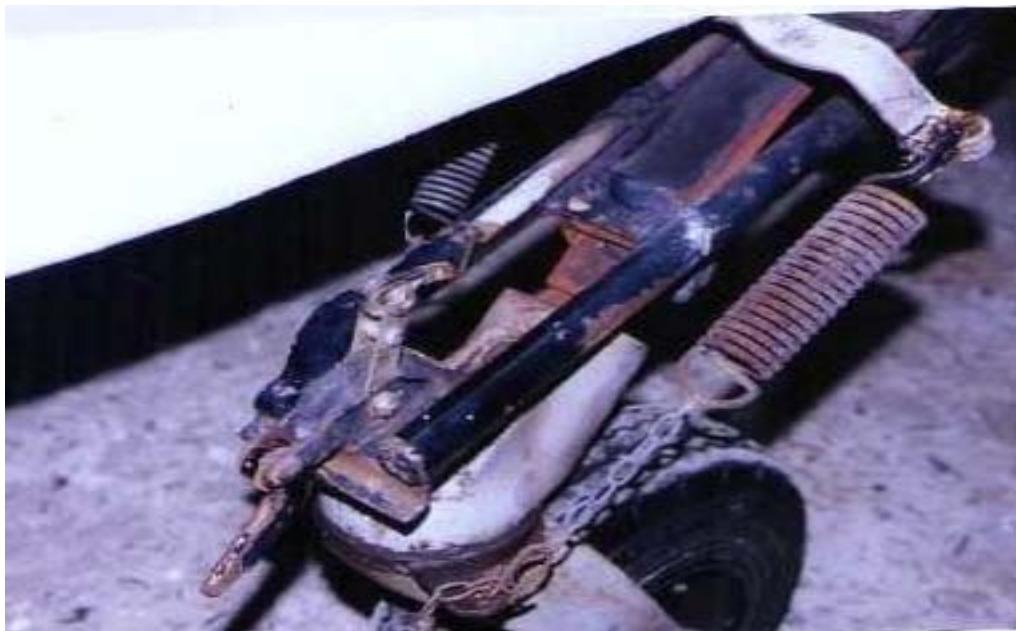
The tow release mechanism (tow hook) and its mounting fixture are attached to the tail of the aircraft (Fig.1). The release mechanism serves as the point of attachment of all trailing equipment and release is remotely operated by cable from the cockpit (Fig.2).

FIG.1 Tow Hitch attached to rear of EI-CIG.

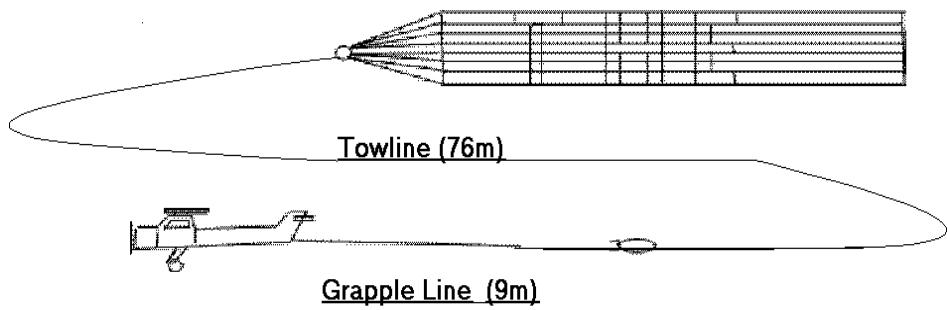
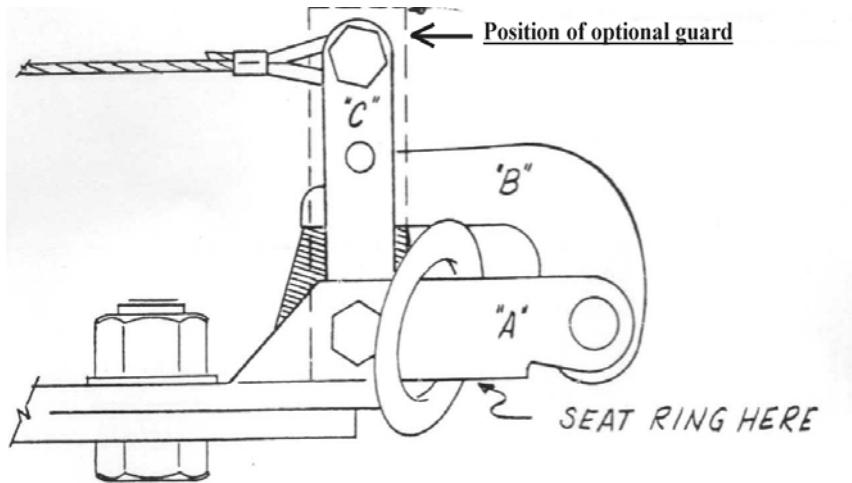
This release mechanism is shown at Fig. 2. When the pilot pulls the cable in the cockpit the resulting tension in the cable causes the latch arm (C) to move forward, thus releasing the "pelican hook" (B) from its rubber mounting. The ring attached to the cable assembly is thus free to drop from the aircraft and the banner with it.

However, it is possible that if the rubber block were worn then in-flight vibration could cause the latch arm to move forward, releasing the pelican hook and with it the banner assembly. The latch arm has only to move 15 degrees to effect release and if the rubber was worn this angle would be even less.

Again, if the cable assembly ring got on to the pelican hook, prior to the in-flight banner pick up, it is possible that the latch arm could be nudged forward. In-flight vibration, plus the drag of the whole banner assembly on the pelican hook, could cause that hook to dislocate from the latch. The installation of the recommended guard could have minimised this likelihood however.

Fig 2 Take off position of hook and (above), general arrangement of towline in flight.

- 4.1** The banner manufacturer's suggestion of a modification regarding a locally made guard to cover the latch arm should be considered by the Operator. (**SR 7 of 2000**)
- 4.2** The release mechanism should be inspected annually and the rubber block replaced. This should be recorded in the aircraft logbook. (**SR 8 of 2000**)
- 4.3** The installation of a release mechanism having a more positive locking device should also be considered as an alternative to the one installed. (**SR 9 of 2000**)

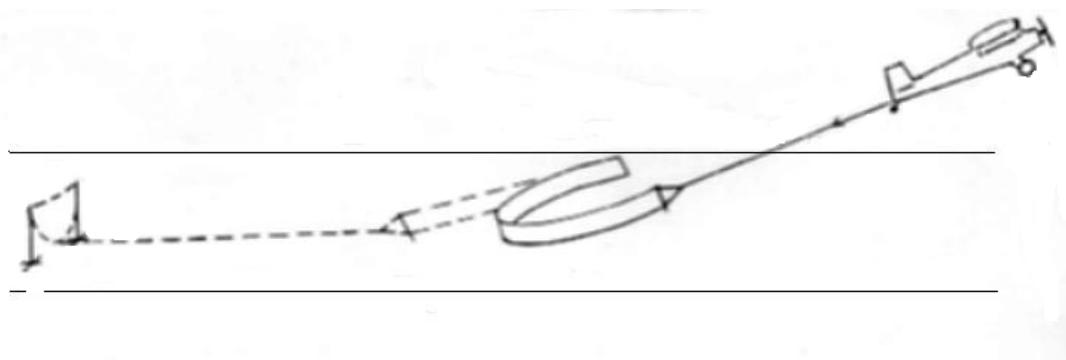
The endless loop of the towline is placed atop two poles placed at right angles to the aircraft approach path and 5M to 6M apart. (See Fig 3). The aircraft approaches with the cable assembly and grapple hook deployed. The loop of the towline is caught by the hook as the aircraft climbs away sharply at full power. From then on, the banner can only be released either through breaking of the safety line (tension greater than 340 kg) or through the operation of the release mechanism.

Fig 3 Sketch of Aerial Pickup.
