*AAIU Synoptic Report No.: 2003-009*

<b>Aircraft Type and Registration:</b>	Piper PA 22-135	N2652P
<b>No. and Type of Engines:</b>	One Lycoming O-290	
<b>Aircraft Serial Number:</b>	22-2992	
<b>Year of Manufacture:</b>	1955	
<b>Date and Time (UTC):</b>	23 August 2002, 13.00 hours	
<b>Location:</b>	RWY 34, Hacketstown Airstrip, Co. Carlow	
<b>Type of Flight:</b>	Private	
<b>Persons on Board:</b>	One	
<b>Injuries:</b>	No reported injuries	
<b>Nature of Damage:</b>	Aircraft inverted, damage to port wing braces and engine.	
<b>Commanders Licence:</b>	PPL	
<b>Commanders Age</b>	54 years	
<b>Commanders Flying Experience:</b>	355 hours	
<b>Information Source:</b>	Information supplied by the pilot of N2652P AAIU Investigation

## **SYNOPSIS**

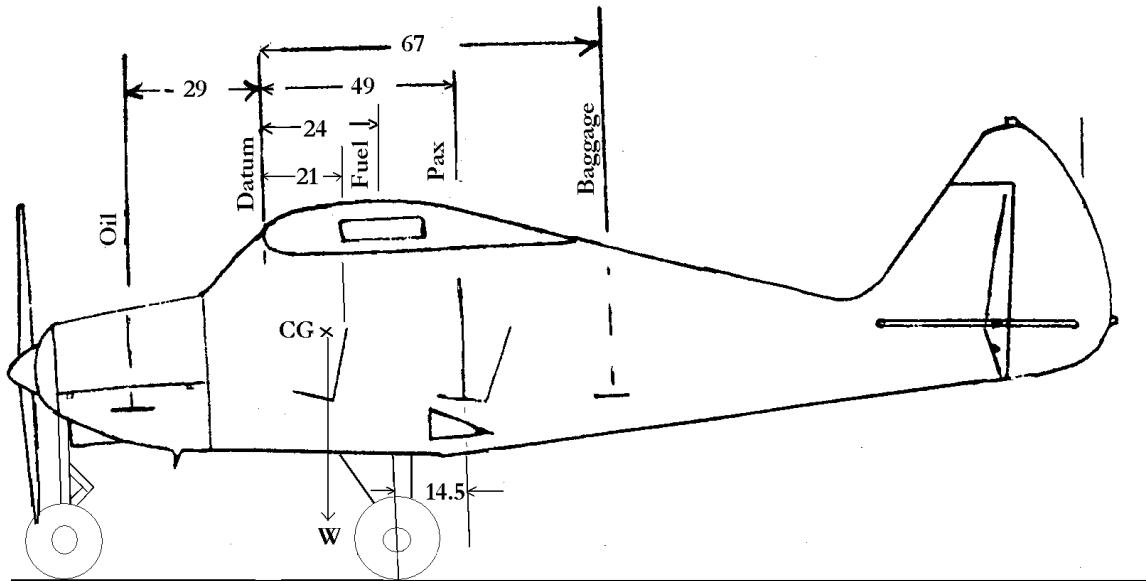
Above: The original position of the nose and main undercarriage of the PA 22-135 aircraft

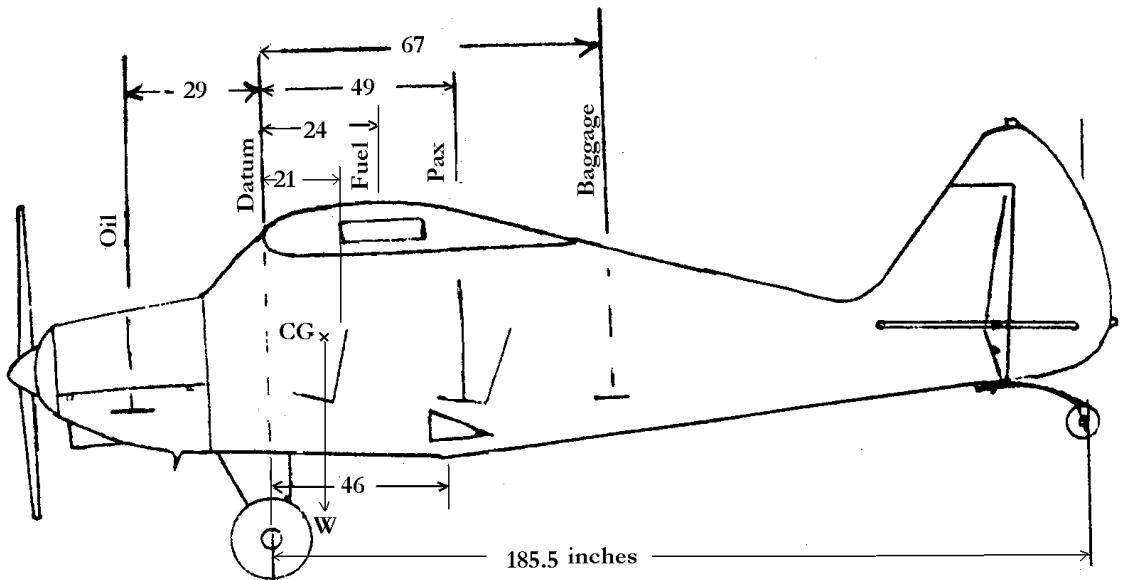
With this type of aircraft, a high CG and narrow spaced wheels increases the tendency for the aircraft to tip over on the ground when turning, when brakes are applied to stop, or when high power is applied on take-off. A high thrust line also increases the tendency to pitch over on its nose when high power is applied, especially with the application of brakes. The high keel surfaces also allow crosswinds to have a greater destabilising effect.

Since 1995 the pilot's number of hours flown have been steadily decreasing. In 2002 the pilot had flown only 3.55 hours in this aircraft. It is difficult to retain currency under these circumstances particularly with a tail wheel aircraft. On take off, with the CG so near the main wheels, braking will tend to pitch the CG forward about the braked wheels thereby pulling the nose of the aircraft down.

Below: The main undercarriage position moved forward 31.5 inches following the modification to the PA 20-135 configuration.
