AAIU Synoptic Report No. 2003-008

Aircraft Type and Registration: AVRO RJ 100 G-BXAR

Nature of Damage: Engine Cowl Separated in Flight

SYNOPSIS

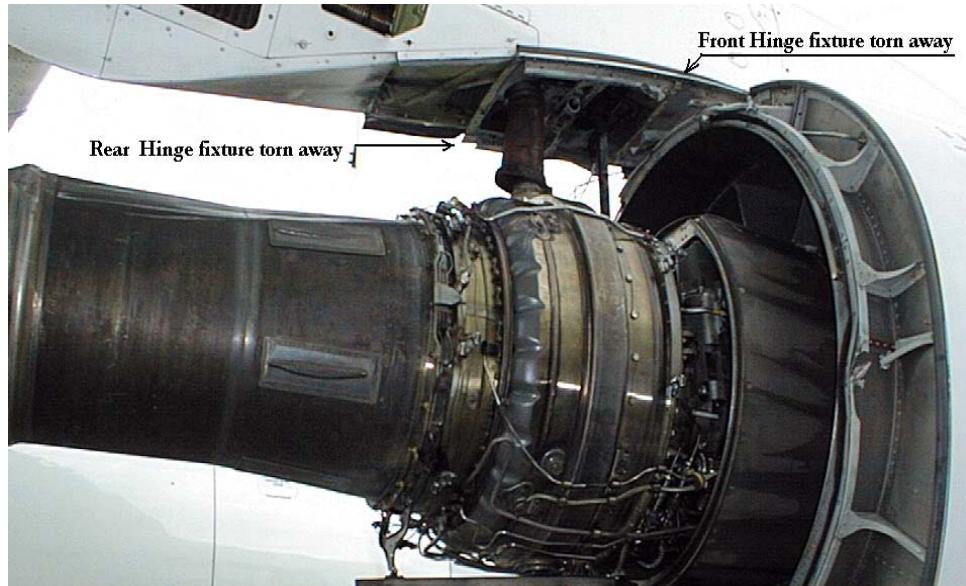
Post flight inspection revealed that the No 2 engine rear fan (Zone 2) cowling doors were missing along with the exhaust cone cowling. The engine jet pipe was damaged and the thermocouple leads torn off. Both zone 2 hinge fixings were missing from the underside of the aft portion of the shoulder cowl. The forward fixing had been ripped away from the shoulder cowl in a downward direction leaving a row of holes where the rivets had pulled through whilst the rear hinge fixing had moved aft, shearing all the retaining rivets. Both door maintenance stays had been ripped away at the attachment point to the fire proof bulkhead. There was no visible damage to the flaps, fuselage or wing structure.

Both hinge fixings broke away from the underside of the aft portion of the shoulder cowl causing the No 2 engine rear fan cowling doors to separate from the aircraft along with the exhaust cone cowling.

- Structural failure of the forward upper attachment of the cowl to the shoulder cowl possibly as a result of engine sudden stoppage on a previous occasion.
- Upper hinge pip pin working loose or not being fitted following previous maintenance.
- The cowling had not been fitted or closed correctly following maintenance.

Above: Photo of No. 2 engine showing top shoulder from which the transverse fixture and cowling doors, complete with exhaust cone cowling, were torn away, the front rivets being pulled out vertically and the rear rivets pulled rearwards in shear.

4.1 The aircraft manufacturer should advise operators to conduct a visual inspection of the shoulder cowl assembly, including cowling attachment points, during an engine change. (**SR 17 of 2003**)

4.2 The aircraft manufacturer should amend the Maintenance Manual to include a structural inspection of the pylon after a sudden engine stoppage. (**SR 18 of 2003**)

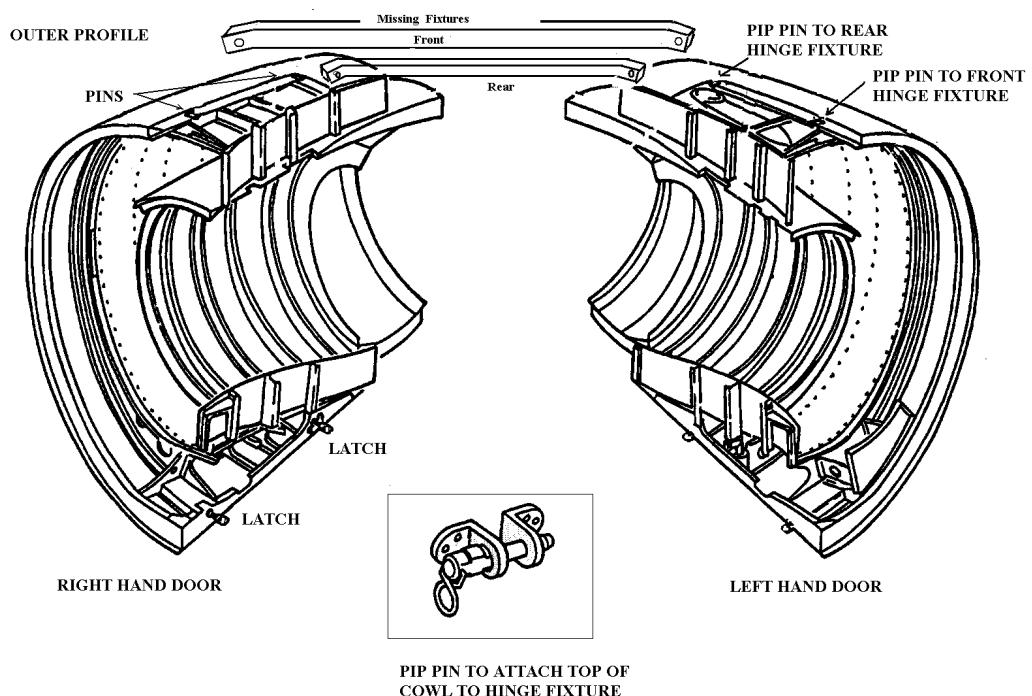
Above: Sketch of missing cowling doors showing their attachment points to the missing transverse top shoulder fixtures.
