AAIU Report No.2001-009

Aircraft Type and Registration:	Robinson R22 Beta, EI-CFX
No. and Type of Engines:	One, Lycoming 0-320-B2C
Aircraft Serial Number:	0793
Year of Manufacture:	1988
Date and Time (UTC):	11 April 2001, 1414 hours
Location:	Weston Aerodrome, Co. Kildare
Type of Flight:	Private (Training)
Persons on Board:	Crew – two
Injuries:	Crew – none
Nature of Damage:	Tail boom severed following strike by main rotor blade
Commanders Licence:	Commercial Pilot's Licence (Helicopter)
Commanders Age:	40 years
Commanders Flying Experience:	1685 hours, all types
Information Source:	Watch Manager, Dublin Airport. AAIU Report Form submitted by pilot

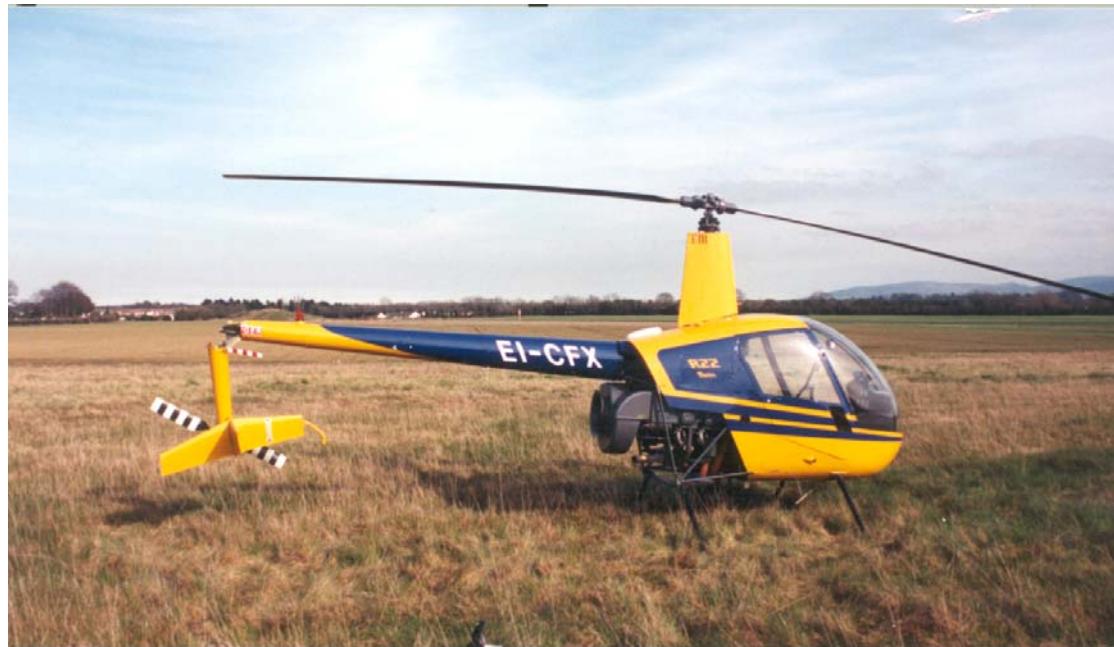
At the end of the approach the pupil flared the helicopter excessively, causing total airspeed loss and the aircraft to sink vertically. The instructor took control to assist in the recovery but the aircraft bounced slightly on ground impact, resulting in both forward and aft pitch movements. A loud bang was heard and some other noise also.

AAIU examination of the helicopter showed that the tail boom had been struck and severed by the main rotor.
