**AAIU Report No. 2001-005**  
**AAIU File No. 19990080**  
**Published: 19/04/2001**

**Name of Operator:** Royal Jordanian Airlines  
**Manufacturer:** Airbus  
**Model:** A310-300  
**Nationality:** Jordanian  
**Registration:** JY-AGK  
**Place of Accident:** Shannon Airport, Ireland  
**Year of Manufacturer:** 1991  
**Date/Time :** 16.09 hrs UTC; 27 December 1999

## **SYNOPSIS**

While landing in Shannon, the aircraft bounced and landed heavily on the nose wheel, causing extensive damage to the forward fuselage frames in the nose wheel area.

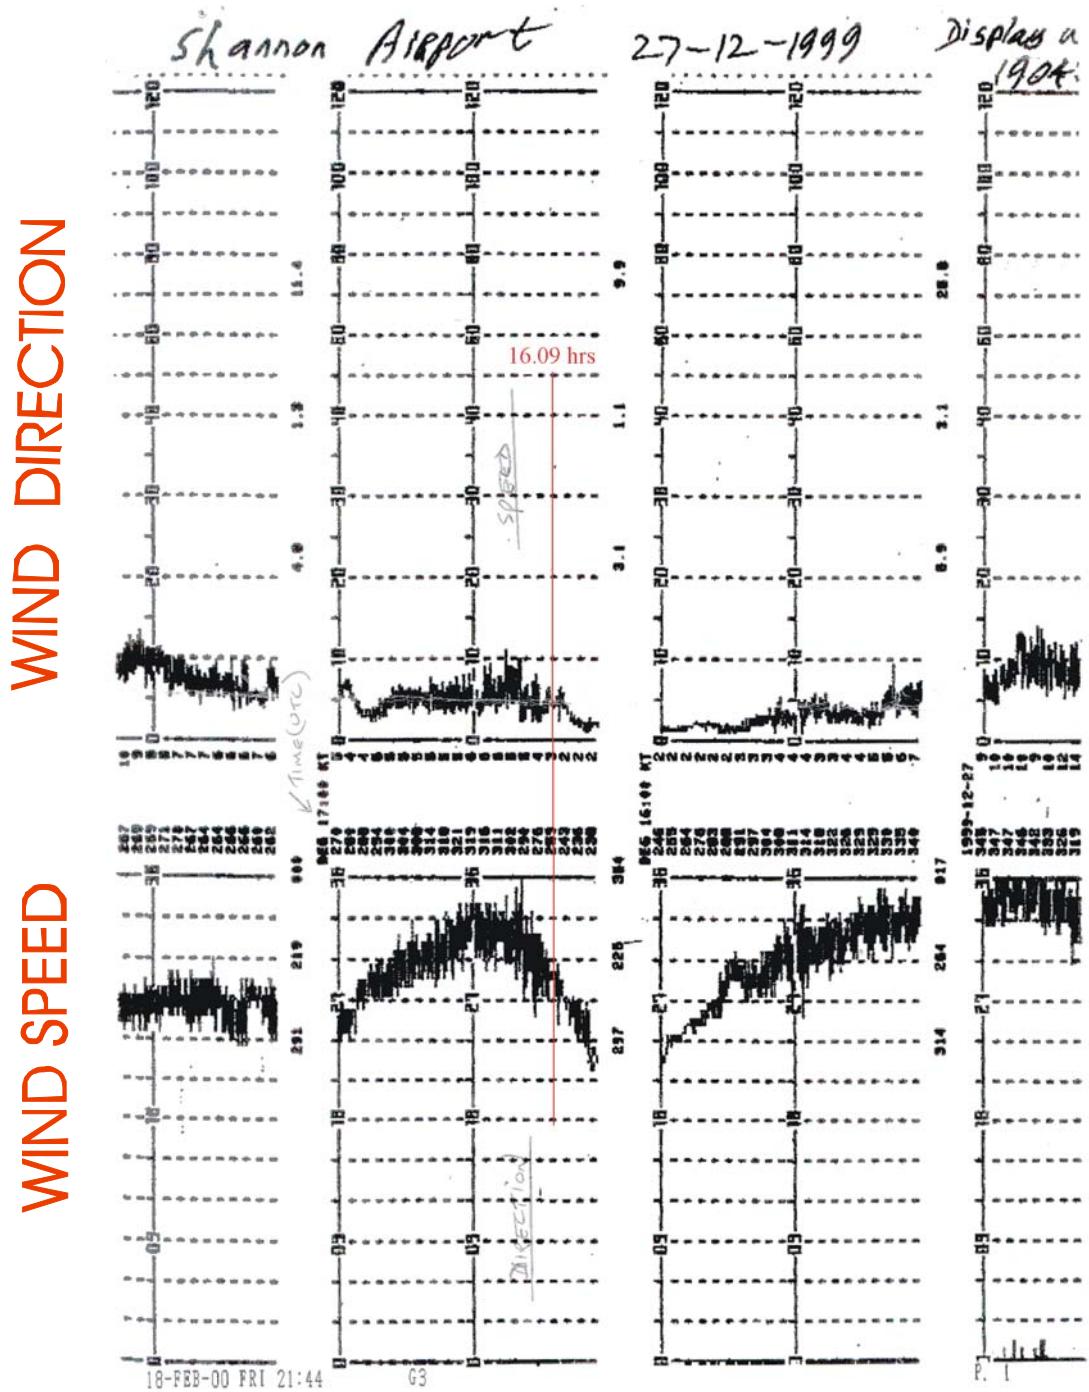
## ANNEX A

These recordings show that the wind speed did not exceed 5 kts between 15.30 and 16.15 and did not exceed 10 kts between 16.15 and 16.30. At 16.09 it was 270° at 3 kts.

The recorded wind direction at 15.45 was 290°. It gradually backed to 260° by 16.00 and then veered to 315° by 16.30. At 16.09 it was 285°.

**2.4.1** The recordings of the anemometer, located close to the runway in use, gave no indications of winds exceeding 5 kts for at least 6 minutes before or after the event. The wind for 1 hour either side of the event did not exceed 10 kts. Furthermore, there are no indications of sudden changes of wind directions. Preceding and subsequent aircraft did not pass any comments on weather conditions to Shannon ATC.

Shannon Anemometer B wind speed and direction data as recorded on 27 December 1999 from 15.00 to 17.00 hrs UTC

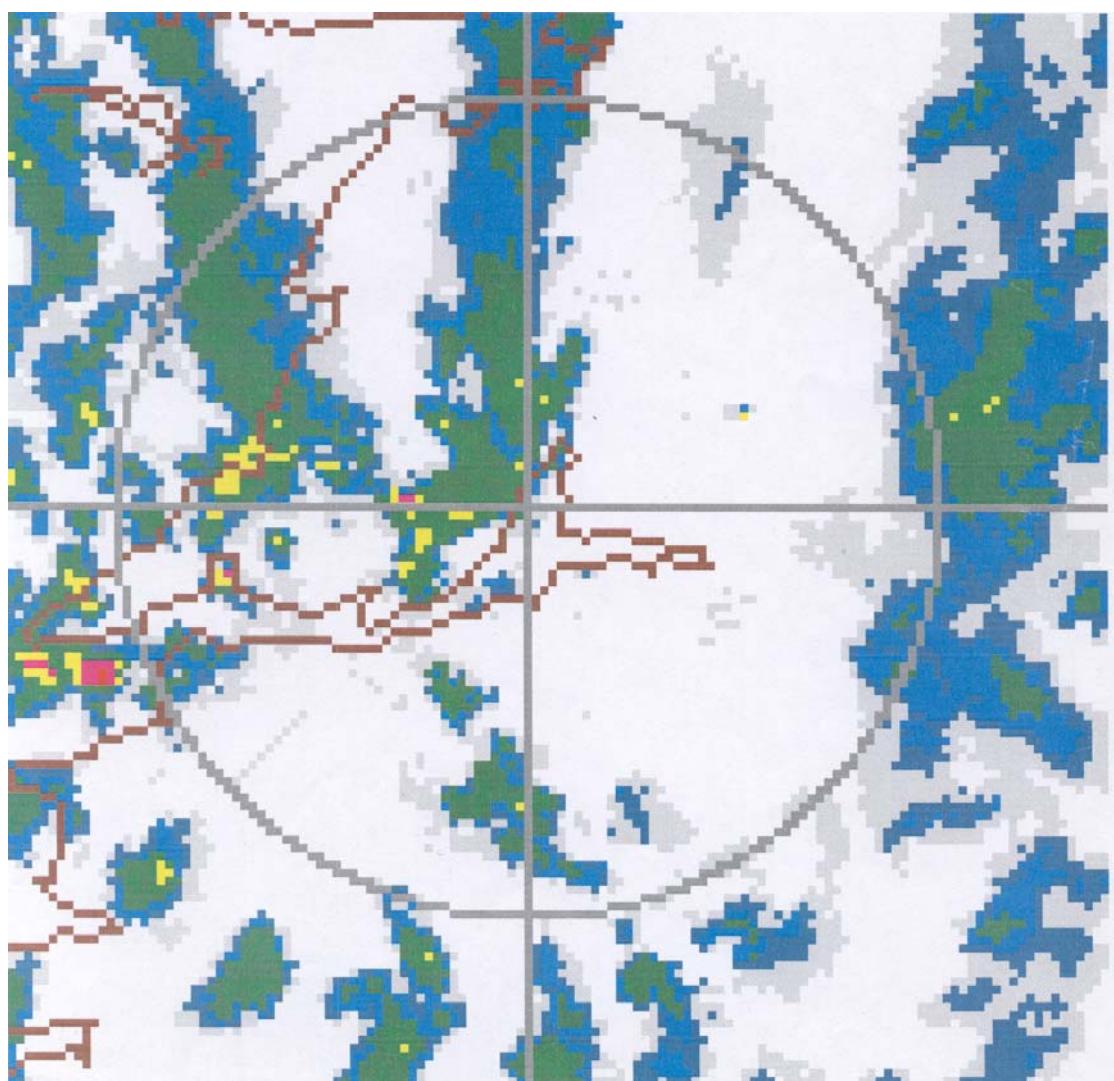
## ANNEX B

*There was Cb activity in the vicinity of the aerodrome at the time of the incident, as indicated by radar analysis and the METAR report for 1600 UTC. However, the shower activity from these Cb's was registered by radar at a maximum of 3.7 mm/hour, a rate sufficient to produce light to moderate showers. Such showers would not be expected to produce severe downdraughts. This contention is supported by the fact that no gusts were reported in the METARs around the time of the incident.”*

Shannon weather radar as recorded at 16.01 hrs UTC on 27 December 1999

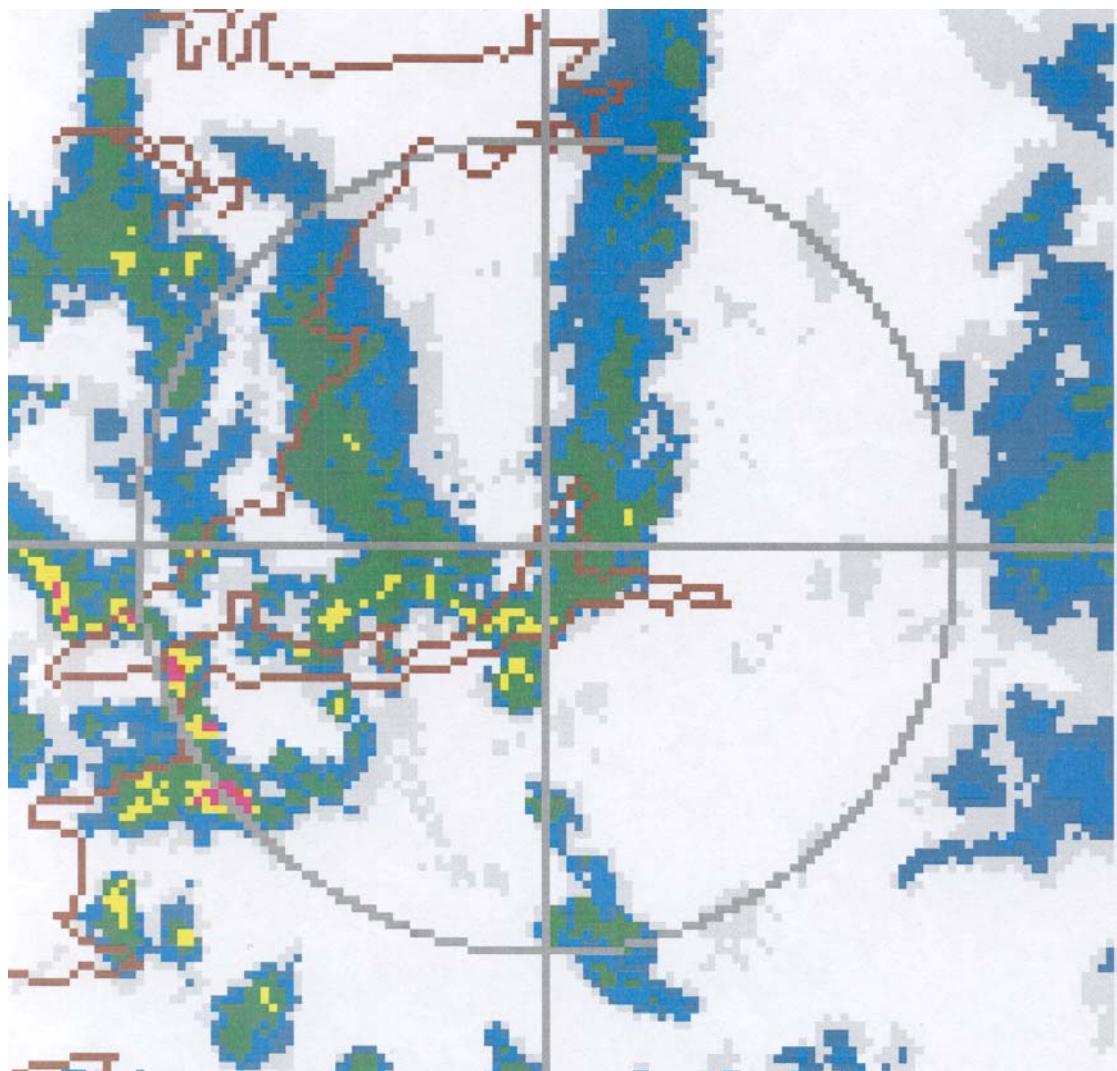
## ANNEX C

Shannon weather radar as recorded at 16.16 hrs UTC on 27 December 1999
