AAIU Report No: 1998-001

Operator: Emerald Airways

Aircraft Type: HS 748-2A

Place of Accident: Stand 55, South Apron, Dublin Airport.

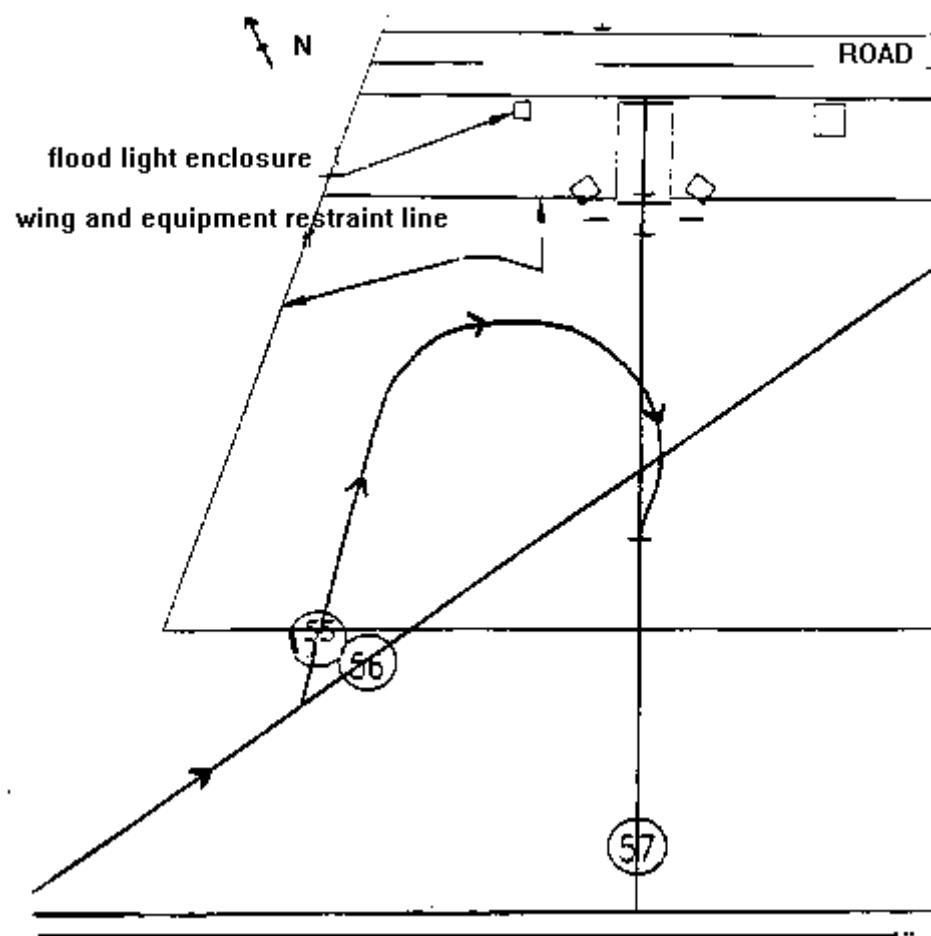
FIG 1

Stand 55 is one of two Stands approved for self-manoeuvring operations on the South Apron and requires a right hand 180° turn onto the Stand, (Fig 1).

Self Manoeuvring Stand 55
South Apron Dublin Airport

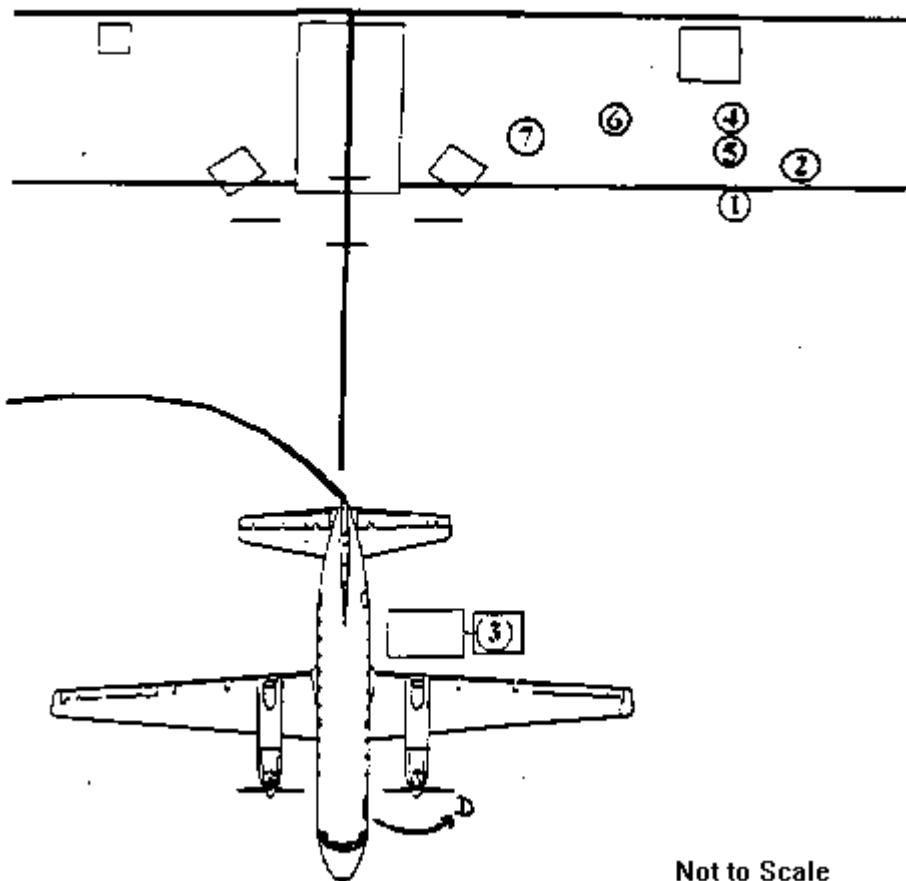
FIG 2

Personnel who were on or in the general vicinity of the stand on the night in question were interviewed over a number of days after the accident. The accounts of where each person and their related equipment was positioned at the time of the accident varied slightly, therefore the positions given in (Fig 2) are deemed to be their most probable positions.

Most Probable Position of Witness Stand 55

Witness No. 1	By Tug at equipment assembly point
Witness No. 2	Walking from car to conveyor at equipment assembly point
Witness No. 3	On Tug and Dolly behind wing
Witness No. 4	On Tug and GPU at equipment assembly point
Witness No. 5	On Tug and GPU at equipment assembly point
Witness No. 6	On conveyor at equipment assembly point
Witness No. 7	Reversing on Tug to hook up trolley at equipment assembly point
 Witness D	 Deceased

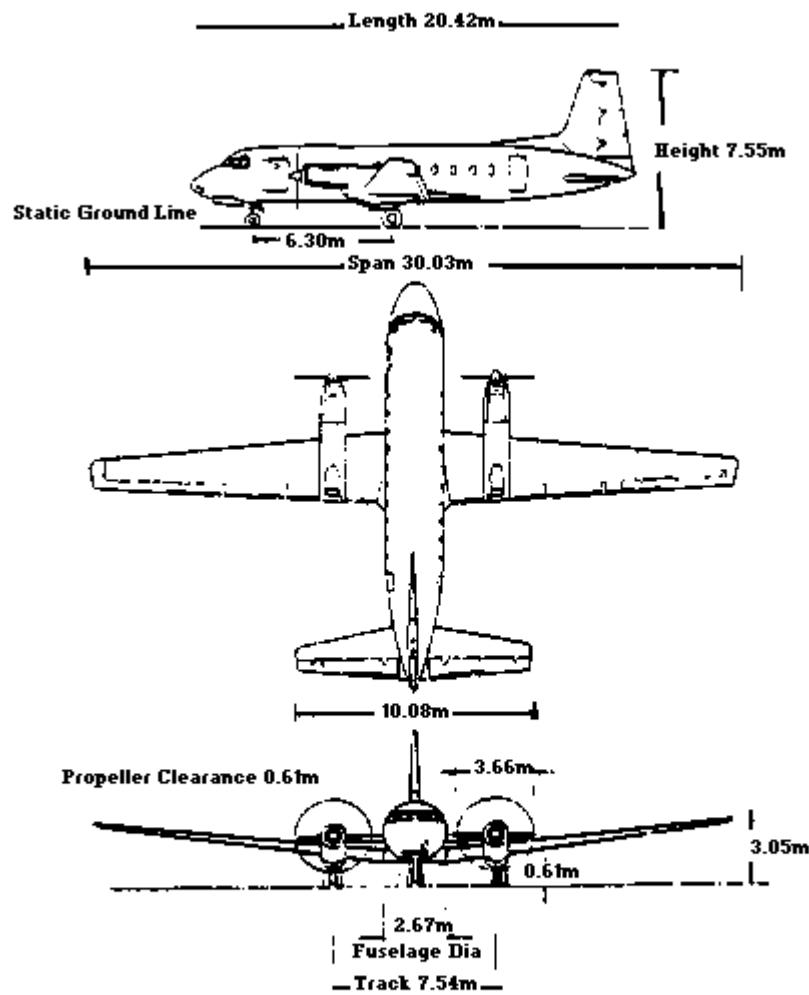
The HS 748 2A is a low-wing cantilever monoplane with a turboprop engine mounted on each wing in a nacelle, that also incorporates a main landing gear bay. The four bladed propellers are of constant-speed/fully-feathering type, and rotate in a clockwise direction when viewed from the front with a normal ground idle speed of 650 rpm approximately. The diameter of the rotating propeller is 3.66m with a ground clearance of approximately 0.61m with the aircraft static on its landing gear. The distance from the fuselage to the inner propeller tip is 0.61m, to the propeller spinner 2.44m and to the outer propeller tip 4.27m, (**Fig 3**).

These dimensions are
approximate due to tyre
and aero deflection

Principle Dimensions HS 748
