AAIU Report No:2003-017
AAIU File No: 2003/0009
Published: 19/12/2003

Aircraft Type and Registration:	Cessna 182P	EI-BCL	CAP 10C	G-CPXC
No. and Type of Engines:	One Continental O-470-S	One Lycoming AEIO-360-B2F		
Aircraft Serial Number:	182-64300		301	
Year of Manufacture:	1976		2002	
Date and Time (UTC):	15 February 2003 at 1400 hrs			
Location:	Kilrush, Co. Kildare			
Type of Flight:	Ground Accident			
Persons on Board:	Two		None	
Injuries:	None reported		None reported	
Nature of Damage:	Damage to propeller and engine		One-piece wing destroyed	
Commanders Licence:	Irish PPL		N/A	
Commanders Age:	51 years		N/A	
Commanders Flying Experience:	Total: 111 hours	On Type: 10 hours	8 hours	N/A
	On Type P1	Previous 30 days	45 Min	
Information Source:			Operator of CAP 10C aircraft

SYNOPSIS

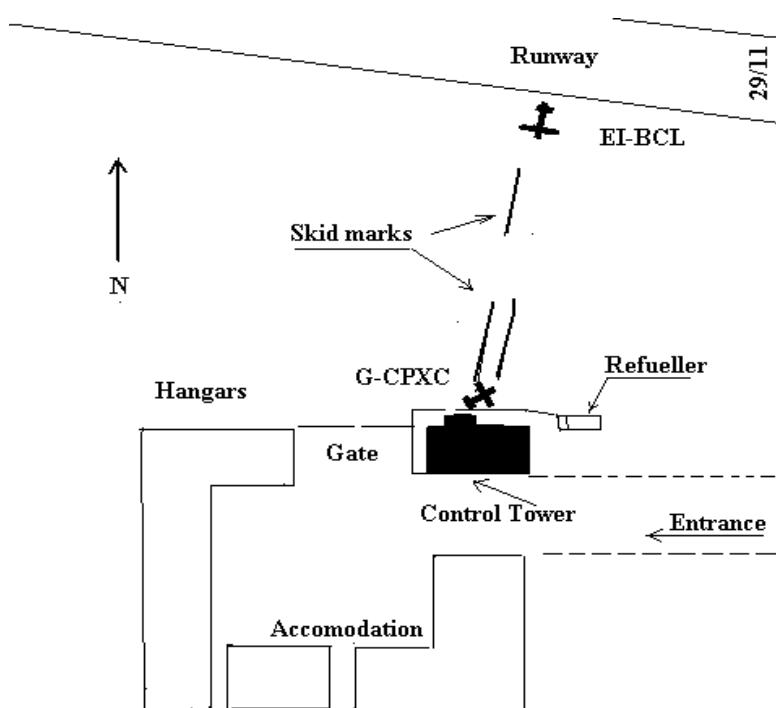
EI-BCL, which was almost at the left edge of Runway 29/11, was facing south towards the control tower which was about 39 metres away. G-CPXC was parked beside the control tower and was being refuelled by its owner at the time. The wind was 130° at 12 knots.

Prior to engine starting, the aircraft, with brakes off and unchocked, was facing towards the refueller, control tower and G-CPXC. Whilst starting the engine, the pilot lost control of his aircraft on the ground as it slid across the grass. It impacted G-CPXC which was being refuelled at the time and destroyed the port wing .(see sketch below)

Site of the accident, showing relative position of the two aircraft prior to the collision.
(not to scale)
