FINAL REPORT

AAIU Synoptic Report No: 2003-019
AAIU File No: 2000/0033
Published: 21/12/2003

Aircraft Type and Registration:	Socata-Aerospatiale Rallye 893E EI-BFM	
No. and Type of Engines:	One Lycoming O-360	
Aircraft Serial Number:	12958	
Year of Manufacture:	1977	
Date and Time (UTC):	15 May 2000, @ 18.30 hrs	
Location:	Coonagh Airfield, Co Limerick	
Type of Flight:	Private	
Persons on Board:	Crew - 2	Passengers - 0
Injuries:	Crew - 0	Passengers - 0
Nature of Damage:	Aircraft was economic write-off	
Commander's Licence:	PPL with Class 1 Instructors rating	
Commander's Age:	57 years	
Commander's Flying Experience:	1900 hours of which 30 were on type	
Information Source:	AAIU Field Investigation and pilots' reports

SYNOPSIS

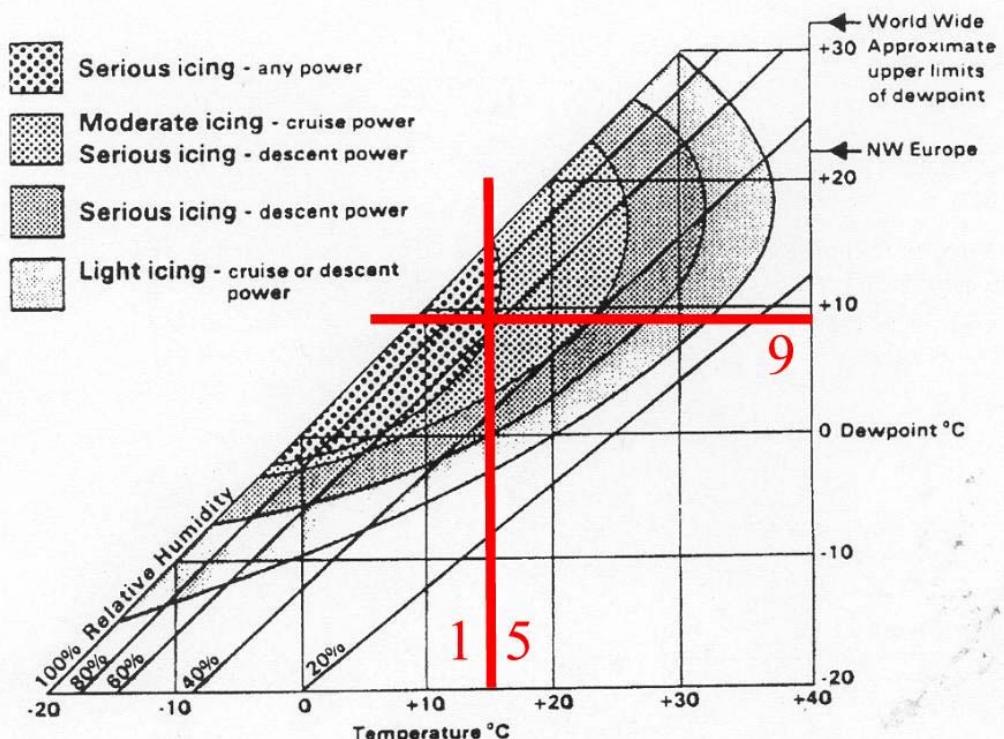
Appendix A

The Dew Point and the Outside Air Temperature, as recorded at Shannon Airport, were plotted on the standard chart for determining the possibility of carburettor icing. [Ref: **IAA Aeronautical Information Circular (AIC) No. 11 of 1997: Induction System Icing on Piston Engines as Fitted to Aeroplanes, Helicopters and Airships**]. The result of this plot is shown in **Appendix A**.

2.4 The plot of air temperature and dew point, based on the data available from nearby Shannon Airport, show that the ambient conditions were just on the edge of the zone where serious carburettor icing could be expected at any power setting. The fact that the carburettor heat had been exercised immediately before take-off would have reduced, but not have eliminated, the risk of carburettor icing on take-off. Because of the power loss associated with the use of carburettor heat, and the short length of the airstrip at Coonagh, the use of any degree of carburettor heat on the actual take-off run would not have been appropriate.

**Extract from IAA Aeronautical Information Circular (AIC) No. 11 of 1997,
with the local data for this accident superimposed**

4.1 The operators of airfields with piston-engined aircraft operating from short runways, such as Coonagh, should consider the installation of equipment to measure both temperature and dew point, so that an accurate prediction as to the likelihood of carburettor icing can be made by pilots. **(SR 33 of 2003)**
