FINAL REPORT

AAIU Report No: 2003/020
AAIU File No: 2002/0027
Published: 23/12/2003

Operator: Private
Manufacturer: Grumman
Model: G 21A/JRF Goose (Amphibian)
Nationality: USA
Registration: N4575C
Location: Knock International Airport
Date/Time (UTC): 26 May 2002 at 14.09 hrs

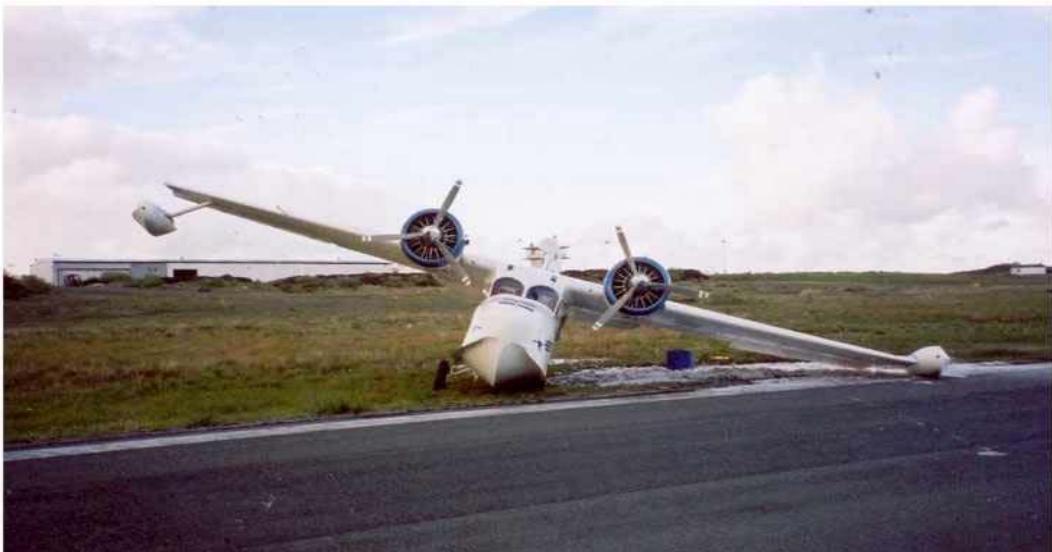
As a result of the left undercarriage collapse, the left lower fuselage came into contact with the ground and suffered damage. The main fuselage frame, supporting the undercarriage and forward wing attachment points, suffered compression damage on the left side. The fuselage skin buckled above the cockpit. The lower left undercarriage doors were also torn off. The left retracted wingtip float was extensively damaged by ground impact, and the outer section of the left wing was deformed upwards.

Fig 2². Final resting position

² The port side wingtip float is seen in the fully retracted position with the wing bent slightly upwards. The starboard wingtip float is partially extended towards the down position. This float condition occurred subsequent to the aircraft coming to a halt.

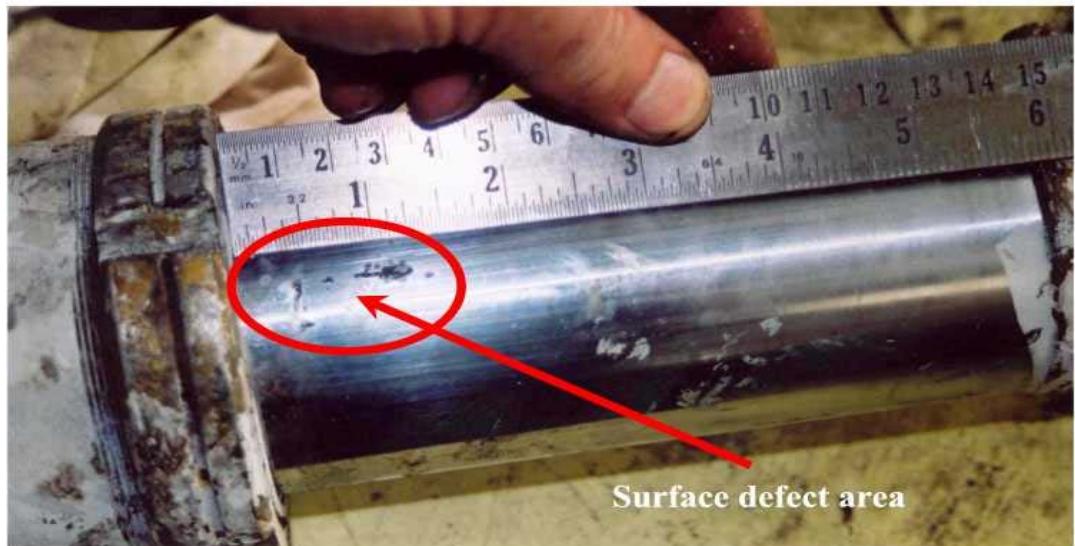
It was noted that the surface of the sliding section (inner cylinder) of the left undercarriage had a deep surface defect approximately 15 mm above its normal resting (extended) position (**Appendix B**). The appearance of this defect indicated that the damage was present before this event and would have been clearly visible during a daily inspection or pilot walkround. The defect appeared to be the result of impact damage. Further research found that maintenance personnel had previously noted the defect, as it was causing damage to the seal in the cylinder, when the leg was compressed by landing loads, to a point where the seal passed over the defect. In order to prevent seal damage, the shock-strut was inflated to approx 1,200 pounds per square inch (p.s.i.), so that during normal landings the shock-strut would not compress to such an extent that the seal would pass over the defect. It was also necessary to over-inflate the right shock-strut to the same pressure, in order to keep the aircraft level. The normal inflation pressure for the struts is 800 to 900 p.s.i.

The overall aircraft was well maintained. However two defects existed in the left leg undercarriage shock-strut, namely the readily-seen defect on the surface of the sliding cylinder and the reduced thickness of the support housing of the centre-point folding bolt. Both of the defects both merited repair or replacement of the leg.

Fig 3. Sliding section of left shock-strut.

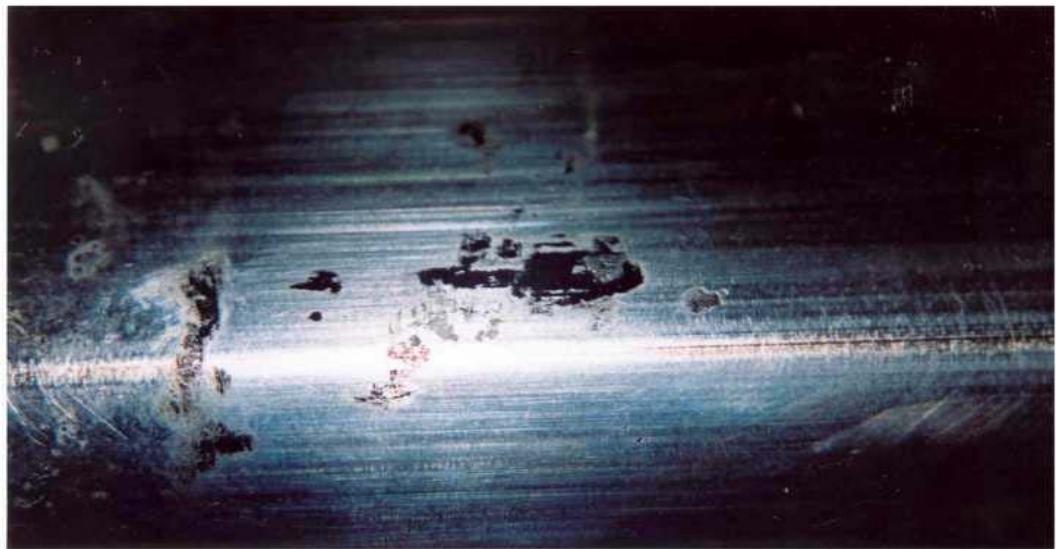
Fig 4. Magnified surface defect area
