AAIU Synoptic Report No: 2004-001

Aircraft Type and Registration: Agusta B206 Jetranger EI-BKT

Location: Dublin Port

Nature of Damage: Heavy landing damage

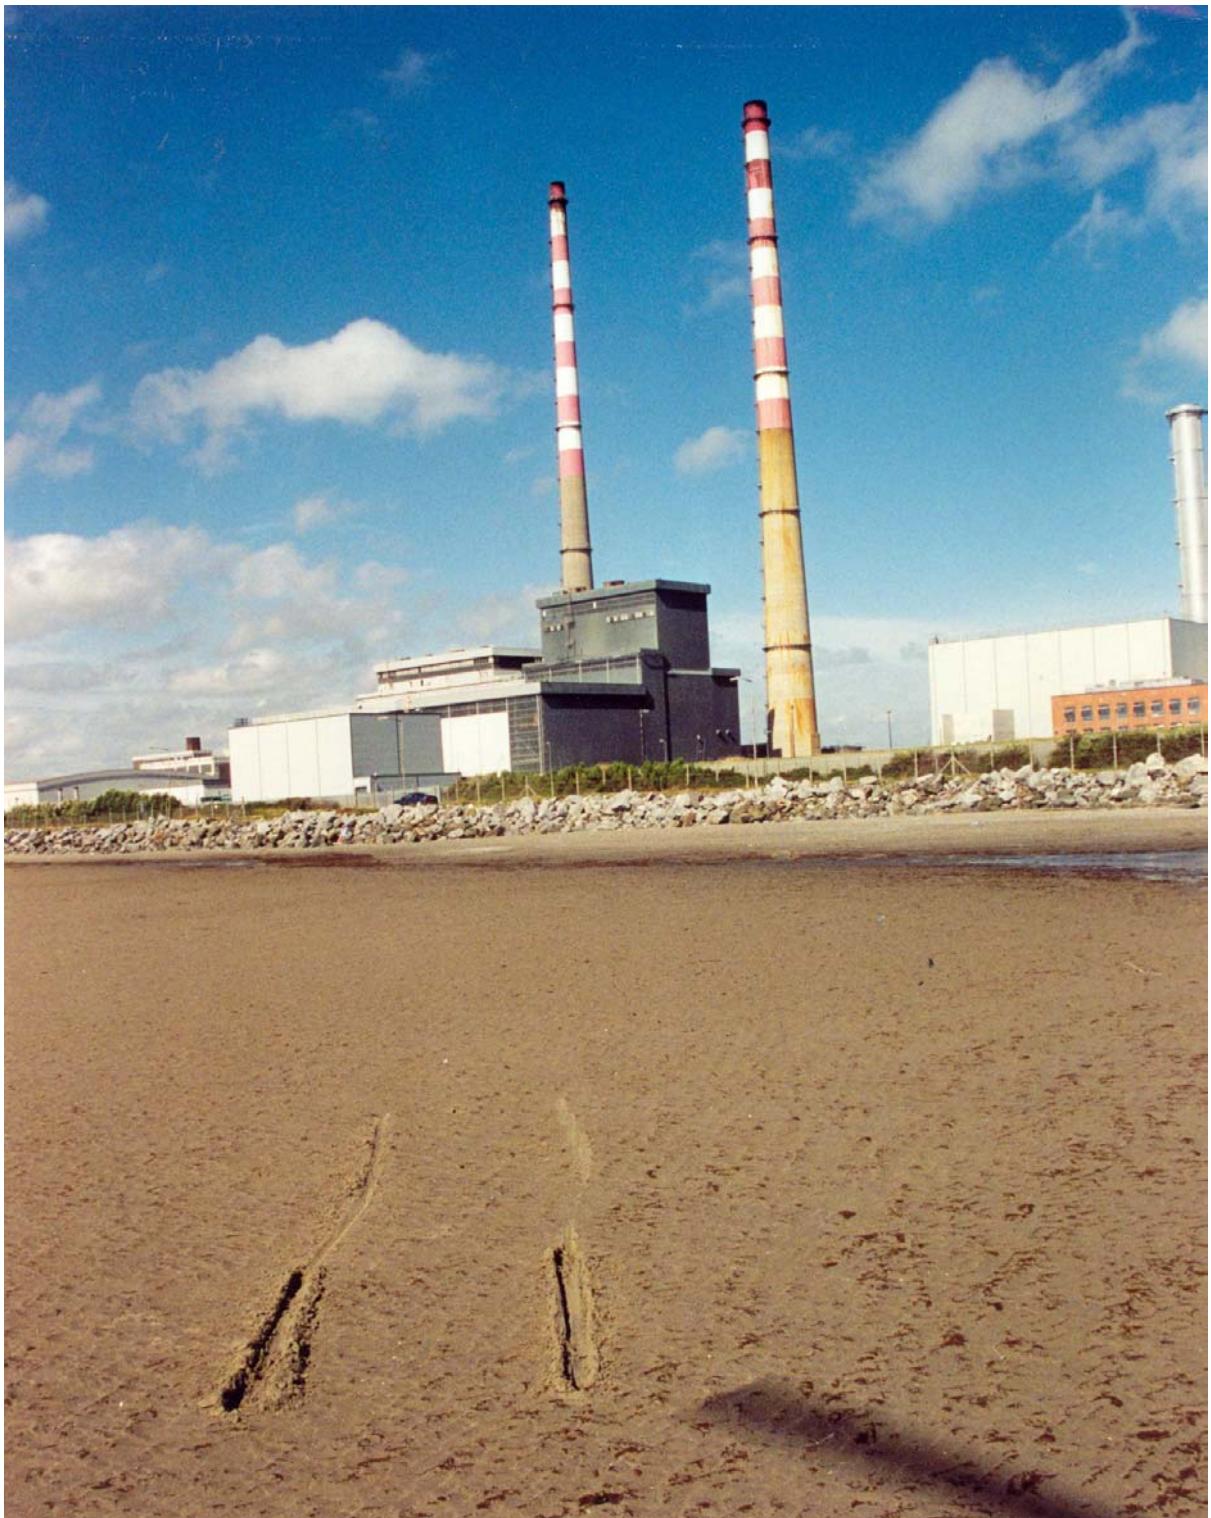
Appendix A

1.3.4 One of the camera crew subsequently stated that he could not see an exhaust plume as the helicopter approached the chimney. A photograph was taken of the landing area shortly after the landing. The chimneys are clearly visible in the background and no plume is visible in the photograph (ref **Appendix A**).

- 2.2 The plume only became visible on the camera tape when the helicopter came very close to the chimney. The fact that the plume was located, from the pilot's view-point, close to the horizon, would have made visual detection of the plume more difficult. It is also noted that one of the camera crew on the aircraft stated that he did not see the plume and that the plume was not visible in the subsequent photograph (Appendix A).

- 2.6 The plume from power stations is frequently invisible, particularly when the station is being powered by natural gas. In this case, neither the evidence of witnesses, the video tape nor the photograph taken after the event (Appendix A) indicate any discernable difference between the active and the inactive chimneys. Therefore the absence of a visible indication of an exhaust plume does not mean that no hazard exists.

Photograph of the landing area, which was taken shortly after the event. The helicopter had restarted and moved a short distance away from the landing point. The ground marks were made during the landing, which took place towards the camera. The chimneys can be seen in the background. The inoperative chimney is on the left and the chimney that produced the exhaust plume is on the right. It is noteworthy that the plume is not visible in this photograph.
