Air Accident Investigation Unit Ireland

FACTUAL REPORT

ACCIDENT
Cessna 172S, EI-DDX
Cork Airport

6 January 2020

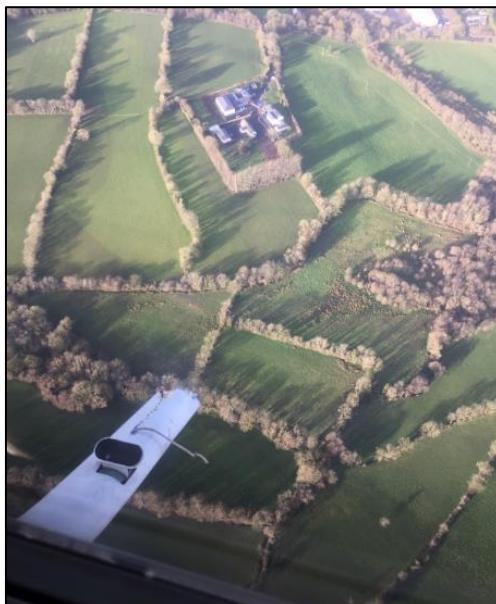
During the climb out, at approximately 300 feet AGL⁵, and whilst checking the position of the aircraft in relation to the runway centreline, the Student Pilot noticed that the left main undercarriage wheel was missing and '*had broken away from the strut*' as shown in **Photo No. 1**. This was relayed to the Instructor who immediately took control of the aircraft.

Photo No. 1: Left Main Undercarriage post touch-and-go (Source: *Student Pilot*)

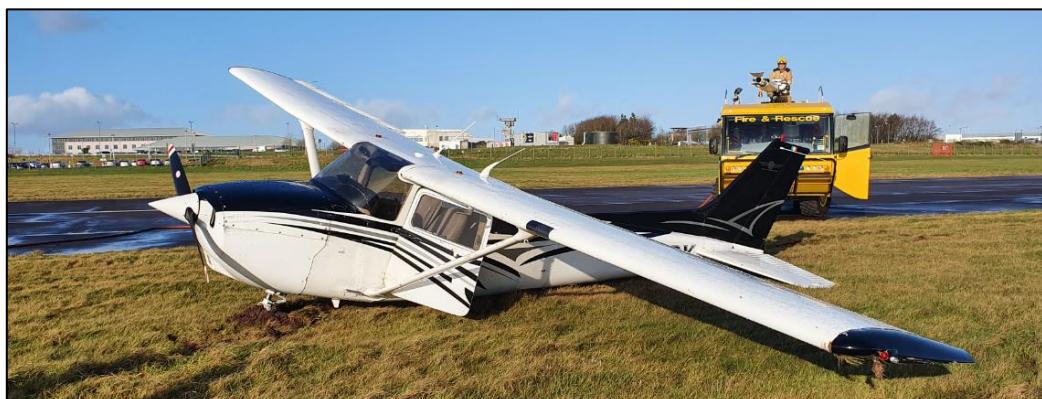
The aircraft sustained substantial damage to its left main undercarriage and associated sub-assemblies. The aircraft was steered off the runway and the aircraft's nose landing gear, propeller, left wingtip, left horizontal stabiliser and elevator all sustained ground impact damage. There was also possible shock loading to the engine. **Photo No. 2** shows the final position of the aircraft where it came to rest adjacent to RWY 25.

Photo No. 2: Final position of EI-DDX

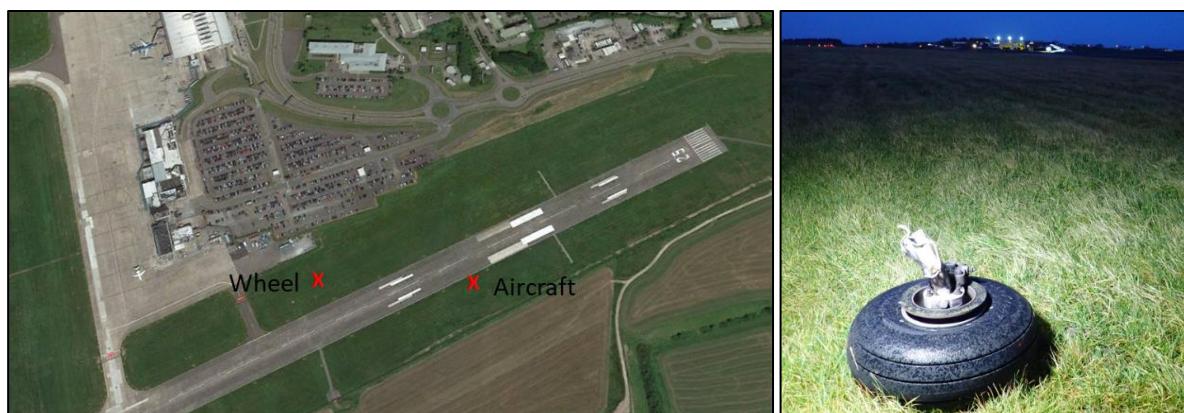
The aircraft's left wheel and brake assembly, which departed from the aircraft during the touch-and-go landing, was recovered from the grass on the right side of RWY 25 as shown in **Figure No. 2** and **Photo No. 3**.

Figure No. 2: Wreckage locations
(Source: Google Earth)

Photo No. 3: Detached Left wheel

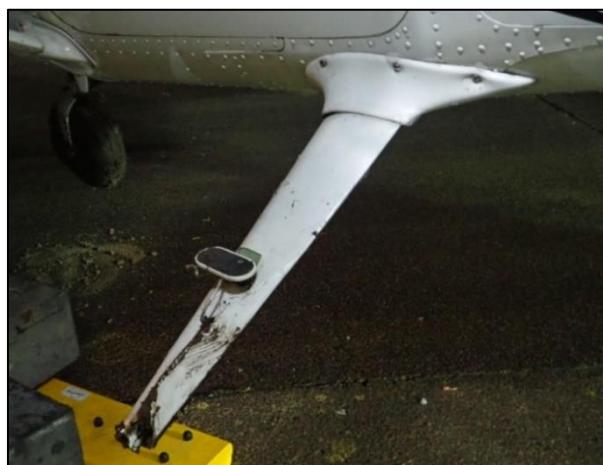
Photo No. 4: Damaged Left Main Undercarriage

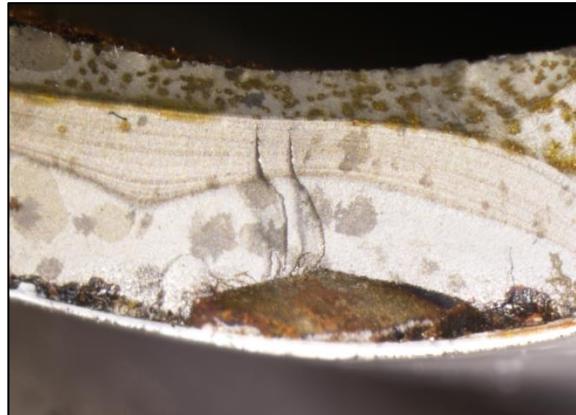
The recovered left undercarriage wheel, which was still securely attached to its axle and a portion of the main undercarriage leg, was retrieved from the grass verge of RWY 25. The fracture surface on the leg displayed distinct markings and discolouration, which were consistent with fatigue cracking. At the fracture surface, a portion of base metal was absent and several cracks emanating from this area were evident (**Photo No. 5**). On subsequent inspection using a microscope, a number of additional areas of surface corrosion around the outside diameter of the leg and in the vicinity of the fracture were also identified. See also **Figure No. 6** and **Figure No. 7**.

Photo No. 5: Microscopic examination of fracture surface (Wheel side)

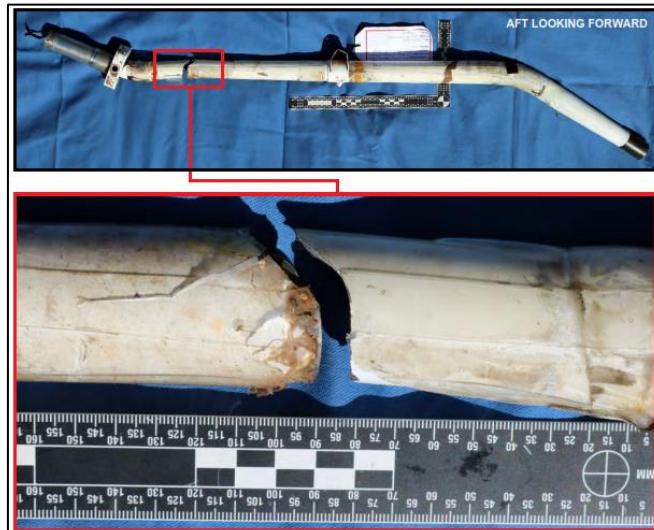
As shown in **Figure No. 3**, the leg had fractured approximately 130 mm from the wheel axle flange. The outer diameter (OD) of the leg had been wrapped in a clear polyurethane type tape. On the wheel side of the failure, the fracture surface was relatively clean, undamaged and the chevron markings indicated that the failure had initiated within a thumbnail-shaped region, which was located on the underside of the spring (as fitted to the aircraft) and the failure had propagated in both directions around the circumference.

Figure No. 3: Failure position

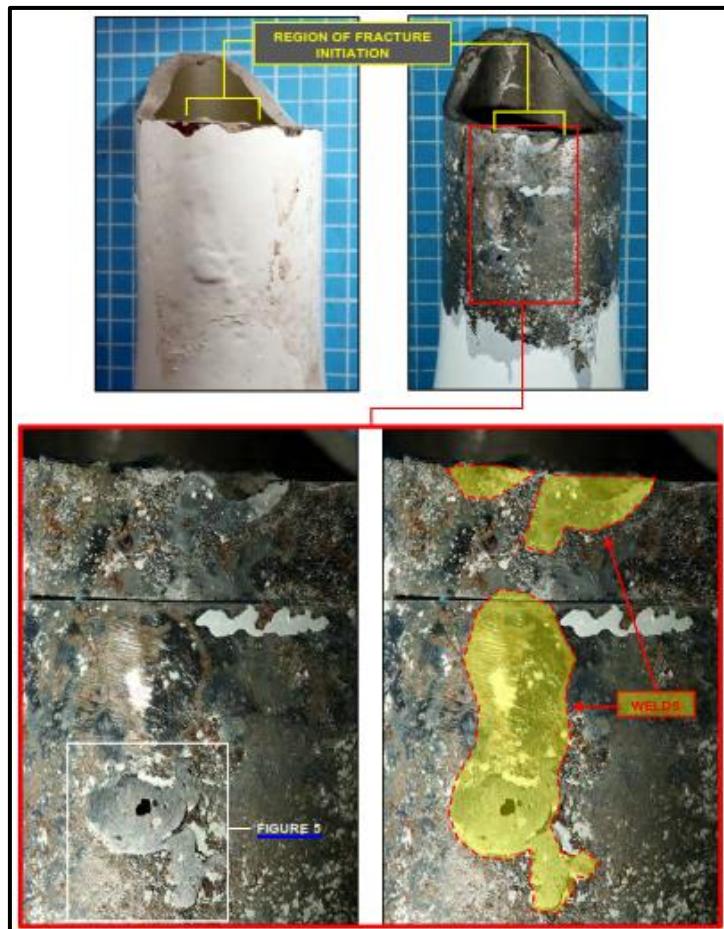
In the vicinity of fracture initiation, the surface of the white enamel paint coating on the OD was uneven and showed a prominent bulge, 25 to 35 mm from the fracture plane. The fracture surfaces were microscopically examined and the paint coatings on the OD of the leg were chemically removed approximately 60 mm from either side of the fracture plane. After paint removal, it became apparent that the bulge was due to a bead of weld. Several other welds were also visible (Figure No. 4(A)). Two of the welds were coincident with the thumbnail-shaped region of crack initiation, on the fracture surface. There were indications that an attempt had been made to grind off the excess weld metal but it still remained slightly proud of the surface.

Figure No. 4(A): Initial examination

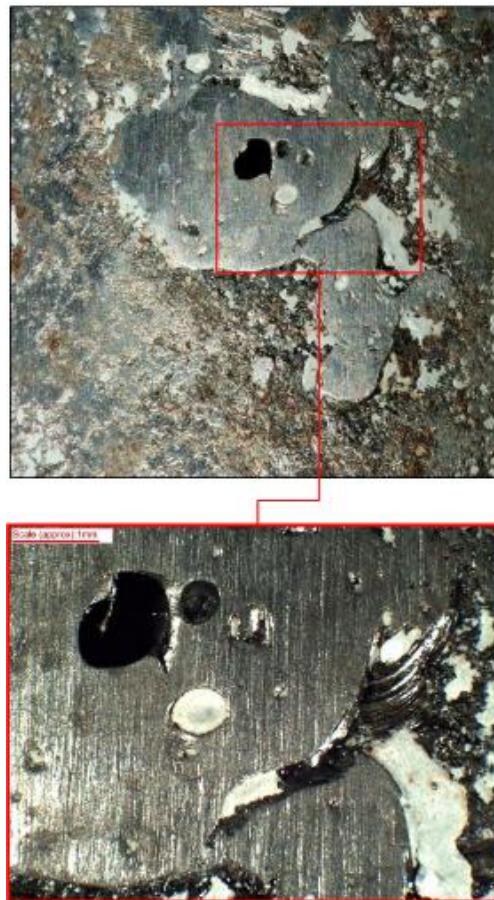
Metallurgical analysis identified that the welds were '*generally of very poor quality*', showing a high degree of surface porosity, and there was no significant evidence of corrosion of the weld metal. However, the surrounding surfaces of the OD showed widespread and severe pitting corrosion to the base metal which can be observed in Figure No. 4 (B). This indicated that the welds had been performed after the corrosion had occurred and that not all corrosion was removed prior to the weld repair.

Figure No. 4 (B): Weld porosity and severe pitting corrosion surrounding the weld

There was evidence of mechanical abrasion of the surface, which suggested that an attempt had been made to blend out some of the corrosion, with limited success. The welds and the residual corrosion had been painted over, resulting in the unevenness and bulge in the coatings described above.

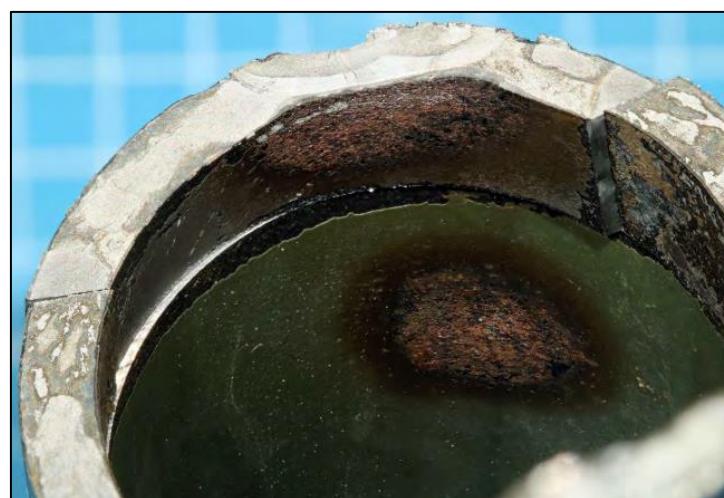
On the inner diameter (ID) of the leg, heat discolouration was evident in the green primer, at locations coincident with the location of the welds and this is shown in **Photo No. 6** below.

Photo No. 6: Internal heat discolouration

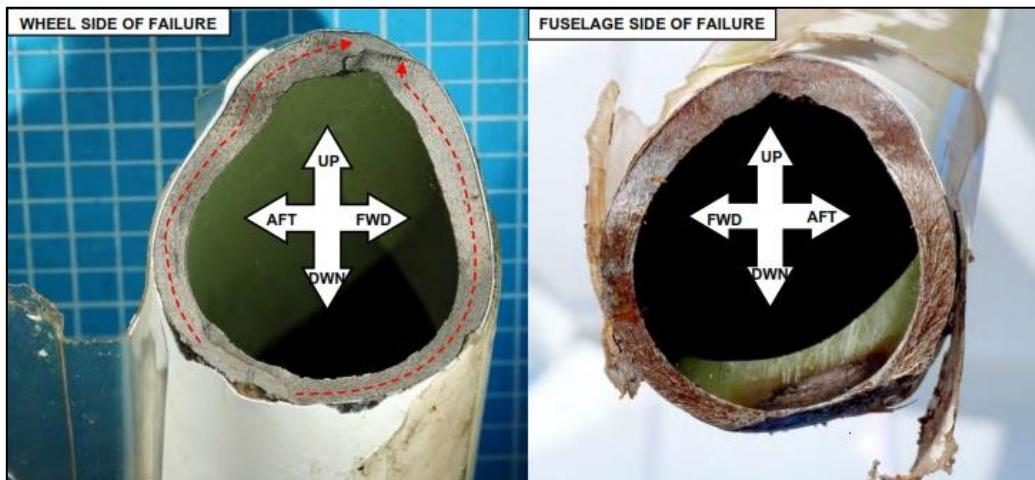
Both surfaces of the fracture can be observed in **Figure No. 5**. On the wheel side of the failure, the fracture surface was relatively clean and undamaged. Chevron markings present on the fracture surface indicated that the failure had initiated within a thumbnail-shaped region, which was located on the underside of the leg (as fitted to the aircraft) and had propagated in both directions around the circumference. The corresponding fracture surface, on the fuselage side of the failure, appeared to have dragged along the ground post fracture and the resulting abrasion had removed the thumbnail-shaped initiation region from it.

Figure No. 5: Fracture surfaces

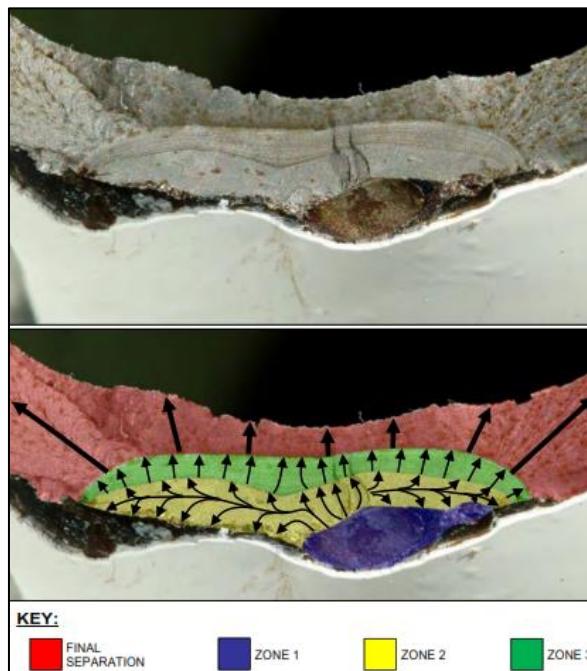
The thumbnail-shaped region of the fracture surface on the wheel side of the failure consisted of three distinct Zones and a Final Separation Area, and is shown in more detail in **Figure No. 6** and **Figure No. 7**.

Figure No. 6: Zones identified in fracture surface

Zone 1 extended inwards from the OD, and was at a shallow angle to it. It showed evidence of straw to violet heat tinting⁸, which indicated that it had formed whilst this region was hot. It also showed a light covering of red rust, which indicated that it had formed some considerable time before the date of the accident. When viewed on the OD, after paint removal, it was surrounded by weld metal.

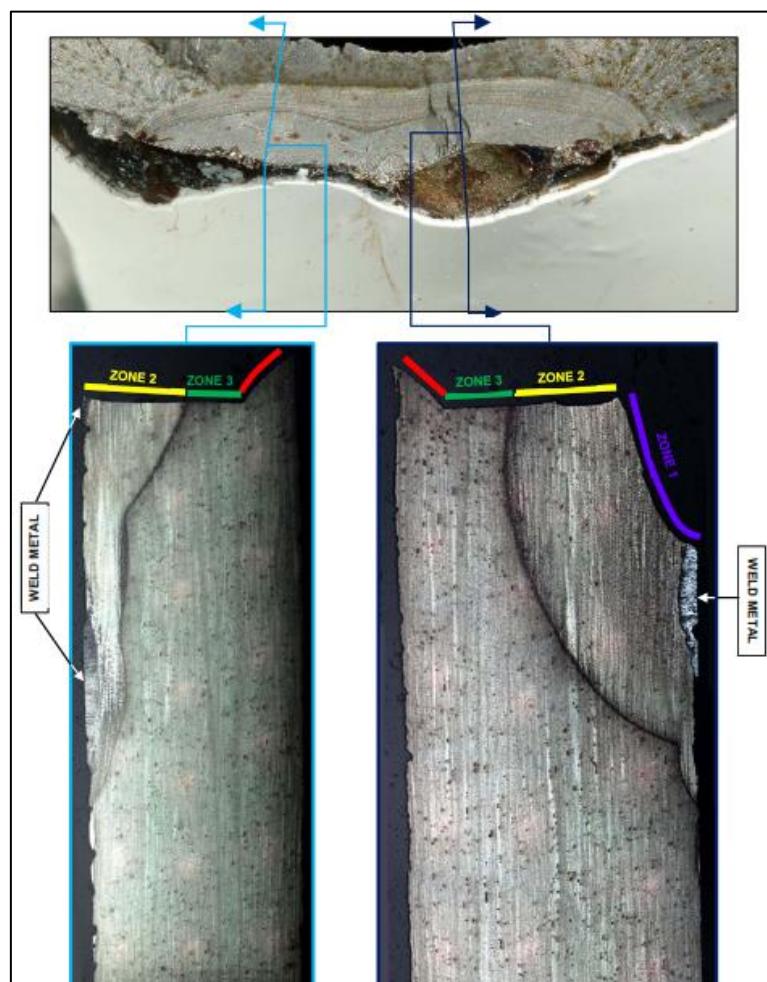
Etched metallographic examination indicated that this zone was entirely within the Heat Affected Zone (HAZ)⁹ of the weld (Figure No. 7).

Figure No. 7: Etched metallographic sections

Etched metallographic examination indicated that this zone represented the full extent of the HAZ of the weld as shown in **Figure No. 7**. When viewed at high magnification in the SEM, the secondary electron image (**Figure No. 9**) of the surface of this zone showed a significant degree of intergranular character. It was considered most likely to be an instantaneous but delayed fracture, which had occurred sometime after the welding had been performed. It was considered most likely that damp conditions during welding had caused hydrogen embrittlement and delayed fracture of the HAZ.

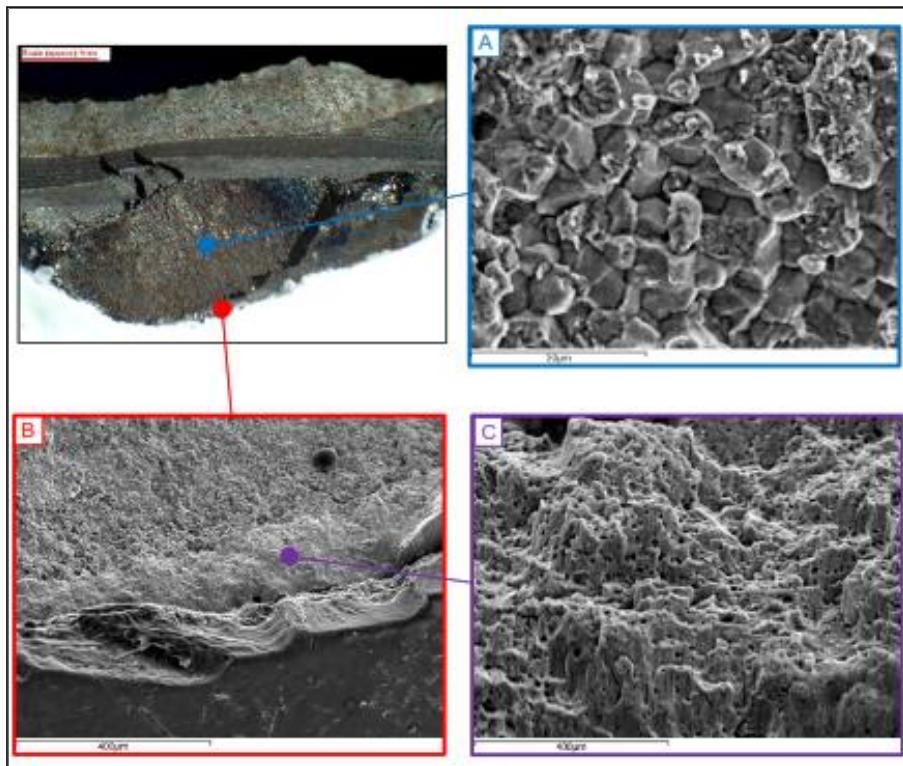
When viewed at high magnification in the SEM, the surface of this zone showed a high degree of intergranular character consistent with an instantaneous brittle fracture (Figure 8 (A)).

Figure No. 8: Secondary electron images of Zone 1

Around the edge closest to the OD, there was a narrow band of the fracture surface, which showed a dimpled texture, characteristic of ductile separation (**Figure No. 8 (B)** and **Figure No. 8 (C)**).

The characteristics of Zone 1 indicated that this crack had initiated sub-surface and spread outwards, towards the surface. It was considered most likely that damp conditions during welding had caused hydrogen embrittlement¹⁰ in the HAZ and that the crack had formed whilst the weld was cooling.

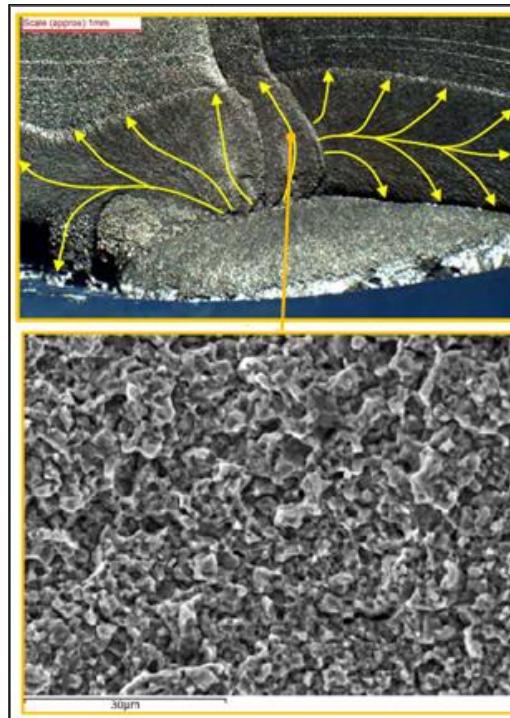
Zone 2 extended inwards from Zone 1 and was perpendicular to the OD. **Figure No. 9** shows the radial markings on its surface, which indicate that it had initiated from the edge of Zone 1. Two steps in the fracture surface indicate that this zone had formed by the coalescence of three separate cracks. No fatigue progression markings (beach marks) were visible on the surface.

Figure No. 9: Radial markings and secondary electron images of Zone 2

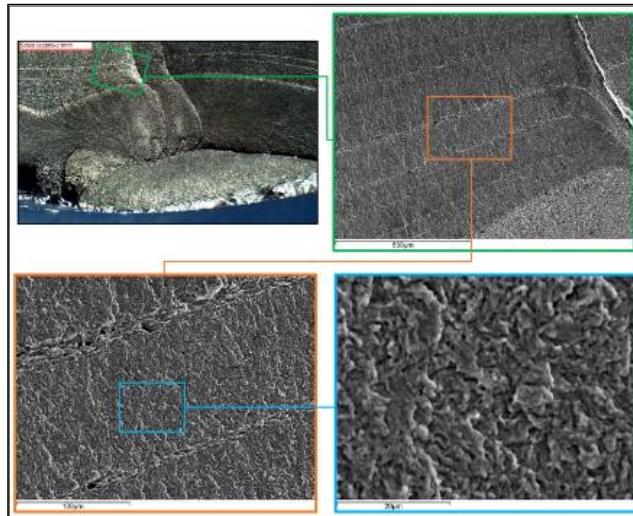
Zone 3 extended inwards from Zone 2 and was also perpendicular to the OD. Fatigue progression markings were clearly visible, which were concentric with the edge of Zone 2. Etched metallographic examination indicated that the transition from the instantaneous but delayed fracture of Zone 2 to the fatigue crack growth of Zone 3 had occurred at the edge of the HAZ of the weld as shown in **Figure No. 7**. When viewed at high magnification in the SEM, fatigue progression markings and fine striations¹¹ were evident, which were concentric with Zone 2 as shown in **Figure No. 10**.

Figure No. 10: Secondary electron images of Zone 3

This indicated that, outside the HAZ of the weld, the crack had extended for a period by stable fatigue crack growth. It was not possible however, to estimate the number of landings over which the crack had extended with any degree of confidence, by evaluation of these markings.

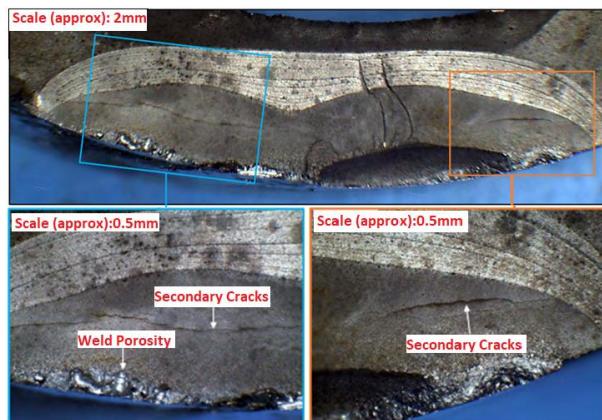
Secondary cracks were also detected in the weld HAZ (Zone 2) and were found to be perpendicular to the fracture surface and are shown in **Figure No. 11**. It was considered likely that they had been caused at the same time and in the same manner as Zone 1.

Figure No. 11: Secondary cracks on fracture surface

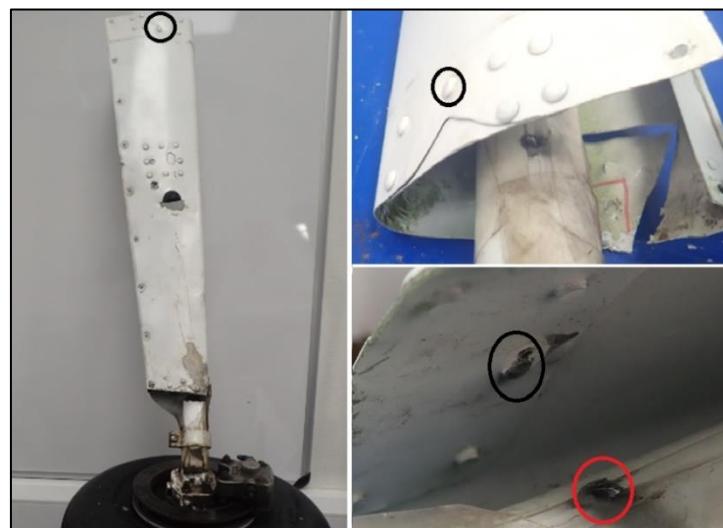
A sheet-metal repair to the left undercarriage aerodynamic fairing was found to have initiated a corrosion point at another location on the undercarriage leg. One of the rivet fasteners (circled in black in **Photo No. 7**) on the repair was found to be in contact with the leg. The contact between the rivet and the undercarriage leg was such that, through the action of fretting, the rivet had worn through the locally applied polyurethane tape and the protective enamel paint. This had eroded the undercarriage leg significantly, thereby exposing the undercarriage leg's base material to corrosion (circled in red in **Photo No. 7**).

Photo No. 7: Sheet-metal repair & associated damage to undercarriage leg

Metallurgical analysis revealed that the rivet had worn through the polyurethane tape and enamel paint coating to a depth of approximately 0.2 mm below the surface of the base metal. This was not considered to be associated with the failure of the undercarriage leg; however, it is possible that the corrosion would be concealed by the undercarriage fairings and therefore would not be evident until the fairings were removed during the next Annual Inspection
