Air Accident Investigation Unit Ireland

Executive Summary for Formal Report 2020-003

ACCIDENT
Cessna 208B, G-KNYS
Near Clonbullogue, Co. Offaly

13 May 2018

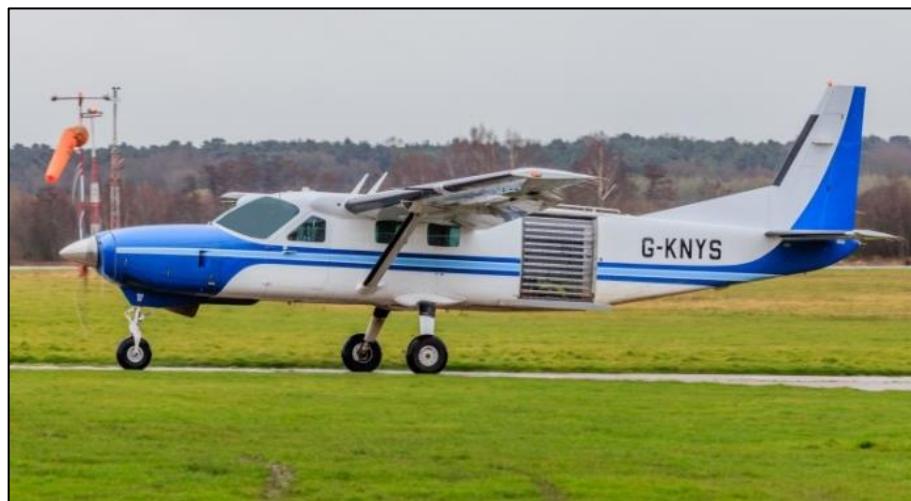
Photo No. 1: G-KNYS - Cessna 208B Grand Caravan (David Reeves)
