**Department of Transport
Air Accident Investigation Unit
25 Clare Street
Dublin 2**

FINAL REPORT

SERIOUS INCIDENT
to
MD 11
N803DE
at
Dublin Airport

AAIU Report No: 2003/004
AAIU File No: 2002/005
Published: 11 April 2003

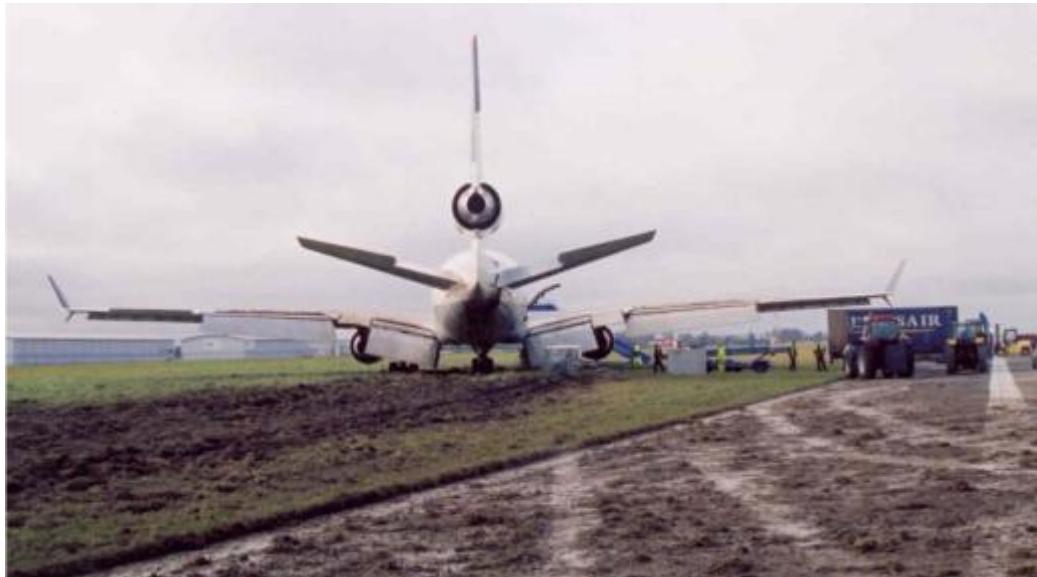
Fig 1

Approximately 3 seconds after touchdown, the FO confirmed “*Spoilers out*” and “*Three in reverse*” thereby indicating that the ground spoilers had fully deployed and that the three engines were providing reverse thrust. The Captain then called out that “*.....it's slippery*”, as the aircraft started drifting initially to the right and then to the left. Inputs from the Captain, consisting of full right rudder and right tiller, failed to arrest the drift to the left and the aircraft departed the paved surface on an indicated heading of approximately 270°, at a point halfway abeam Taxiway E5 and E6³. The aircraft continued through the prepared graded ground, which was rain soaked, for a distance of approximately 250 metres before finally coming to a halt at approximately 08.05:13 hours (See **Fig 1**). The RFO immediately asked the Captain if he required “*Engines off/Auxiliary Power Unit (APU) on*”. The Captain replied, “*Affirmative, tell them to remain seated*” and this action was carried out by the RFO, with the FO calling out the shutdown checks. The subsequent emergency response and disembarkation is covered under **Section 1.15, Survival Aspects**.

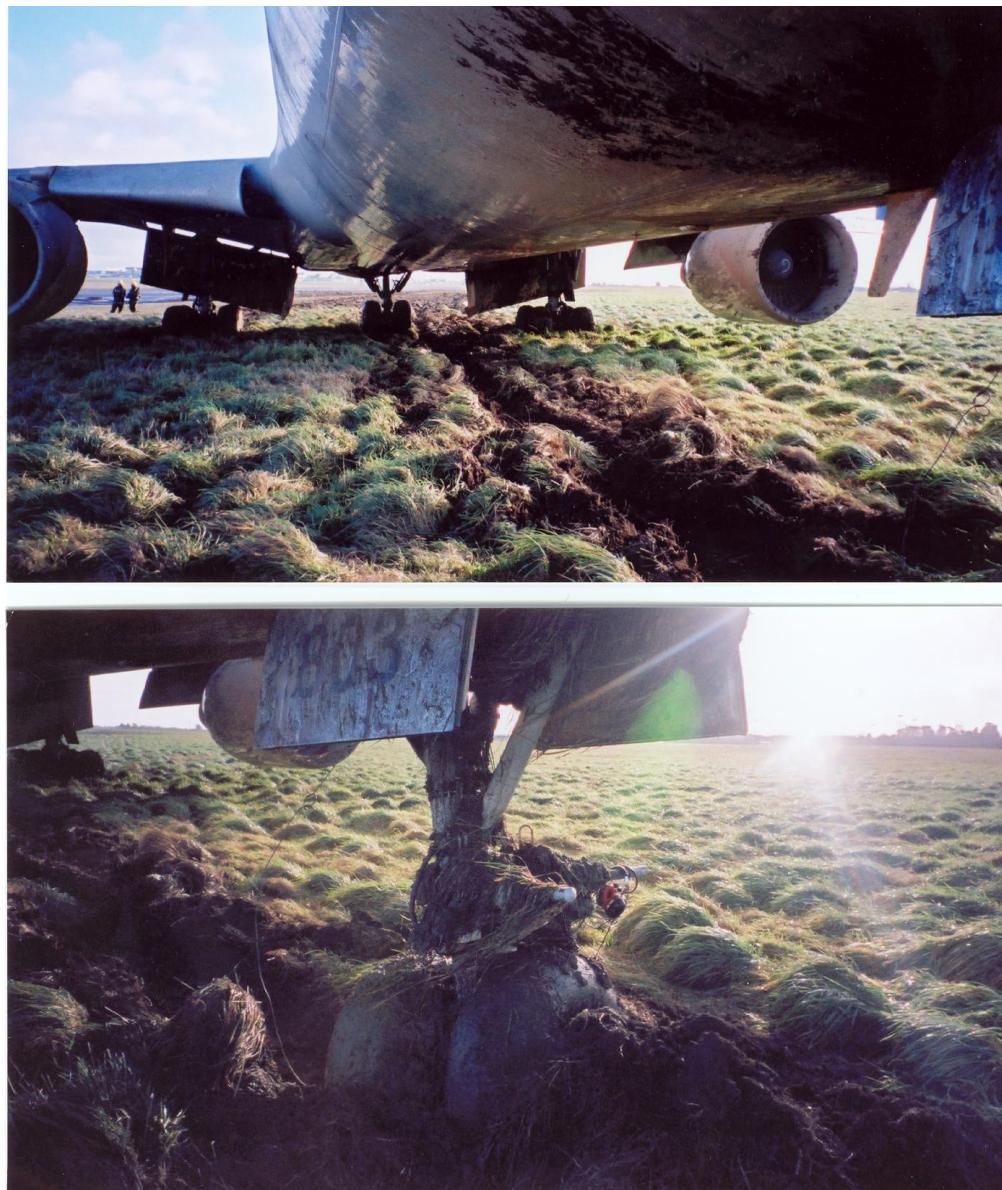
Fig 2

The initial damage inspection determined that the aircraft was covered in mud splash, in particular on the left side. The flaps and slats were deployed and the thrust reversers were stowed. The nose gear wheels were rotated at near 90° to the right of the aircraft centreline (See Fig 2). The brakes and wheels were embedded with mud. All wheels were still inflated and the brakes were intact.

No 1 and No 3 engine showed evidence of moderate Foreign Object Damage (FOD) ingestion in both the hot and cold sections, and damage was caused to the fan blades. The No 1 engine intake acoustic lining had a 3-inch hole in the (8) o’clock position. There was also evidence of mud around the No 2 engine intake. The left inboard flap fairing was damaged.

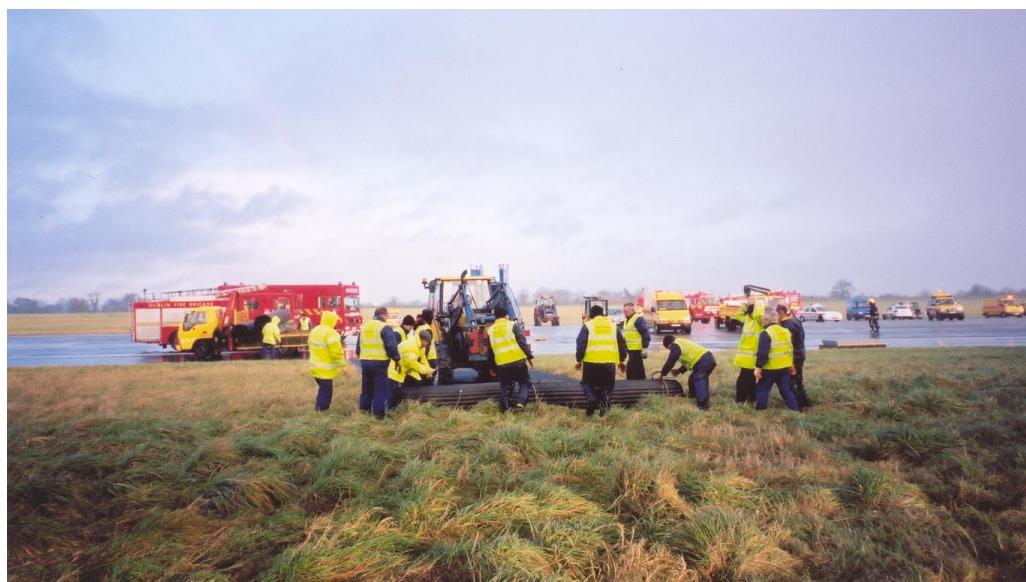
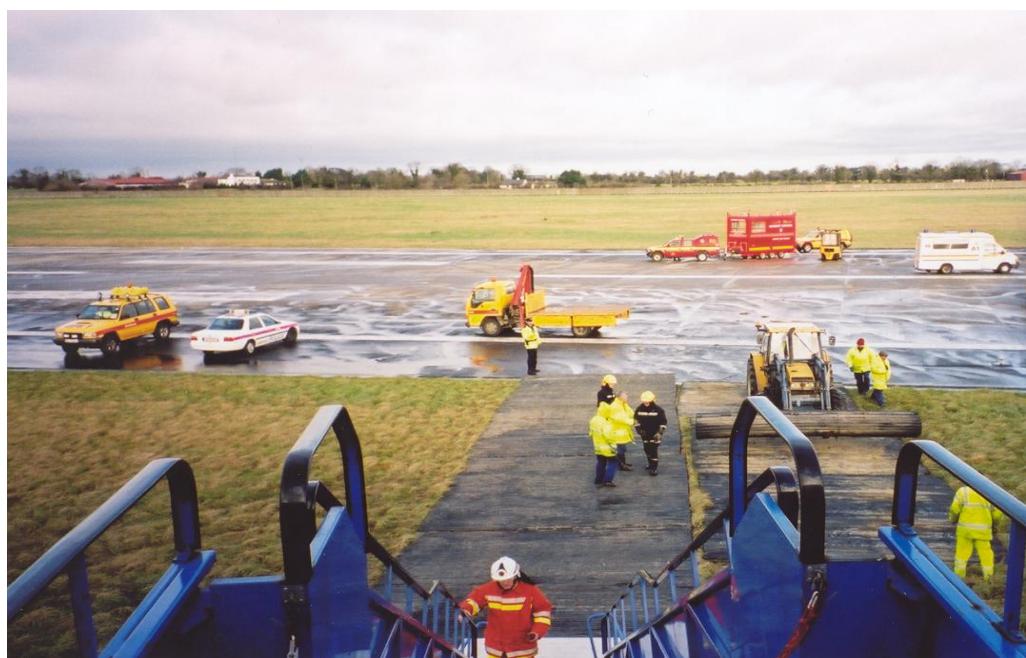
Fig 3

Disembarkation of the passengers and the crew commenced at approximately 10.05 hours through the R2 door and down the mobile stairs to the waiting buses. Both the Operator's Station Manager and one Company Agent were present for the passenger disembarkation and subsequent bus transfer. The passengers were bussed (about 10.29 hours) to Stand 34 (Gate B 26), where they were met by representatives from the Handling Agent and the Airport Authority.
